# EVELEIGH LOCOMOTIVE WORKSHOPS

## F A B R I C I N V E N T O R Y

## 1.0 EXECUTIVE SUMMARY

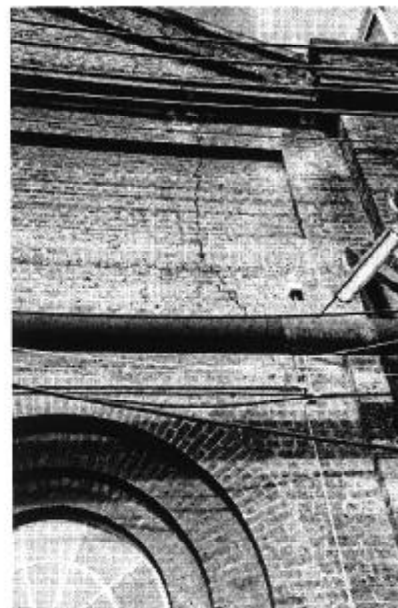
Cracks that affect a large portion of the wall, such as this one (shown above), require prompt repair in order to halt irreversible deterioration.

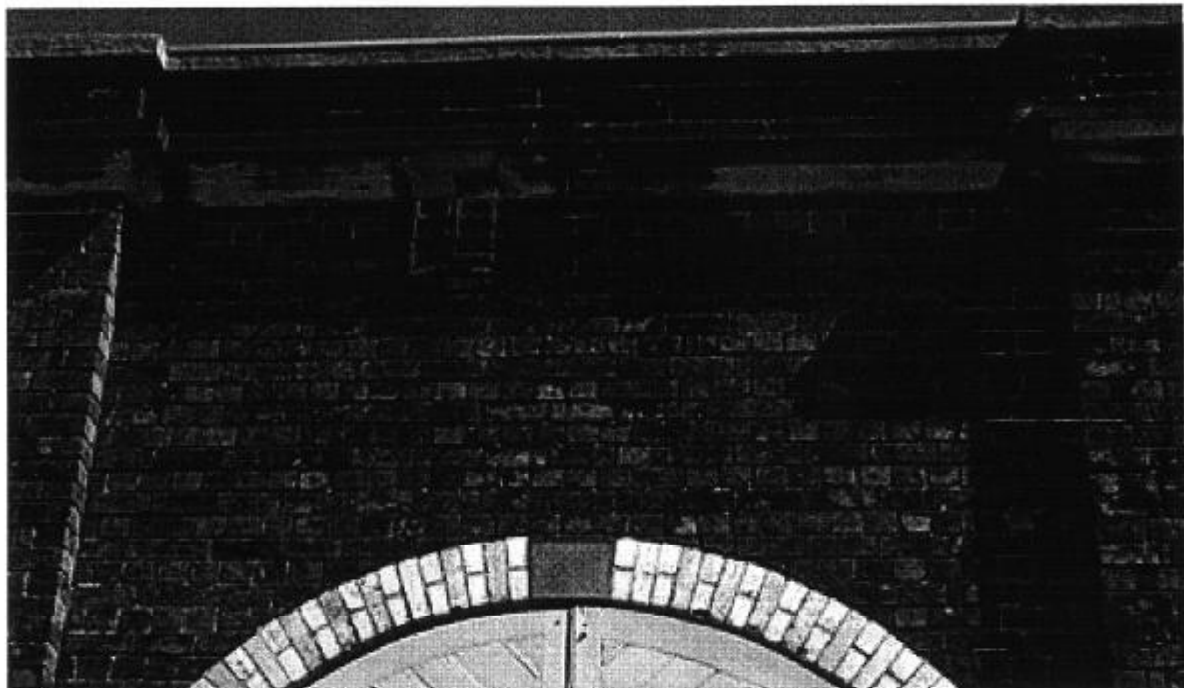
Damage to underside of cornice. Stones missing. South wall of annexe 13. Source: OCP 2002.

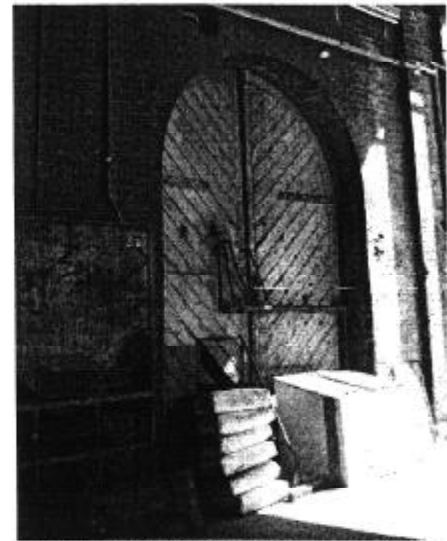
The doors on the south side in Bays 1 and 2 are the only remaining originals but are in an advanced state of deterioration and not operational. The doorjambs show extensive termite damage and require replacement. The door leaves in Bay 1 have numerous penetrations and the replacement of those must be coordinated with the conservation of the machinery, which the penetrating pipes are connected to. These doors should be preserved rather than replaced.

The gate into Bay 1/South has been severely damaged by termites and excessive penetrations. Both original timber doors in this bay are in very poor condition. Source: OCP 2002.

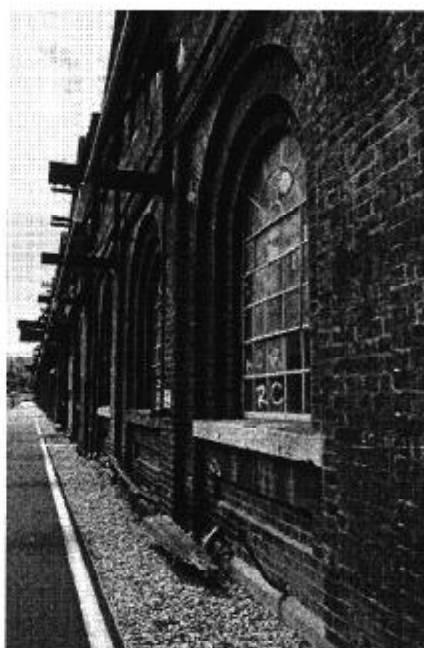
Timber seating, in various states of decay, runs along the north wall from this point (bay 14 looking east). Reconstruction is not required, but preservation and interpretation are recommended. Source: OCP 2002.

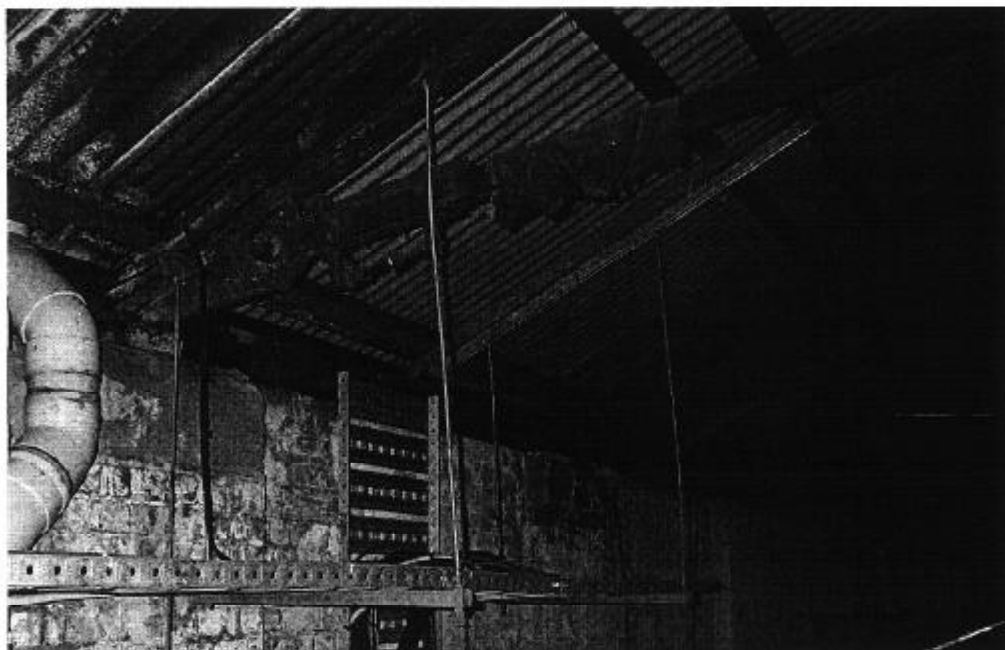
Cast iron wind bracing connecting to external wall, Bay 14 showing surface rust. Source: OCP May 2002.

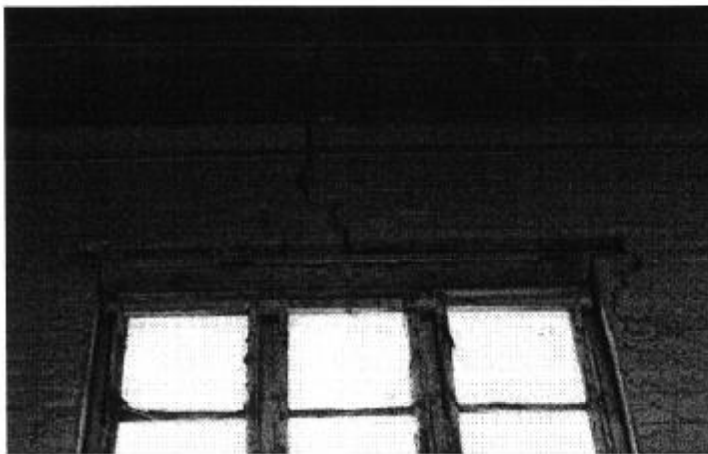
Severe internal cracking above an upper panel window of Bay 2 South. Source: OCP 2002

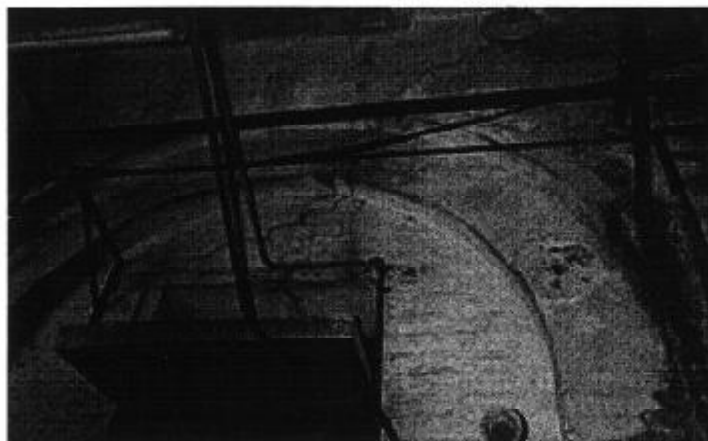
The air conditioning system installed through the blind window of Bay 3 South is intrusive and may also be the cause of severe cracking extending from this opening. This air conditioning unit should be removed in consultation with the structural engineer's report and the window made good.

The intrusive air conditioning unit installed in the eastern window of Bay 3 South may have caused the severe cracking. Source: OCP 2002

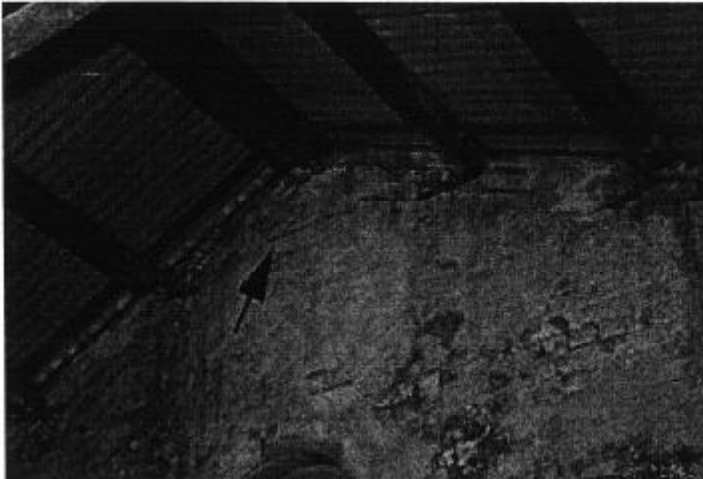
Commonly at the apex of the gable pediment, horizontal cracking has occurred. This recurring problem may be associated with the building structure so should be addressed by the structural engineer. Cracks on the pediments of Bays 11, 12 and 14 South should be repointed.

This type of cracking at the apex of the gable pediment is a recurring problem and should be addressed by a structural engineer. Bay 11 / South. Source: OCP May 2002

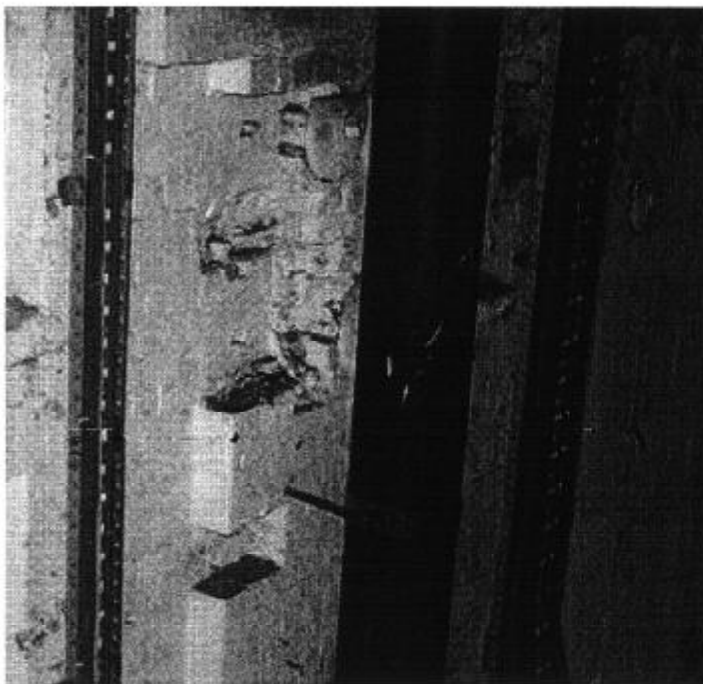
Interior brickwork on Pilaster 11 / South requires stitching. Source: OCP May 2002

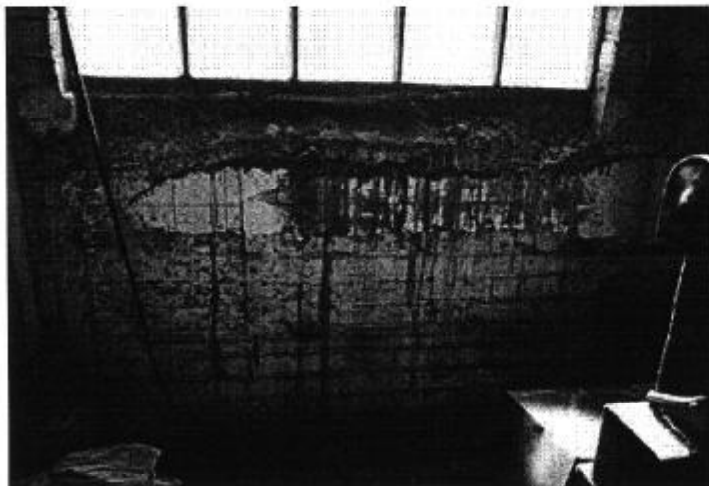
This sill is severely damaged and should be replaced. Annex 2. In most cases, similar repairs are noted on the line drawings. Source: OCP 2002.

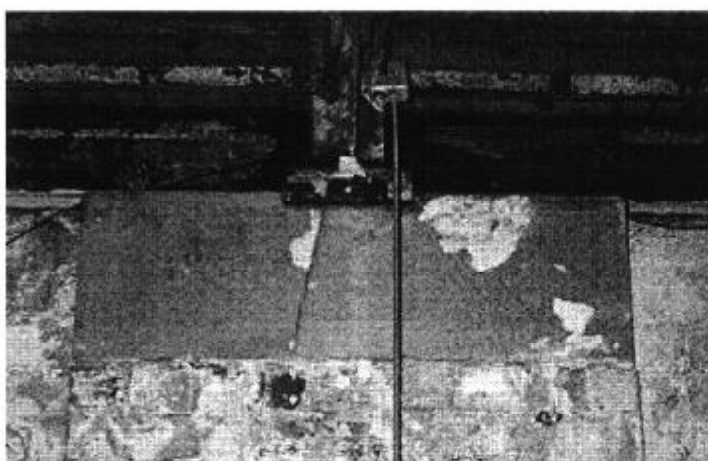
The sandstone seats atop pilasters display cracks, erosion and damage from exploding inserts. Access permitting, these stones should be monitored and cracks sealed. If the problem develops further a structural engineer's report may be required.

Crack in the sandstone seat of Pilaster A, Bay 14. This is a recurring problem that requires monitoring. Source: OCP 2002.

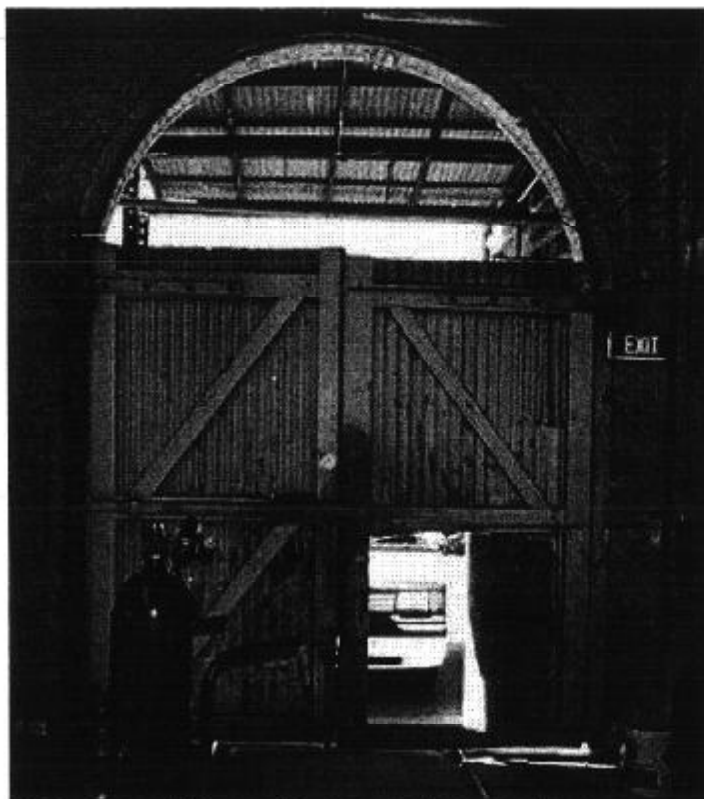
While this gate has been clad with corrugated sheeting, the original hinges remain and should be preserved. Bay 2 South. Source: OCP 2002.

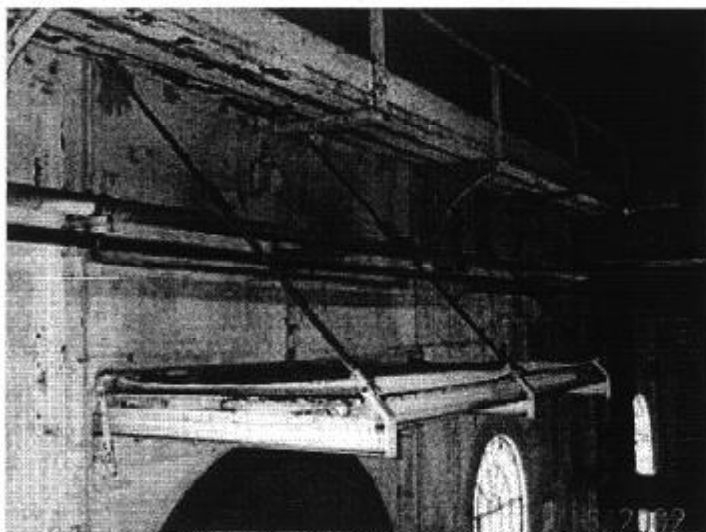
The awning over a doorway and the timber footbridge running along the north wall are part of the workshops phase and should be preserved. Bay 11 North. Source: OCP 2002.

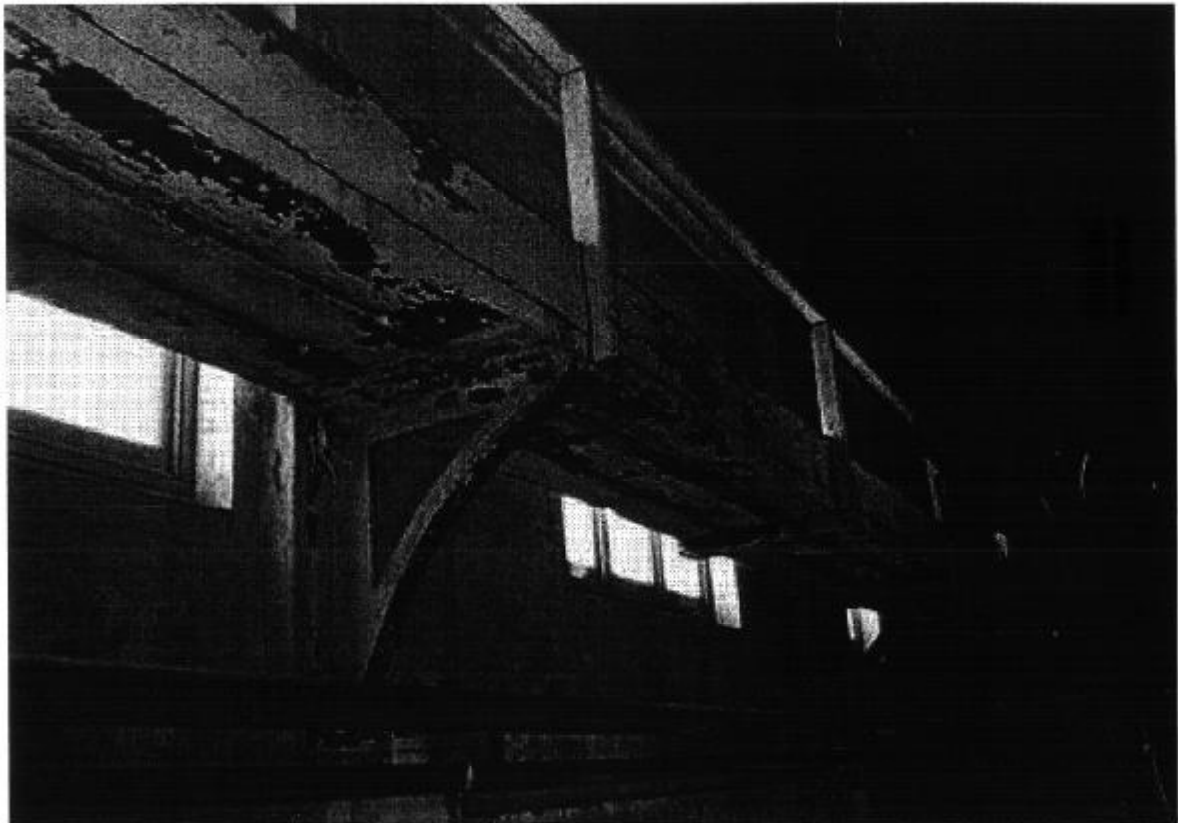
A wooden footbridge supported by steel brackets runs along the north wall. It is part of the workshops phase and should be preserved. Inspect regularly for termite damage and treat accordingly. Rust proof brackets if required. Bay 12, North Wall. Source: OCP 2002.

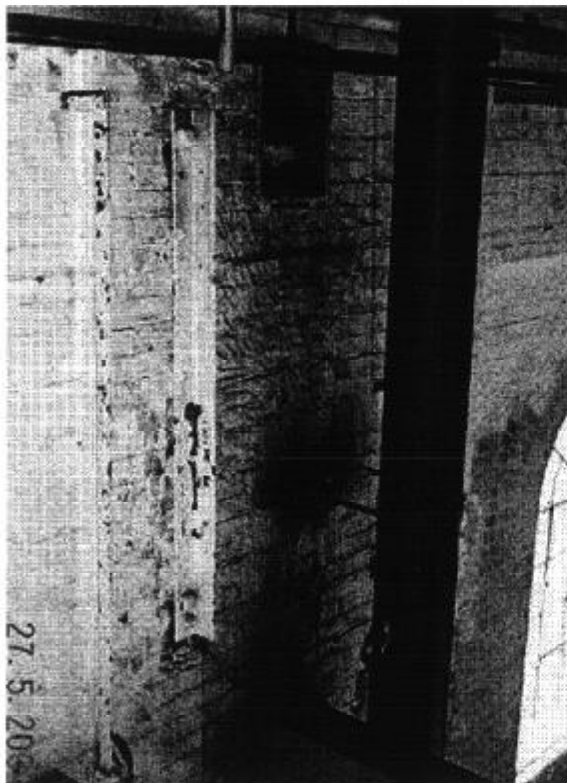
Discolouration to the brickwork of Pillar 12, North Wall. Source: OCP 2002.

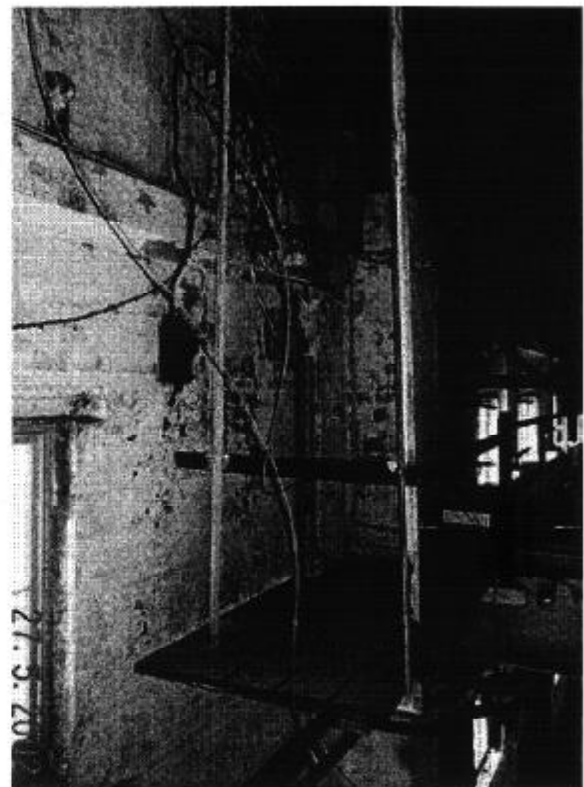
Mezzanine levels should be inspected for termite damage and monitored for stability. Bay 13 mezzanine. Source: OCP 2002.

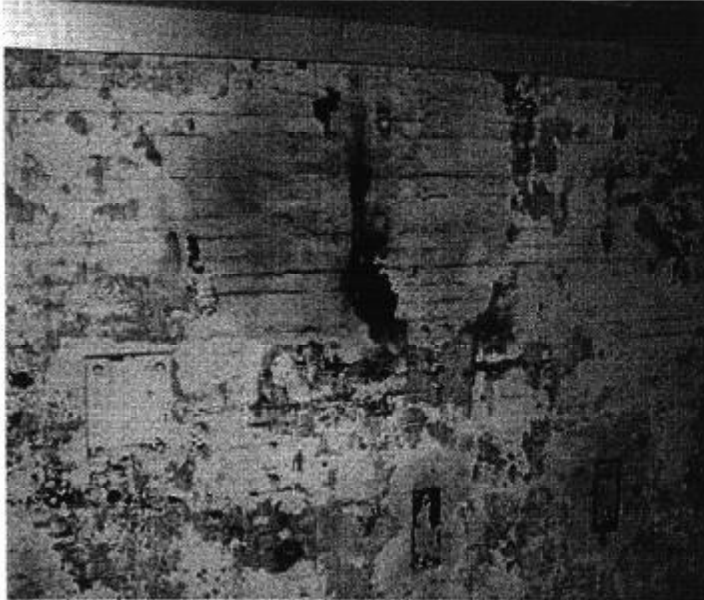
The partition wall dividing Bays 14 and 15 is in varying states of deterioration. Exploding inserts have caused extensive damage to the brickwork. Cracking and discolouration have resulted. These areas should be carefully monitored and repointed if further cracks develop.

Discoloured brickwork around an exploding insert. Eastern side of the partition wall dividing Bay 14 and 15. Source: OCP 2002.

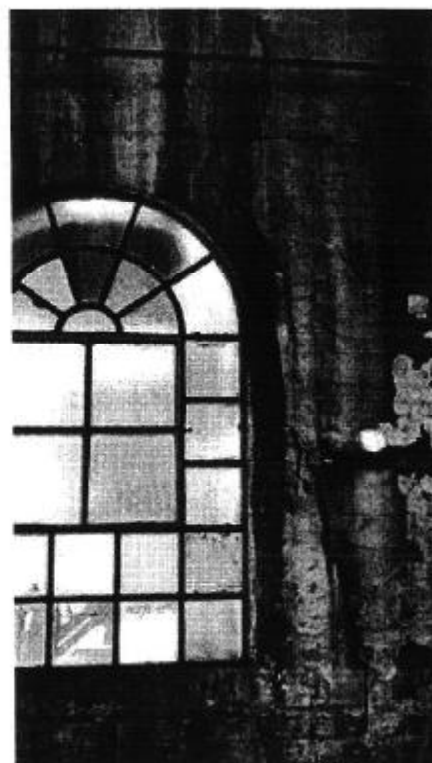
This large vertical crack in the South Wall of Annex 2 is one example of structural damage in Bays 1 and 2. Source OCP 2002.

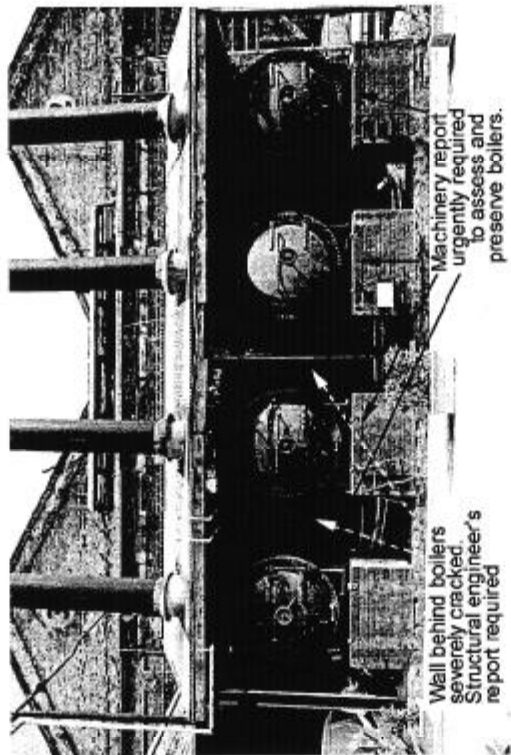
Wall behind boilers  
severely cracked.  
Structural engineer's  
report required
