# EVELEIGH LOCOMOTIVE WORKSHOPS

## F A B R I C I N V E N T O R Y

## 1.0 EXECUTIVE SUMMARY

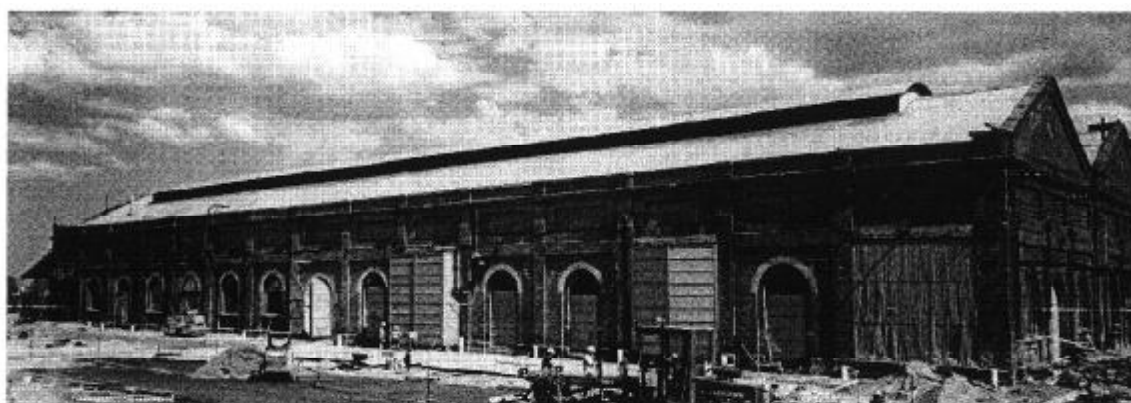
The east wall of the Locomotive Workshops Building, Bay 1, Rows 1-15, during restoration works in 1996. Row 1 is at the left. The photo shows the many alterations to this wall. The wall was subsequently repaired and the original detail reinstated in most bays. Fire doors etc. were added in bays already altered. Source: OCP 1996

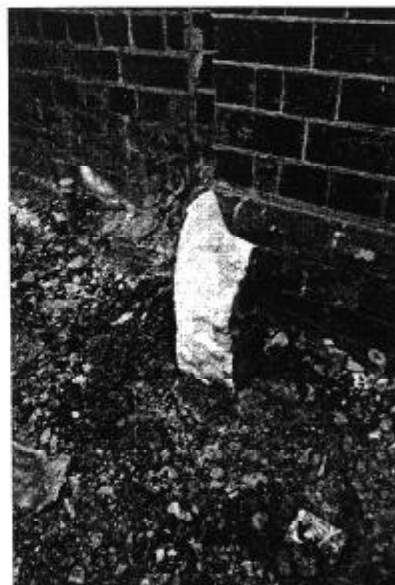
A section of cornice that has fallen from the building. Urgent works are a maintenance priority to ensure the safety of users of the ATP as well as to halt the deterioration of the building.

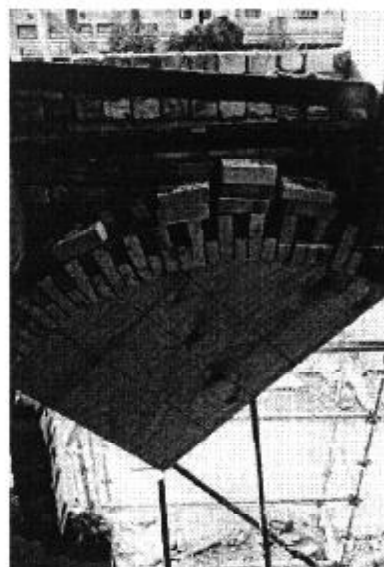
Restoration of some missing or deteriorated features, such as this brick archway, is acceptable in some cases. The works should be undertaken by specialist tradespeople with proven skills to ensure that the result is of the same high standard of the original construction. Source: OC+P 1996.

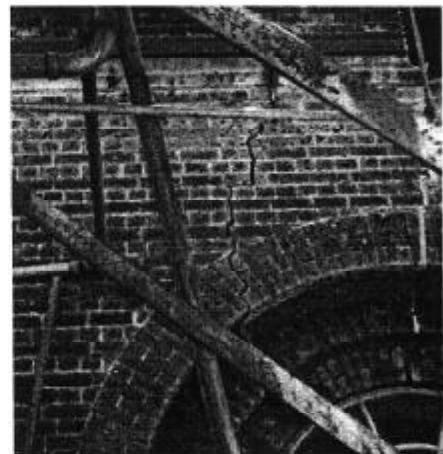
Some major cracks are still left unattended on the north side (Bays 1 & 2) and on the south side (Annexe 2 and Bay 2). A structural engineer's report addressing the stability and the recommended remedial works of the affected areas is required.

External cracks on the west wall of annexe 2, over arch (above) and at the junction between bay and annexe (below.) Source: OCP 2002.

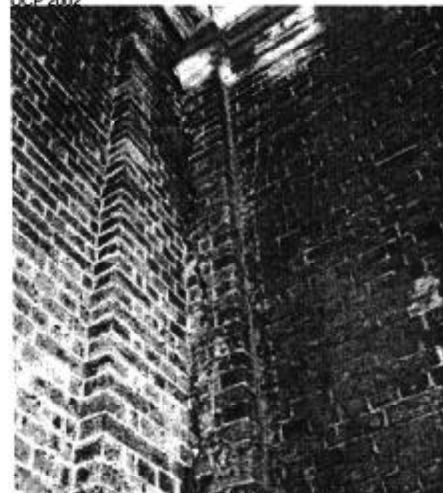
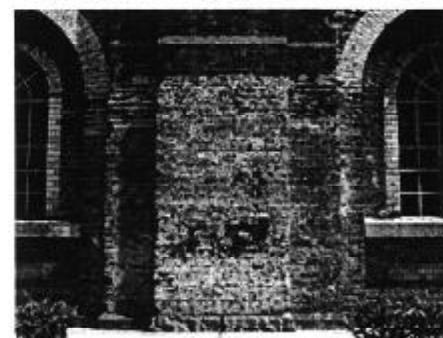
The pointing of the brickwork is in a reasonable condition. The areas to be repointed are indicated on the accompanying drawings. Some brickwork has been recently repointed, particularly on the south wall. Poor quality craftsmanship has left unfinished and intrusive patches of mortar. In future, any repointing work should be carefully monitored for quality, and undertaken by skilled tradespeople, as outlined in Policy 2.2.9.

Poor quality repointing work on pilaster 13, South. Source: OCP 2002.

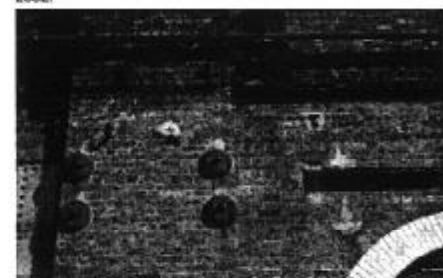
A large number of brackets and other support structures and elements are attached to the walls via various fixing methods and materials inside as well as out. Most of the fixing elements are made of ferrous metal in various states of corrosion. In some cases the levels of corrosion have resulted in the insert expanding and "exploding" the material it is inserted into. These inserts require prompt attention.

Numerous ferrous metal inserts, bolts and brackets on a south wall pilaster. Source: OCP 2002.

Where inserts are deemed intrusive and warrant removal, it is noted in the inventory. Unless otherwise stated, the treatment for most of the ferrous inserts is monitoring and rust proofing in order to prevent further deterioration. In general removal is not recommended unless specific inserts are damaging the surrounding fabric. These items are visible in the photographs but have not been included in the drawings.

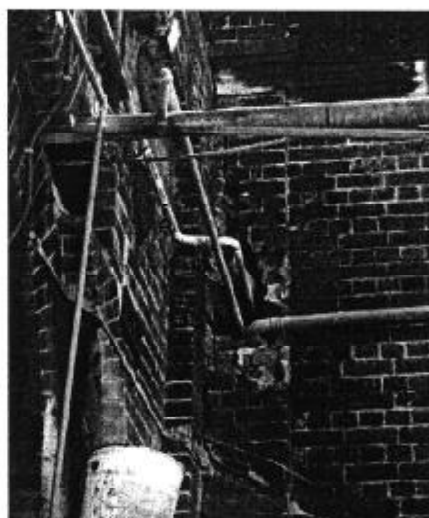
Inserted pipes have severely damaged the brickwork at this junction where Bay 2 meets the west wall of Annex 2. Source: OCP 2002.

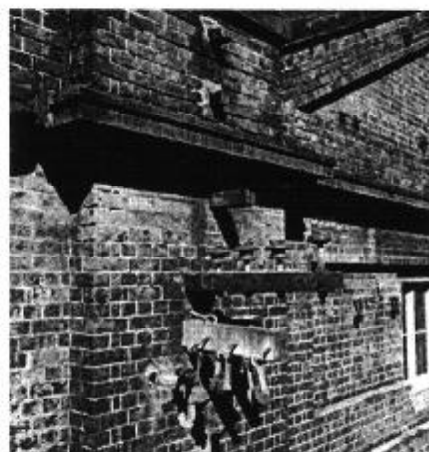
Note that some of the wood inserts still in situ are in a state of advanced decay. Thus the joint between the wall and the insert creates a potential for water ingress. The regular swelling and shrinking of the wood blocks is potentially damaging to both the wood blocks and the brick walls.

Timber inserts and brackets should be monitored for damage to brickwork and water ingress. Photo Bay 13 North Wall. Source: OCP 2002.

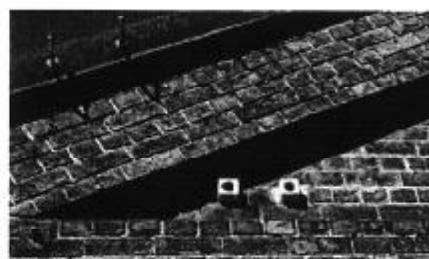
There are occasions where the porcelain insulators formed rows without support (lintel) for the brickwork above ( $1\frac{1}{2}$  to  $2\frac{1}{2}$  brick length). These places are to be monitored and action taken when necessary.

(Above) Extruded porcelain inserts. (Below) Inserts are supporting brickwork. Carefully monitor, secure as required. Photos from Bay 10 North. Source: OCP 2002.

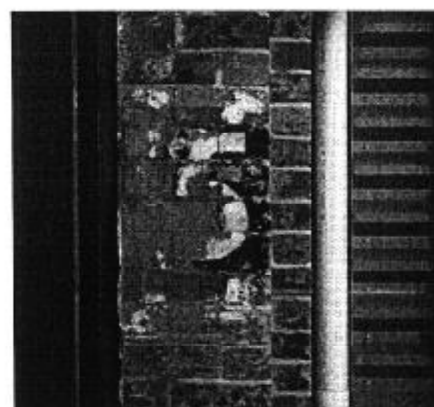
Remnants of original bay number on Bay 16, south. Source: OCP 2002.

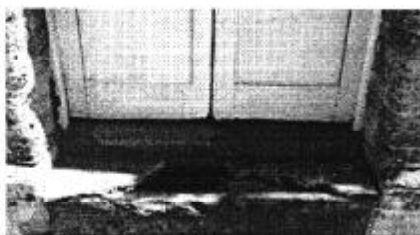
Cracked threshold. West wall of annexe 6. Source: OCP 2002.

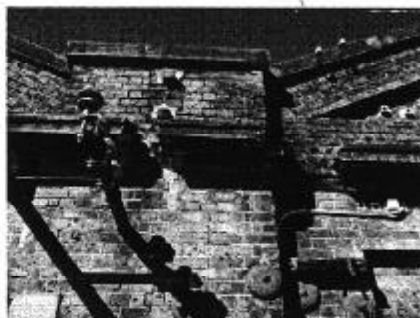
Missing cornice stones. Pilaster 8, North wall. Source: OCP 2002.

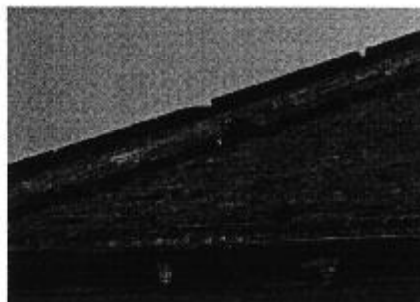
Some coping stones are badly exfoliated as a result of their high salt content (particularly on the southern side). Open joints should be filled with lime mortar to match existing. All joints on the horizontal surfaces have to be re-pointed using elastomeric sealant on the top only. The stones that are beyond repair (shown in the drawings) should be replaced.

Eroded coping stones. Source: OCP 2002

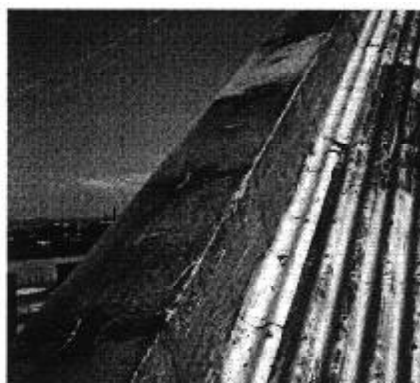
Traditional cast iron toggles, shown in the parapets above and below, should be replaced with stainless steel fixings if damaging the stone. Source: OCP 1995.

Where they are damaging to the stone, replace the traditional cast iron fixing and connecting elements (ie. cramps, dowels etc.) with stainless steel.

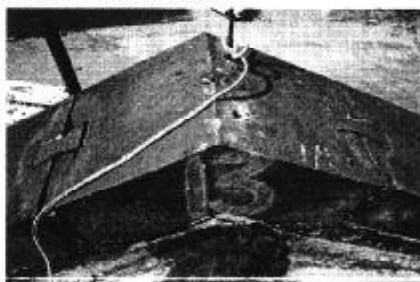
The underside of the cornice stones have deteriorated extensively due to the polluted air, the salt content and acidic stormwater. Most of the loose particles have been removed, resulting in safe but significantly damaged elements. The long-term strategy of the building maintenance should include the replacement of the affected stones. Note that replacement means indent repair, ie. cutting out and replacing the external part of the cornice stones only. There are, however, stones of the cornice that show cracks at the seating of the roof trusses internally. It is necessary to replace these whole stones.

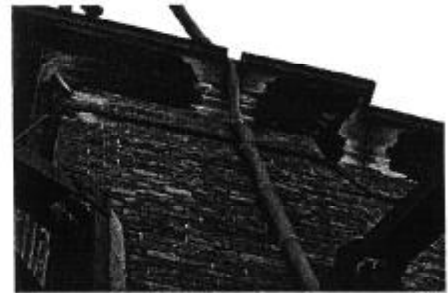
Piping penetrating cornice. Also note damage to underside of stonework. Plaster A, West wall. Source: OCP 2002.

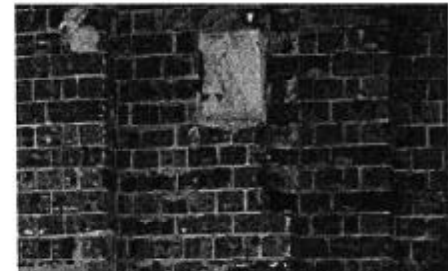
Broken corbel. Also shows damaged brickwork. Bay 7 / South. Source: OCP 2002.

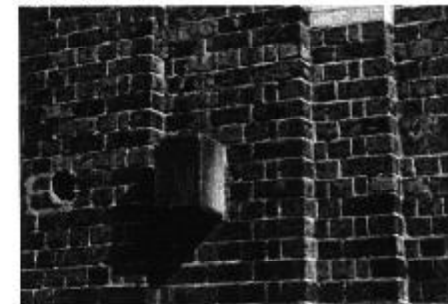
The three sandstone corbels on the southern facade of Bay 16 are intact and in excellent condition. This is the only bay where these remain as Bay 7 corbels have been removed. The corbels are believed to have formerly supported first floor amenities and should be conserved.

Remaining intact corbel. Bay 16 / South. Source: OCP 2002.

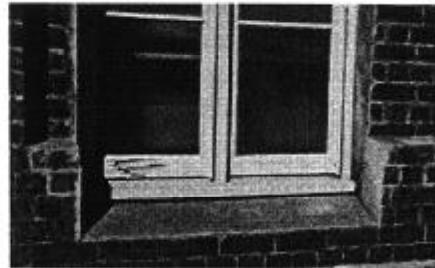
Splintered timber window. Possibly termite damaged. Bay 9 / North Wall. Source: OCP 2002.

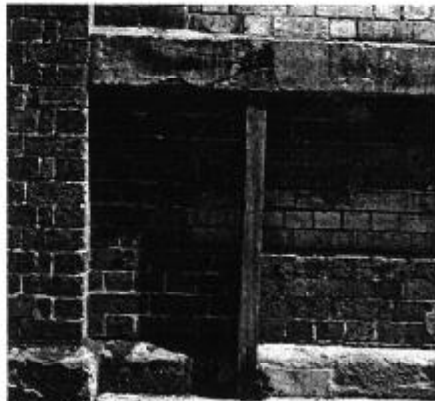
Broken sill supported by timber wedge. Bay 12 / South. Eastern window. Source: OCP 2002.

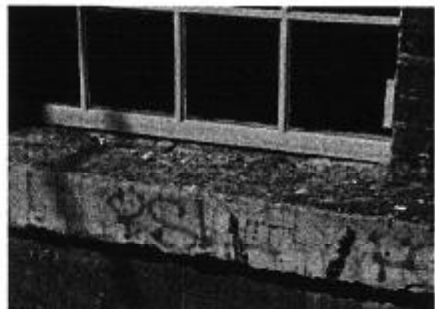
(Above) This sill is exfoliating and damaged by weathering and graffiti. (Below) An example of water damage to the sill underside. This could be avoided by incorporating drip grooves into new sills. Source: OCP 2002.

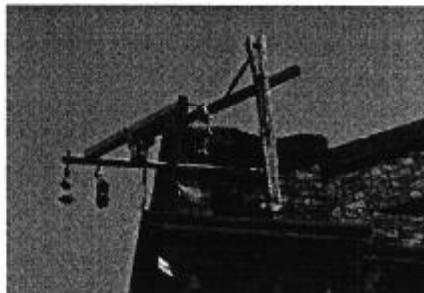
The large bracket attached to the south-west corner of Bay 16 and Row Q is deteriorating dangerously. It is not considered significant and should be repaired or removed urgently.

The large timber bracket hanging precariously from the corner of Bay 16 South / Row Q West should be repaired or removed urgently. Source: OCP 2002.

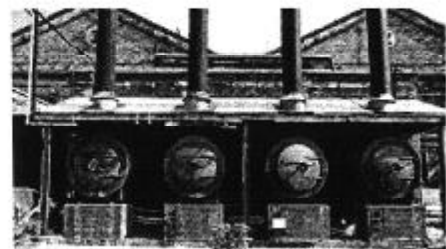
A machinery report has been compiled by Roger Parris to assess the physical condition of historic machinery and associated pipe work. In particular, machinery on the north wall is rusting with some holes and requires urgent attention to prevent further corrosion. The boilers on the south wall are also in very bad condition. Asbestos dust is leaking through holes in the body of some boilers and will obviously require professional attention immediately.

Original machinery, such as the boilers, requires urgent preservation. See separate machinery report, Annex 4a South. Source: OCP 2002.

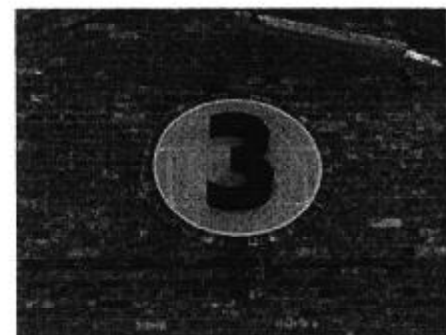
On the south wall, the bullseye windows have been covered with modern signage, displaying the bay numbers. No conservation work has been done on the bullseyes, or the louvres. If other work is carried out in the vicinity then the opportunity should be used to remove the mesh signs and conserve the bullseyes and louvres as required. Louvres should be reinstated if missing. The signage is considered to be of neutral significance and may be replaced after the conservation work is carried out if desired.

An example of the modern mesh signage covering bullseyes on the south wall. Source: OCP 2002.

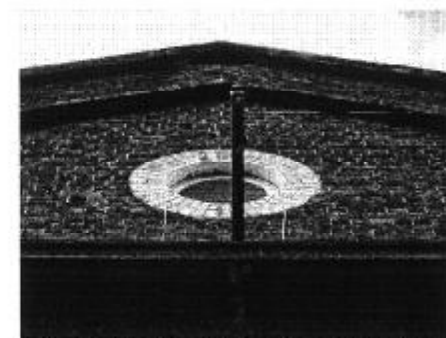
White paint dripping from a bullseye on the north wall. In future, such inattention to detail should be avoided and these drips should be cleaned. (See Policy 2.2.9). Source OCP 2002.

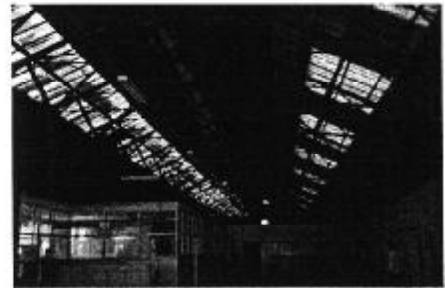
Underside view of deteriorating corrugated sheeting, Bay 14. Source: OCP May 2002

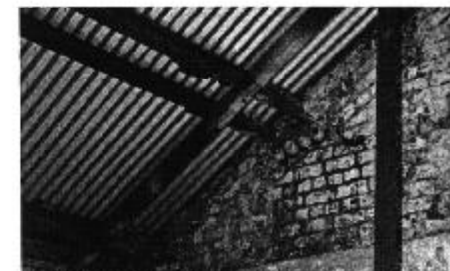
A timber roof purlin has replaced the original cast iron purlin when the roof sheeting was replaced. Source: OCP May 2002.

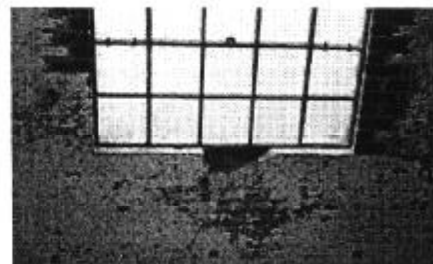
Window sills to be replaced or repaired have generally been noted on the external line drawings. Internal repairs to stone should be undertaken at the discretion of maintenance staff. Specifically, the westernmost sill of Bay 12 South, requires a stone insert. Elastometric sealant should be applied to all exposed joints on the top side of horizontal stone surfaces and any cracks in cornices should be repointed.

The damaged sill of the western window of Bay 12 South. Source: OCP 2002.

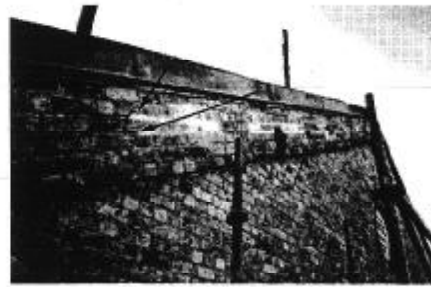
Horizontal cracking of the gable has occurred along the coping courses of brickwork in Bays 1 to 4 South. The courses are split on the bed planes. Cracks should be repointed and the gables monitored for further damage. If this is a structural fault, the problem may recur along the South Wall, so all gables should be monitored for similar cracks.

An example of how the coping courses are split on the bed planes.  
Source: OCP 1996.

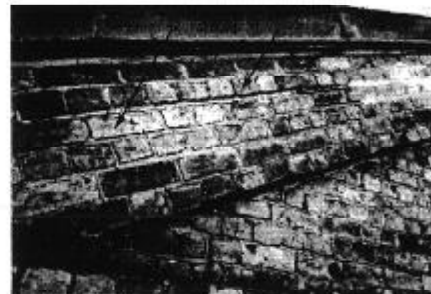
A detail showing the split bed planes on the coping.  
Source: OCP 1996.

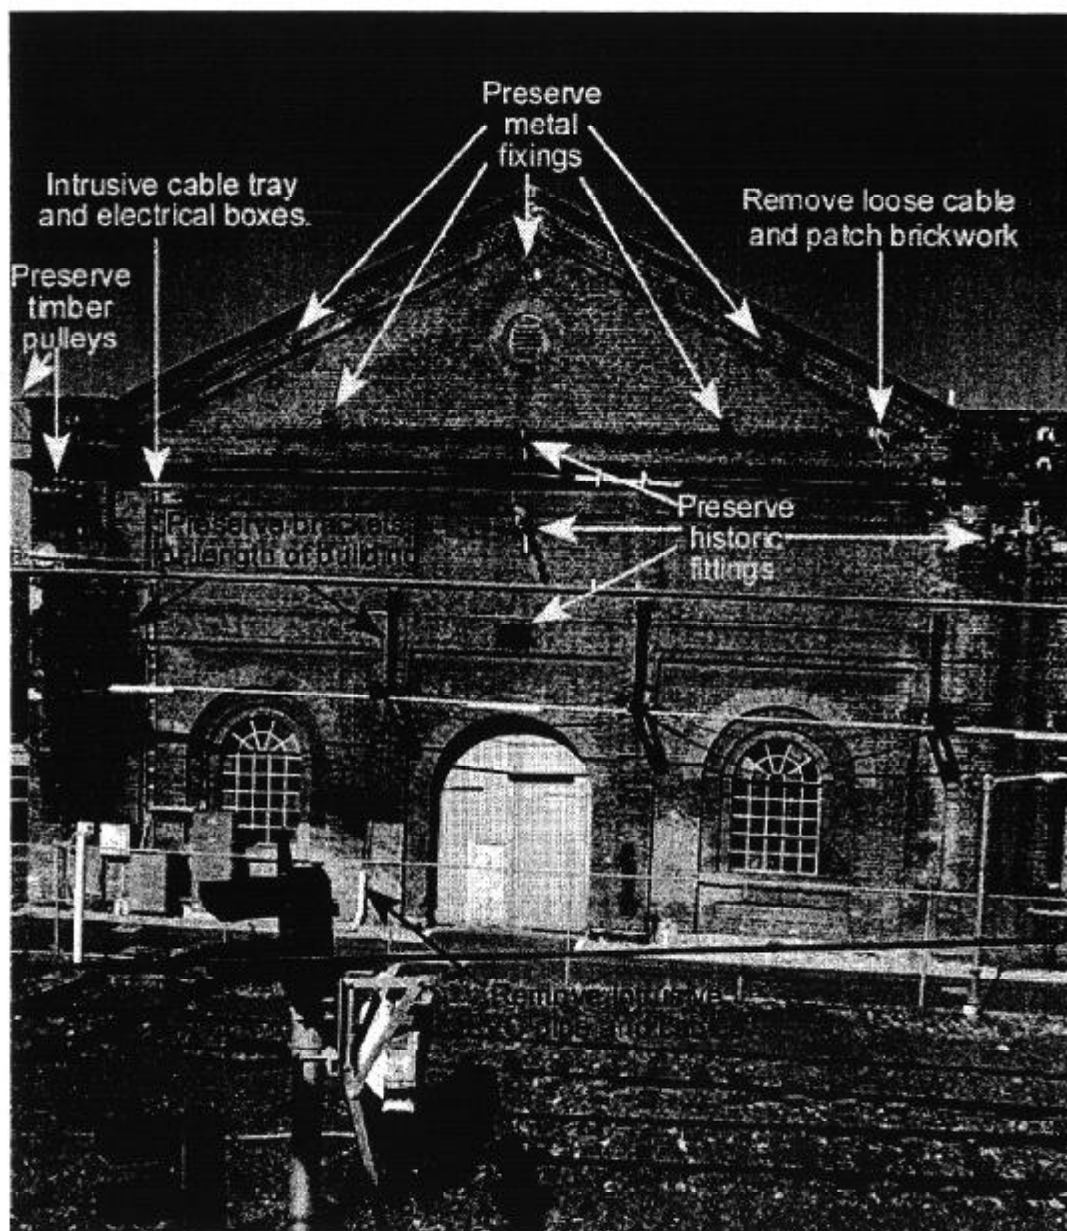
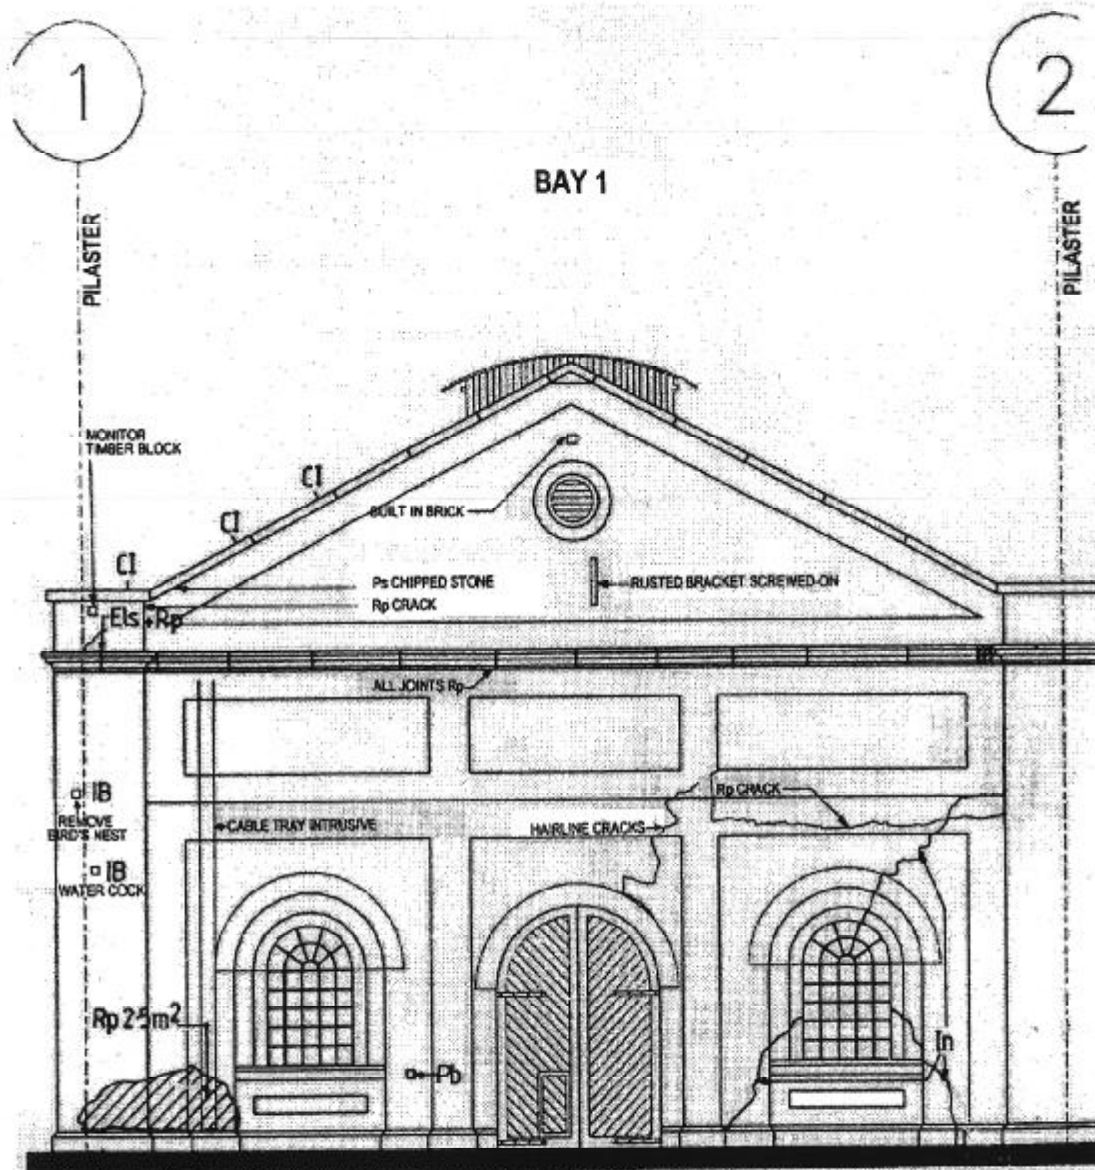
LOCATION Bay 1/1 north

Consider a more sympathetic lighting solution for the North Wall. The fluorescent tube lighting is not causing physical damage to the brickwork at present, but is aesthetically unappealing.

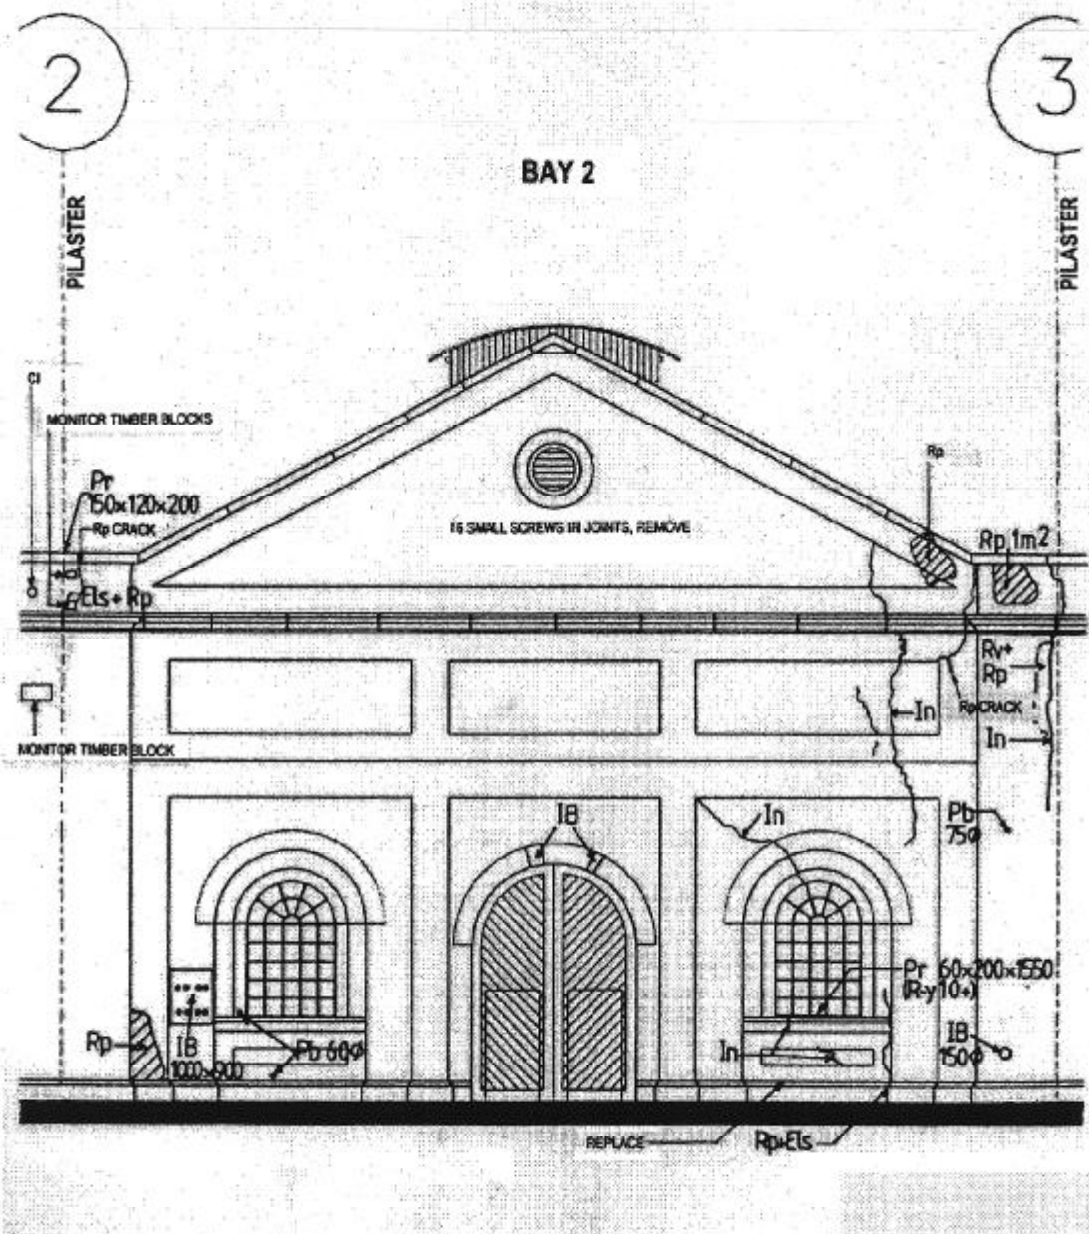
LOCATION Bay 2/2 north

One of the sills is noted on the drawing to be repaired but it will require replacement in the future (10 years plus).

A section of plinth below this sill is also noted for replacement. See general notes re plinths. New stone plinths were installed in sections of the east wall in 1995. Some of the stone is already cracked and exfoliating. The cause of this is not known but is likely to be inferior stone or chemical treatment to the stone at the time of installation. The repair of plinths needs further consideration. It may be preferable to treat with sacrificial render prior to installation of new stones. Care should be taken not to breach the asphalt damp proof course in any works to the plinth.

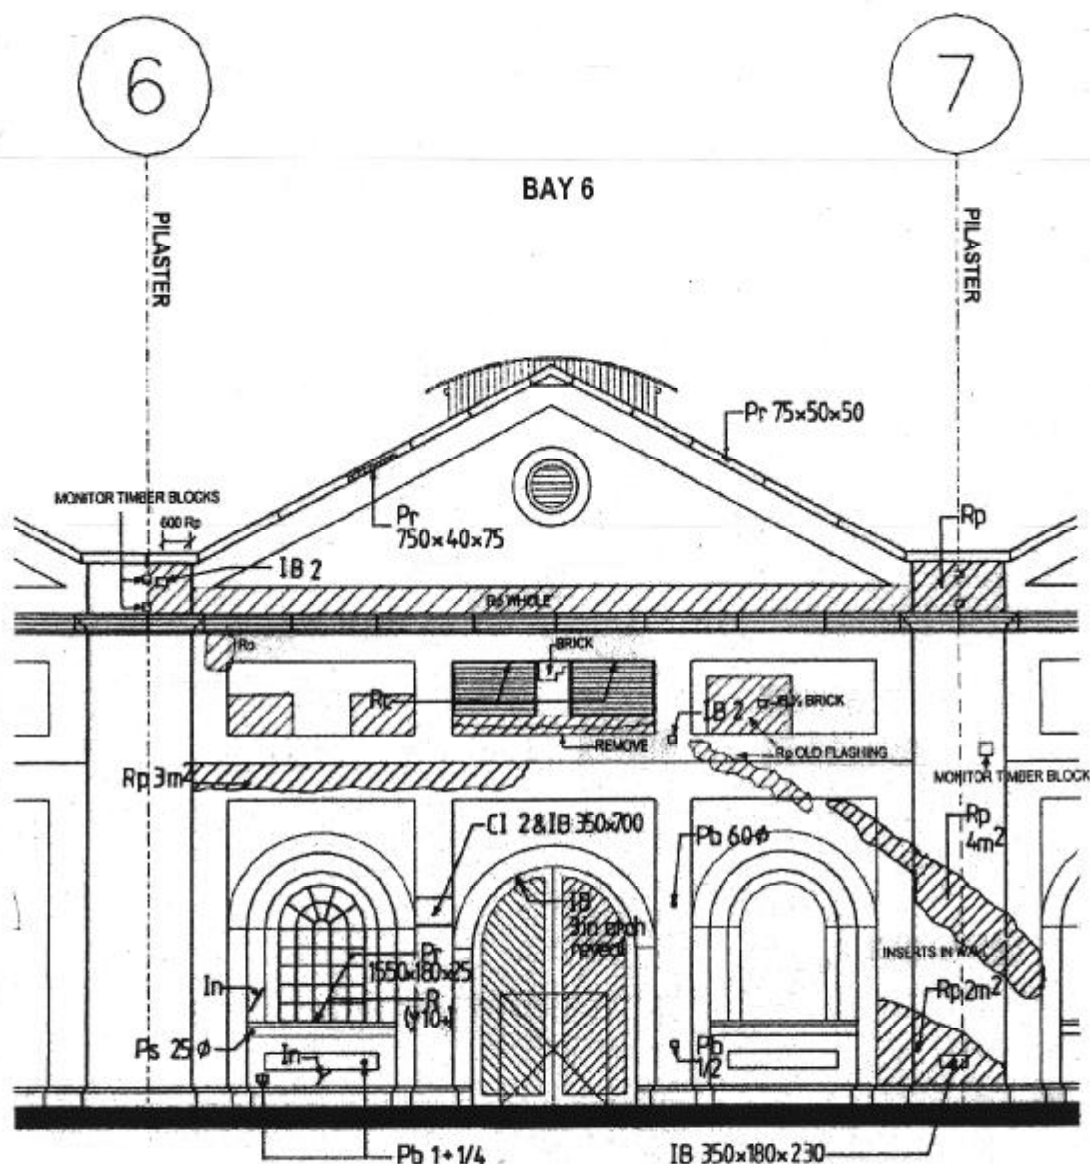
Record # 6

DESCRIPTION	SIGNIFICANCE	CONDITION	RECTIFICATION	RECOMMENDED WORKS	NOTES
PEDIMENT/PARAPET	S1	C2	R3		
STONWORK					
coping	S1	C2	R3	Patch with reinforcement as indicated.	
weathering	N/A				
inserts	N/A				
BRICKWORK					
rims	S1	C2	R3	Repoint whole rim. Light wash.	
panels	S1	C3	R1	Light wash and repoint as required.	
inserts	N/A				
BULLSEYE	S1	C2	R3	Rust proof and monitor for corrosion.	
UPPER WALL	S1	C2	R3		
STONWORK					
cornice	S1	C3	R1		
BRICKWORK					
rims	S1	C3	R1	Repoint as indicated in drawing.	
panels	S1	C1	R3	Specific repointing required: see drawing. Insert brick.	HP
inserts	N/A				
WINDOWS	S1	C2	R3	Apply rust converter to window frame.	
LOUVRES	S1	C2	R3	Apply rust converter to louvres.	
LOWER WALL					
BRICKWORK					
rim	S1	C1	R3	Repoint as indicated.	HP
arches	S1	C3	R1	Repair crack in window arch. Insert bricks in door arch.	HP
panels	S1	C3	R1	Light wash and repoint as required.	
panel under sill	S1	C3	R1	See drawing for minor repairs. Light wash, repoint as

inserts	N/A				
STONWORK					
window sills	S1	C3	R3	Replace sill or patch with reinforcement. See drawing.	
plinth	S1	C3	R1	Els horizontal joints.	
corbel	N/A				
inserts	N/A				
WINDOWS	S1	C3	R1		
DOOR(S)	S1	C3	R1

DESCRIPTION	SIGNIFICANCE	CONDITION	RECTIFICATION	RECOMMENDED WORKS	NOTES
lower wall continued					
GLAZED INFILL	S1	C3	R1		
THRESHOLD	S1	C2	R3	Els horizontal joints.	
TIMBER FRAMED WALL	N/A				
SERVICE PIPES	N/A				
STEELWORK	S1	C3	R1	Rust proof and monitor significant steel work.	
PILASTER	S1	C3	R1		
STONework					
coping	S1	C3	R1	Light wash and repoint as required.	
comice	S1	C3	R1	Light wash and repoint as required.	
plinth	S1	C3	R1	Light wash and repoint as required.	
inserts	Nil				
BRICKWORK					
parapet	S1	C1	R3	Repoint whole parapet	
body	S1	C2	R3	Repoint where indicated. Light wash.	HP
down pipes	N/A				
inserts	S3	C2	R1	Monitor for corrosion	
END PILASTER	N/A				
STONeworks					
coping	N/A				
comice	N/A				
plinth	N/A				
inserts	Nil				
BRICKWORK					
parapet	N/A				
body	N/A				
pipes	N/A				
inserts	NI				
OTHER 1	S1	C1	R2	Sign on plaster hanging precariously. Reattach immediately.	URGENT
OTHER 2	S1	C3	R1	Monitor significant bolts and metal fixings. Rust proof as required.

- ☒ R replace stone
- ☐ I Indent stone
- ☐ H Hairline jointed stone insert
- ☒ Rp Re point
- ☒ C Corroded insert, remove and epoxy patch
- ☒ Ps Small epoxy patch
- ☒ Pr Patch stone with reinforcement
- ☒ IB Insert Brick
- ☐ Els Mortar fill joint, elastometric sealant and backing rod to top

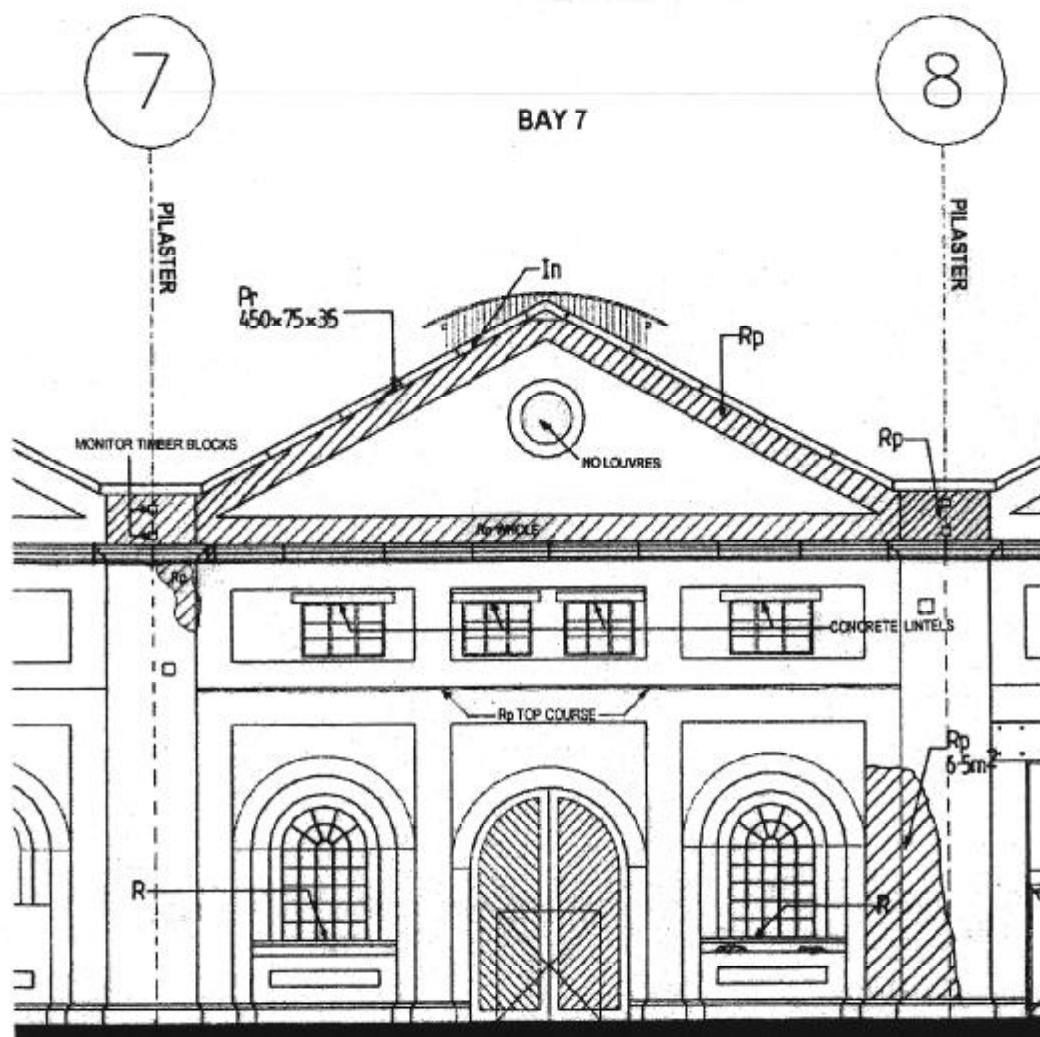
Record # 7

DESCRIPTION	SIGNIFICANCE	CONDITION	RECTIFICATION	RECOMMENDED WORKS	NOTES
PEDIMENT/PARAPET	S1	C2	R3	Repoint brickwork and reinstate louvres. Light wash.	
STONework					
coping	S1	C2	R3	Patch coping as indicated in drawing.	
weathering	N/A				
inserts	N/A				
BRICKWORK					
rims	S1	C1	R3	Repoint entire rim. Light wash as required.	HP
panels	S1	C3	R1	Light wash and repoint as required.	
inserts	N/A				
BULLSEYE	S1	C1	R3	Reinstate louvres, funds permitting.	
UPPER WALL					
STONework					
cornice	S1	C2	R3	Patch stone with reinforcement as indicated.	
BRICKWORK					
rims	S1	C3	R1	Light wash and repoint as required.	
panels	S1	C3	R1	Light wash and repoint as required.	
inserts	N/A				
WINDOWS	S1	C3	R1		
LOUVRES	S1	C1	R3	Replace broken and missing glass louvres.	
LOWER WALL					
BRICKWORK					
rim	S1	C2	R3	Repoint top course. Generally repoint & light wash as	
arches	S1	C3	R1	Light wash and repoint as required.	
panels	S1	C3	R1	Light wash and repoint as required.

panel under sill	S1	C3	R1	Light wash and repoint as required.	
inserts	N/A				
STONework					
window sills	S1	C1	R3	Replace sills.	
plinth	S1	C3	R1	Re horizontal joints.	
corbel	N/A				
inserts	N/A				
WINDOWS	S1	C3	R1		
DOOR(S)	S1	C3	R1	Door reinstated in 1995.	Done

DESCRIPTION	SIGNIFICANCE	CONDITION	RECTIFICATION	RECOMMENDED WORKS	NOTES
lower wall continued					
GLAZED INFILL	S1	C3	R1		
THRESHOLD	S1	C3	R1	Els joints	
TIMBER FRAMED WALL	N/A				
SERVICE PIPES	N/A				
STEELWORK	S1	C2	R1	Monitor significant metal fittings. Rust proof if required.	
PILASTER					
STONEMWORK					
coping	S1	C3	R1	Light wash and repoint as required.	
cornice	S1	C3	R1	Light wash and repoint as required.	
plinth	S1	C3	R1	Light wash and repoint as required.	
inserts	Nil				
BRICKWORK					
parapet	S1	C2	R3	Repoint entire parapet	
body	S1	C2	R3	Repoint as indicated in line drawing.	
down pipes	N/A				
inserts	Nil				
END PILASTER					
STONEMWORKS					
coping	N/A				
cornice	N/A				
plinth	N/A				
inserts	Nil				
BRICKWORK					
parapet	N/A				
body	N/A				
pipes	N/A				
inserts	Nil				
OTHER 1	S3	C1	R2	Splintered timber bracket requires urgent attention. See photo.	URGENT
OTHER 2					
OTHER 3

<input checked="" type="checkbox"/> R replace stone	<input checked="" type="checkbox"/> In Inject crack with epoxy mixture
<input type="checkbox"/> I Indent stone	<input type="checkbox"/> Rc Apply rust-converter to corroded ferrous metal insert
<input type="checkbox"/> H Hairline jointed stone insert	<input type="checkbox"/> Tme To match existing
<input checked="" type="checkbox"/> Rp Re point	<input type="checkbox"/> Zac New Zincalume capping to replace corroded capping
<input type="checkbox"/> Ci Corroded insert, remove and epoxy patch	<input type="checkbox"/> Rv Remove vegetation and rake out joints 20mm deep
<input type="checkbox"/> Ps Small epoxy patch	<input type="checkbox"/> MS Make safe by removing loose stone
<input checked="" type="checkbox"/> Pr Patch stone with reinforcement	<input type="checkbox"/> Pb Patch brickwork
<input type="checkbox"/> IB Insert Brick	<input type="checkbox"/> Rb Reconstruction of brick surface of wall

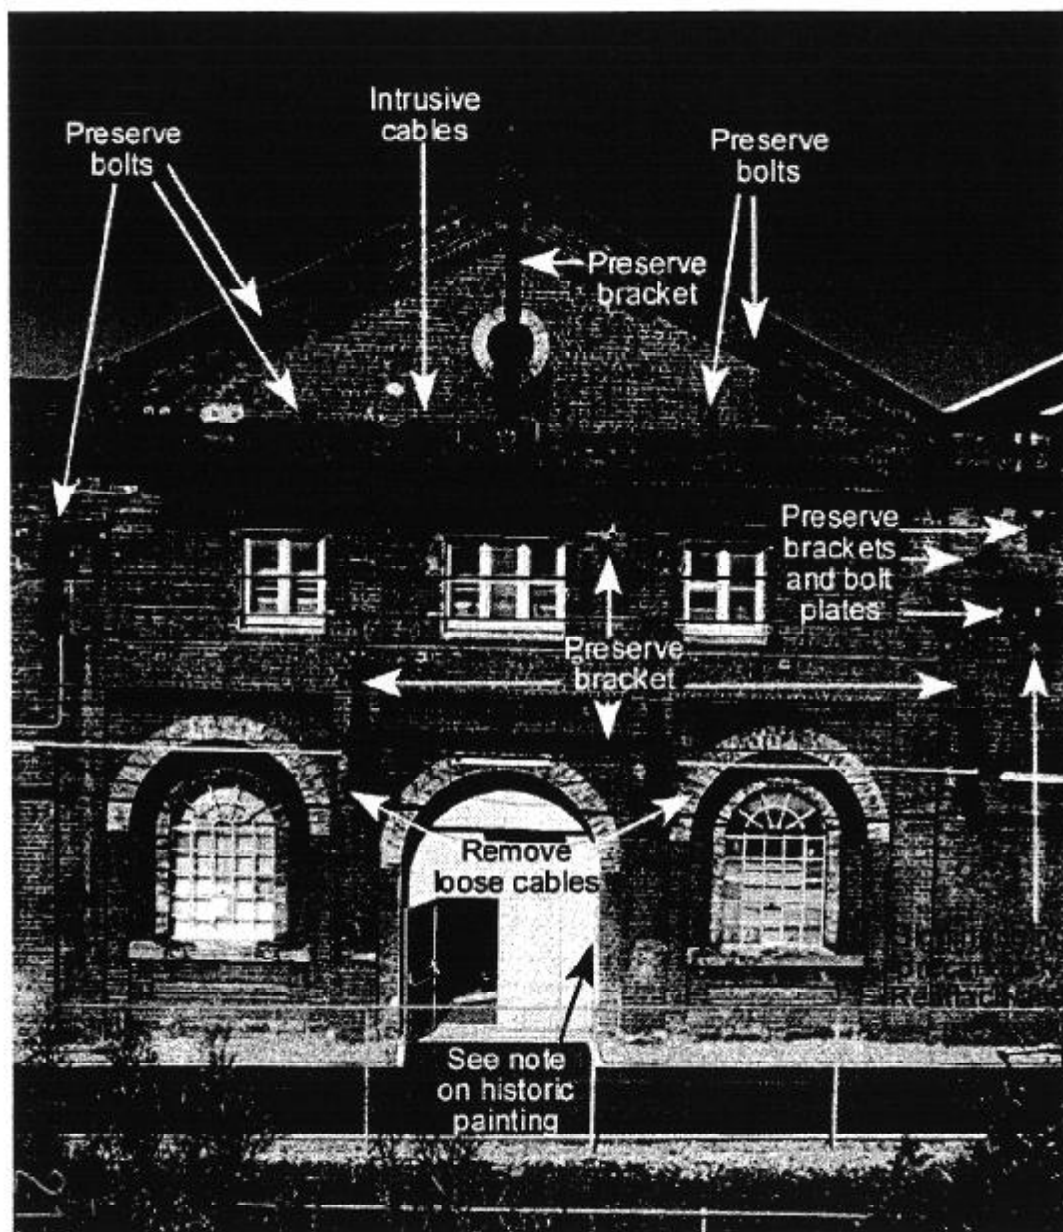
LOCATION Bay 9/8 north

The corroded pipes are significant as they are part of the operation of the place as a railway workshop. However they are severely corroded. They should be assessed in detail and preferably preserved.

DESCRIPTION	SIGNIFICANCE	CONDITION	RECTIFICATION	RECOMMENDED WORKS	NOTES
lower wall continued					
GLAZED INFILL	S1	C3	R1		
THRESHOLD	S1	C2	R3	Mortar fill and els top of horizontal stone joint	
TIMBER FRAMED WALL	N/A				
SERVICE PIPES	N/A				
STEELWORK	S1	C2	R3	Apply rust converter to steel brackets for length of building	
PILASTER	S1	C2	R3	General repair required. See drawing.	
STONEMWORK					
coping	S1	C3	R1		
cornice	S1	C3	R1	Mortar fill and els top of horizontal stone joint	
plinth	S1	C2	R3	Plinth severely exfoliating, immediate attention required.	
inserts	Nil				
BRICKWORK					
parapet	S1	C2	R3	Repoint as indicated.	
body	S1	C2	R3	Patch & insert brick indicated. Light wash, repoint as required.	
down pipes	N/A				
inserts	Nil				
END PILASTER	N/A				
STONEMWORK					
coping	N/A				
cornice	N/A				
plinth	S4				
inserts	Nil				
BRICKWORK					
parapet	N/A				
body	N/A				
pipes	N/A				
inserts	Nil				
OTHER 1	S1	C1	R2	Corroded pipes require urgent attention.	URGENT

See photograph for further recommendations for preservation and interpretation, particularly paint remnants and the timber seating along wall. Reconstruction not required but interpretation is recommended.

If the replacement or indenting of coping or cornice stones as recommended does not proceed then these stone should be monitored and made safe at least every two years. This is a matter of public safety.

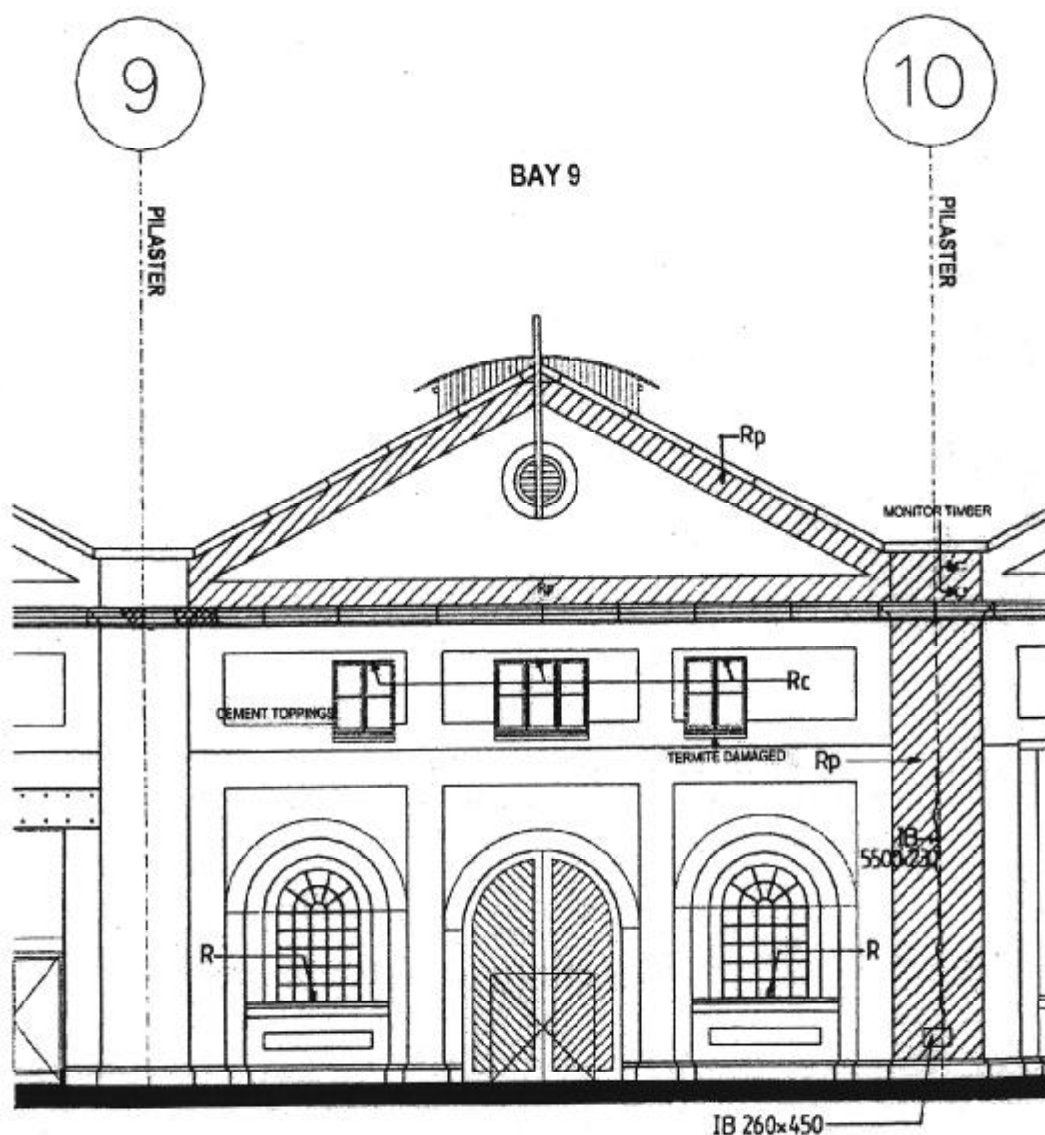
Record # 9

DESCRIPTION	SIGNIFICANCE	CONDITION	RECTIFICATION	RECOMMENDED WORKS	NOTES
PEDIMENT/PARAPET	S1	C2	R3		
STONework					
coping	S1	C2	R3	Patch with reinforcement as indicated in drawing.	
weathering	N/A				
inserts	N/A				
BRICKWORK					
rims	S1	C2	R3	Repoint rim as indicated.	
panels	S1	C2	R1	Light wash and repoint as required.	
inserts	S1	C3	R1	Preserve historic metal fixings as indicated.	
BULLSEYE	S1	C2	R3	Reinstate louvres, funds permitting.	
UPPER WALL	S1	C2	R3		
STONework					
cornice	S1	C2	R3	Repair cornice where indicated in drawing.	
BRICKWORK					
rims	S1	C2	R3	Repoint where indicated. Light wash.	
panels	S1	C3	R1	Light wash and repoint as required.	
inserts	S1	C3	R1	Preserve all porcelain inserts.	
WINDOWS	S1	C2	R3	Apply rust converter to window heads.	
LOUVRES	N/A				
LOWER WALL					
BRICKWORK					
rim	S1	C3	R1	Light wash and repoint as required.	
arches	S1	C2	R3	Insert brick, patch as noted in drawing. Light wash as

panels	S1	C3	R1	Light wash and repoint as required.	
panel under sill	S1	C2	R3	Patch brick. Light wash and repoint as required.	
inserts	N/A				
STONework					
window sills	S1	C2	R3	Mortar fill & els stone joint. Repair crack as noted in drawing.	
plinth	S1	C3	R1		
corbel	N/A				
inserts	N/A				
WINDOWS	S1	C3	R1		
DOOR(s)	S1	C3	R1

| <input checked="" type="checkbox"/> R replace stone | <input type="checkbox"/> In Inject crack with epoxy mixture |
| <input type="checkbox"/> I Indent stone | <input checked="" type="checkbox"/> Rc Apply rust-converter to corroded ferrous metal insert |
| <input checked="" type="checkbox"/> Rp Re point | <input type="checkbox"/> Zac New Zincalume capping to replace corroded capping |

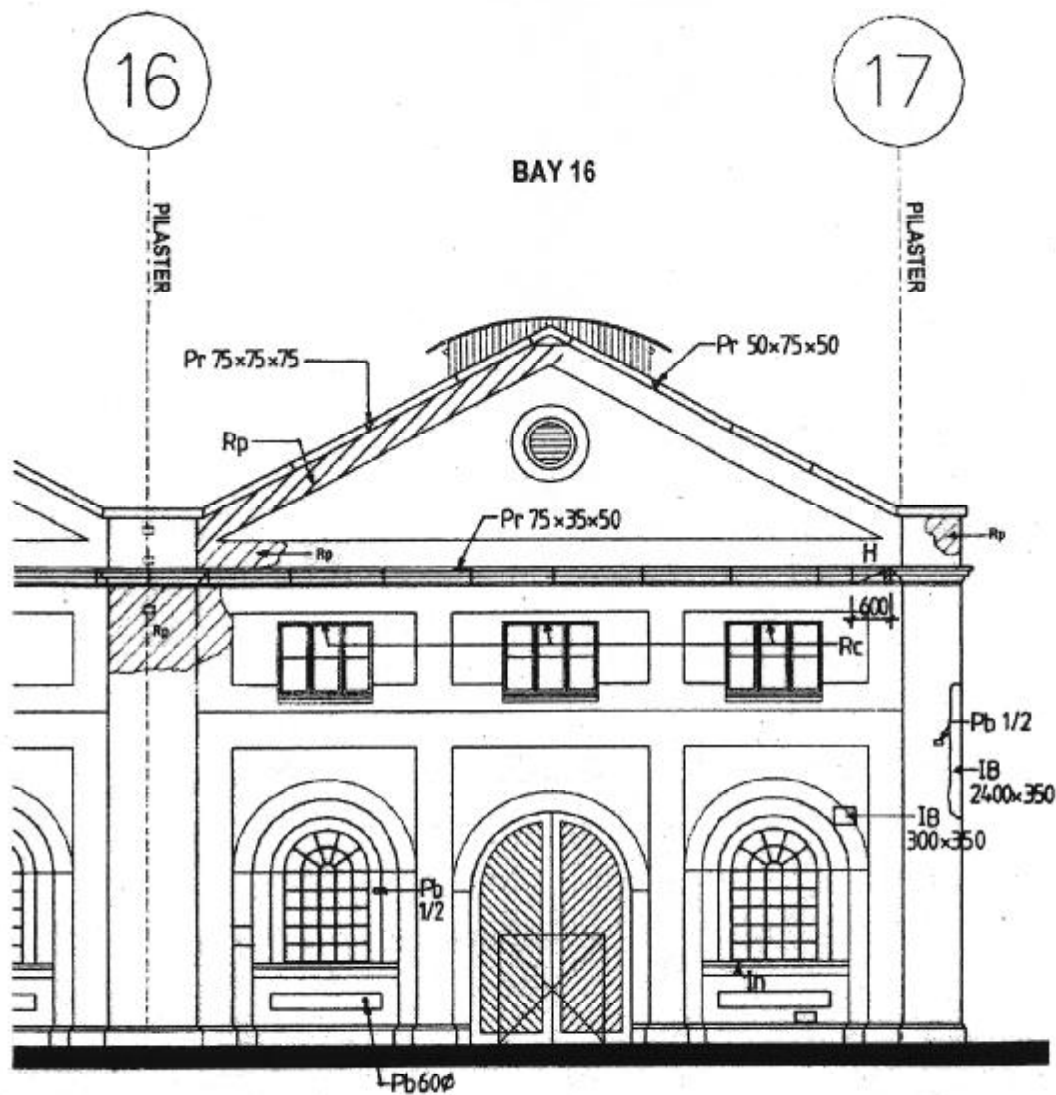
Record # 16

DESCRIPTION	SIGNIFICANCE	CONDITION	RECTIFICATION	RECOMMENDED WORKS	NOTES
PEDIMENT/PARAPET	S1	C2	R3	Major repointing of rim. Fill & els joints. Light wash	HP
STONework					
coping	S1	C3	R1		
weathering	N/A				
inserts	N/A				
BRICKWORK					
rims	S1	C1	R3	Repoint entire rim. See drawing.	HP
panels	S1	C3	R1	Light wash and repoint as required.	
inserts	N/A				
BULLSEYE	S1	C1	R3	Clean up dripped paint. Reinstate louvres.	
UPPER WALL					
STONework					
cornice	S1	C2	R3	Patch gap with reinforcement. Fill & els joint.	
BRICKWORK					
rims	S1	C3	R1	Light wash and repoint as required.	
panels	S1	C3	R1	Light wash and repoint as required.	
inserts	N/A				
WINDOWS	S1	C2	R3	Apply rust converter to window heads as indicated.	
LOUVRES	N/A				
LOWER WALL					
BRICKWORK					
rim	S1	C2	R3	Repoint as indicated. Light wash.	
arches	S1	C2	R3	Repair large crack in arch. Inject with epoxy mixture	HP
panels	S1		R1	Light wash and repoint as required.

panel under sill	S1	C2	R3	Repair crack. Patch brick. Light wash and repoint as required.	
inserts	N/A				
STONework					
window sills	S1	C2	R3	Mortar fill and els top of horizontal stone joint	
plinth	S1	C3	R1		
corbel	N/A				
inserts	N/A				
WINDOWS	S1	C3	R1		
DOOR(s)	S3	C3	R1	New glazed door added 1995.

| <input checked="" type="checkbox"/> Rp Re point | <input type="checkbox"/> Zac New Zincalume capping to replace corroded capping |
| <input checked="" type="checkbox"/> IB Insert Brick | <input type="checkbox"/> Rb Reconstruction of brick surface of wall |

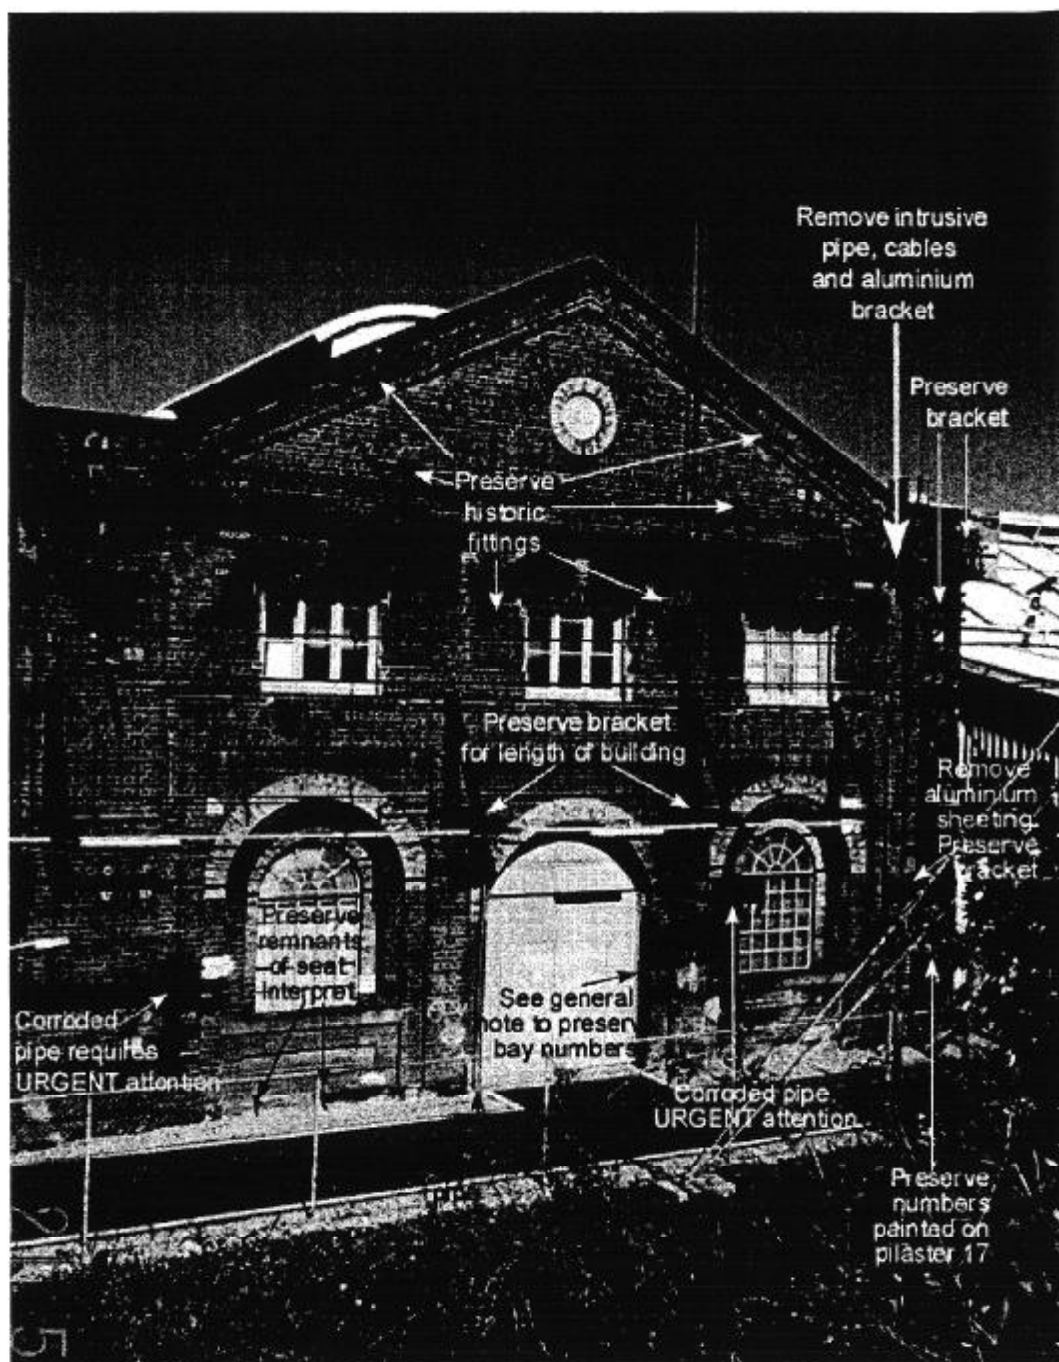
LOCATION Bay 16/15 north

The corroded pipes are significant as they are part of the operation of the place as a railway workshop. However they are severely corroded. They should be assessed in detail and preferably preserved.

DESCRIPTION	SIGNIFICANCE	CONDITION	RECTIFICATION	RECOMMENDED WORKS	NOTES
lower wall continued					
GLAZED INFILL	S1	C2	R1		
THRESHOLD	S1	C2	R3	Mortar fill and els top of horizontal stone joint	
TIMBER FRAMED WALL	N/A				
SERVICE PIPES	N/A				
STEELWORK	S1	C3	R1	Apply rust converter to steel brackets for length of building.	
PILASTER	S1	C3	R1		
STONWORK					
coping	S1	C3	R1	Light wash and repoint as required.	
cornice	S1	C3	R1		
plinth	S1	C3	R1		
inserts	Nil				
BRICKWORK					
parapet	S1	C1	R3	Repoint entire parapet.	
body	S1	C2	R3	Repoint as indicated. Light wash.	
down pipes	N/A				
inserts	S2	C3	R1	Monitor timber blocks. Preserve historic fittings. See photo.	
END PILASTER	N/A				
STONWORKS					
coping	N/A				
cornice	N/A				
plinth	N/A				
inserts	Nil				
BRICKWORK					
parapet	N/A				
body	N/A				
pipes	N/A				
inserts	Nil				
OTHER 1	S1	C1	R2	Corroded pipe requires urgent attention.	URGENT
OTHER 2					
OTHER 3
