# EVELEIGH LOCOMOTIVE WORKSHOPS

## F A B R I C I N V E N T O R Y

## 1.0 EXECUTIVE SUMMARY

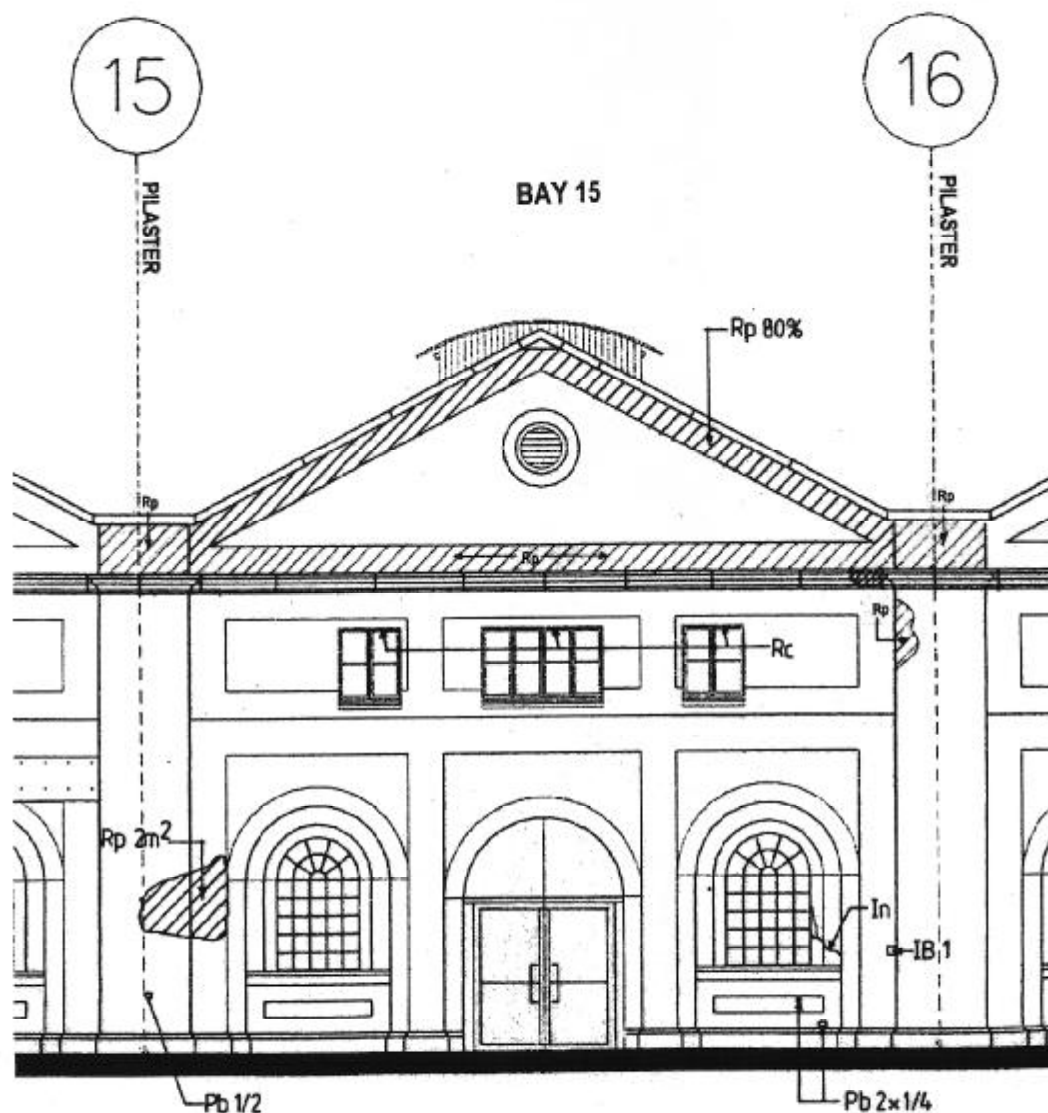
Record # 15

DESCRIPTION	SIGNIFICANCE	CONDITION	RECTIFICATION	RECOMMENDED WORKS	NOTES
PEDIMENT/PARAPET	S1	C2	R3	Major repointing of rim. Light wash.	
STONEWORK					
coping	S1	C3	R1	Light wash and repoint as required.	
weathering	N/A				
inserts	N/A				
BRICKWORK					
rim	S1	C1	R3	Repoint entire rim.	HP
panels	S1	C3	R1	Light wash and repoint as required.	
inserts	S1	C2	R3	Remove cables from porcelain inserts and preserve. Do not	
BULLSEYE	S1	C2	R3	Reinstate louvres	
UPPER WALL	S1	C2	R1		
STONEWORK					
cornice	S1	C2	R3	Patch gaps with reinforcement. Remove insert where	
BRICKWORK					
rim	S1	C3	R1	Light wash and repoint as required.	
panels	S1	C3	R1	Light wash and repoint as required.	
inserts	S1	C3	R1	Preserve porcelain inserts.	
WINDOWS	S1	C2	R3	Apply rust converter to window heads as indicated.	
LOUVRES	N/A				
LOWER WALL					
BRICKWORK					
rim	S1	C3	R1	Patch brick as indicated. Light wash and repoint as required.	
arches	S1	C3	R1	Light wash and repoint as required.

panels	N/A				
panel under sill	S1	C3	R1	Patch brick where indicated.	
inserts	N/A				
STONEWORK					
window sills	S1	C1	R3	See drawing. Patch, replace, fill as indicated. Fill & els joints	
plinth	S1	C3	R1		
corbel	N/A				
inserts	N/A				
WINDOWS	S1	C3	R1		
Door(s)	N/A

- ☐ R replace stone
- ☐ I Indent stone
- ☐ H Hairline jointed stone insert
- ☒ Rp Re point
- ☐ C Corroded insert, remove and epoxy patch
- ☐ Ps Small epoxy patch
- ☐ Pr Patch stone with reinforcement
- ☒ IB Insert Brick
- ☐ Eis Mortar fill joint, elastometric sealant and backing rod to top

- ☒ In Inject crack with epoxy mixture
- ☒ Rc Apply rust-converter to corroded ferrous metal insert
- ☐ Trme To match existing
- ☐ Zac New Zincalume capping to replace corroded capping
- ☐ Rv Remove vegetation and rake out joints 20mm deep
- ☐ M5 Make safe by removing loose stone
- ☒ Pb Patch brickwork
- ☐ Rb Reconstruction of brick surface of wall
- ☐ Ot Other, see "Notes"

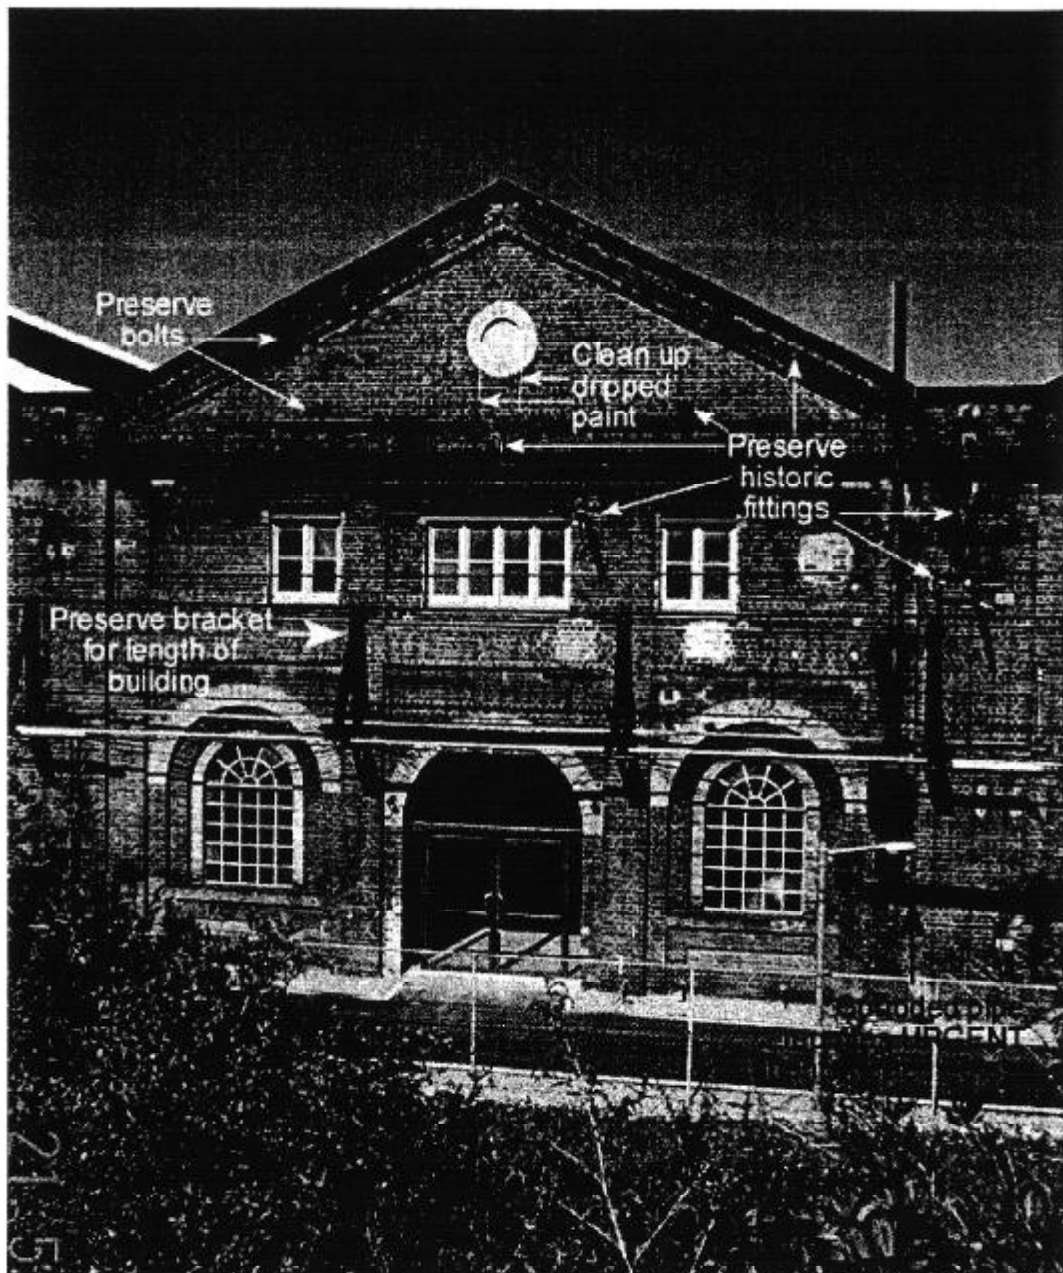
LOCATION Bay 15/14 north

This bay originally had a traverser in it and the large steel beam was to form a large opening through which the traverser moved. In the similar Carriage Workshops Building, on the opposite side of the railway line, the top of the beam is severely rusted. This is not evident here but the top of the beam should be monitored. The deterioration in the other building is believed to be because of the deterioration of the cement weathering at the base of the brick panel above. This allowed water to enter the wall and lay on top of the beam causing it to rust. It is recommended that this weathering be repaired throughout this building but in particular in the traverser bays where there is a risk to the beam.

The sills are noted on the drawing to be repaired but will require replacement in the future (10 years plus).

DESCRIPTION	SIGNIFICANCE	CONDITION	RECTIFICATION	RECOMMENDED WORKS	NOTES
lower wall continued					
GLAZED INFILL	S1	C3	R1		
THRESHOLD	N/A				
TIMBER FRAMED WALL	N/A				
SERVICE PIPES	N/A				
STEELWORK	S1	C2	R2	Rust converter to beam & cement weathering over. See	Interpret
PILASTER	S1	C2	R3	Repoint and Els as indicated in drawing.	
STONWORK					
coping	S1	C2	R3	Mortar fill and els top of joints.	
cornice	S1	C2	R3	Mortar fill and els top of joints.	
plinth	S1	C3	R1		
inserts	Nil				
BRICKWORK					
parapet	S1	C1	R3	Repoint entire parapet. See drawing for Bay 15 North.	
body	S1	C2	R3	Repoint and patch brick as indicated in Bay 15 North.	
down pipes	N/A				
inserts	S2	C3	R1	Monitor timber block inserts.	
END PILASTER	N/A				
STONWORKS					
coping	N/A				
cornice	N/A				
plinth	N/A				
inserts	Nil				
BRICKWORK					
parapet	N/A				
body	N/A				
pipes	N/A				
inserts	Nil				
OTHER 1	S1	C3	R1	Preserve the numbers painted on the lower panel, near pilaster.	Interpret

OTHER 2	S1	C2	R3	Apply rust converter to steel brackets for length of building.	
OTHER 3	S1	C3	R1	Preserve timber pulley system (electrical insulators).	Interpret

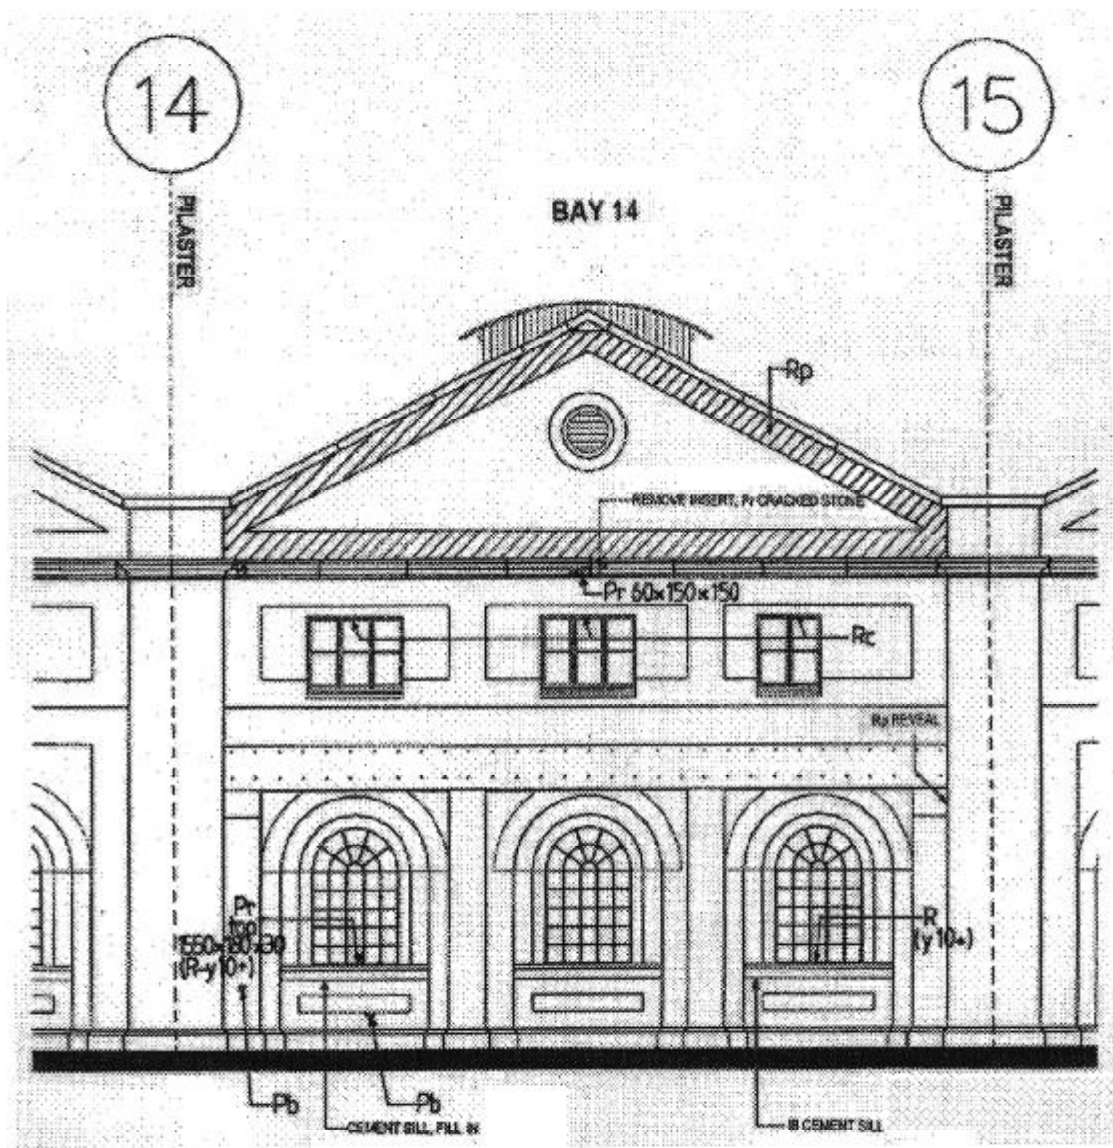
Record # 14

DESCRIPTION	SIGNIFICANCE	CONDITION	RECTIFICATION	RECOMMENDED WORKS	NOTES
PEDIMENT/PARAPET	S1	C2	R3		
STONework					
coping	S1	C3	R1		
weathering	N/A				
inserts	N/A				
BRICKWORK					
rims	S1	C1	R3	Repoint entire rim.	HP
panels	S1	C3	R1	Light wash and repoint as required.	
inserts	N/A				
BULLSEYE	S1	C1	R3	Reinstate louvres.	
UPPER WALL	S1	C3	R1	Light wash and repoint as required.	
STONework					
cornice	S1	C3	R1		
BRICKWORK					
rims	S1	C3	R1	Light wash and repoint as required.	
panels	S1	C3	R1	Light wash and repoint as required.	
inserts	S1	C2	R1	Preserve porcelain inserts. Do not fill. Monitor timber block.	
WINDOWS	S1	C2	R3	Apply rust converter to window heads	
LOUVRES	N/A				
LOWER WALL					
BRICKWORK					
rim	S1	C3	R1	Light wash and repoint as required.	
arches	S1	C3	R1	Light wash and repoint as required.	
panels	S1	C3	R1	Light wash and repoint as required.	
panel under sill	S1	C3	R1	Insert bricks where indicated.

inserts	N/A				
STONework					
window sills	S1	C1	R3	Patch stone with reinforcement. Mortar fill and els joint.	
plinth	S1	C2	R3	Patch large gap in plinth under window. Mortar fill & els	
corbel	N/A				
inserts	N/A				
WINDOWS	S1	C3	R1		
DOOR(s)	S1	C3	R1	Timber gate reinstated in 1995.	done

- ☒ R replace stone
- ☐ I Indent stone
- ☐ H Hairline jointed stone insert
- ☒ Rp Re point
- ☐ C Corroded insert, remove and epoxy patch
- ☐ Ps Small epoxy patch
- ☒ Pr Patch stone with reinforcement
- ☒ IB Insert Brick
- ☐ Bs Mortar fill joint, elastometric sealant and backing rod to top

- ☐ In Inject crack with epoxy mixture
- ☐ Rc Apply rust-converter to corroded ferrous metal insert
- ☐ Tme To match existing
- ☐ Zac New Zincalume capping to replace corroded capping
- ☐ Rv Remove vegetation and rake out joints 20mm deep
- ☐ MS Make safe by removing loose stone
- ☒ Pb Patch brickwork
- ☐ Rb Reconstruction of brick surface of wall
- ☐ Ot Other, see "Notes"

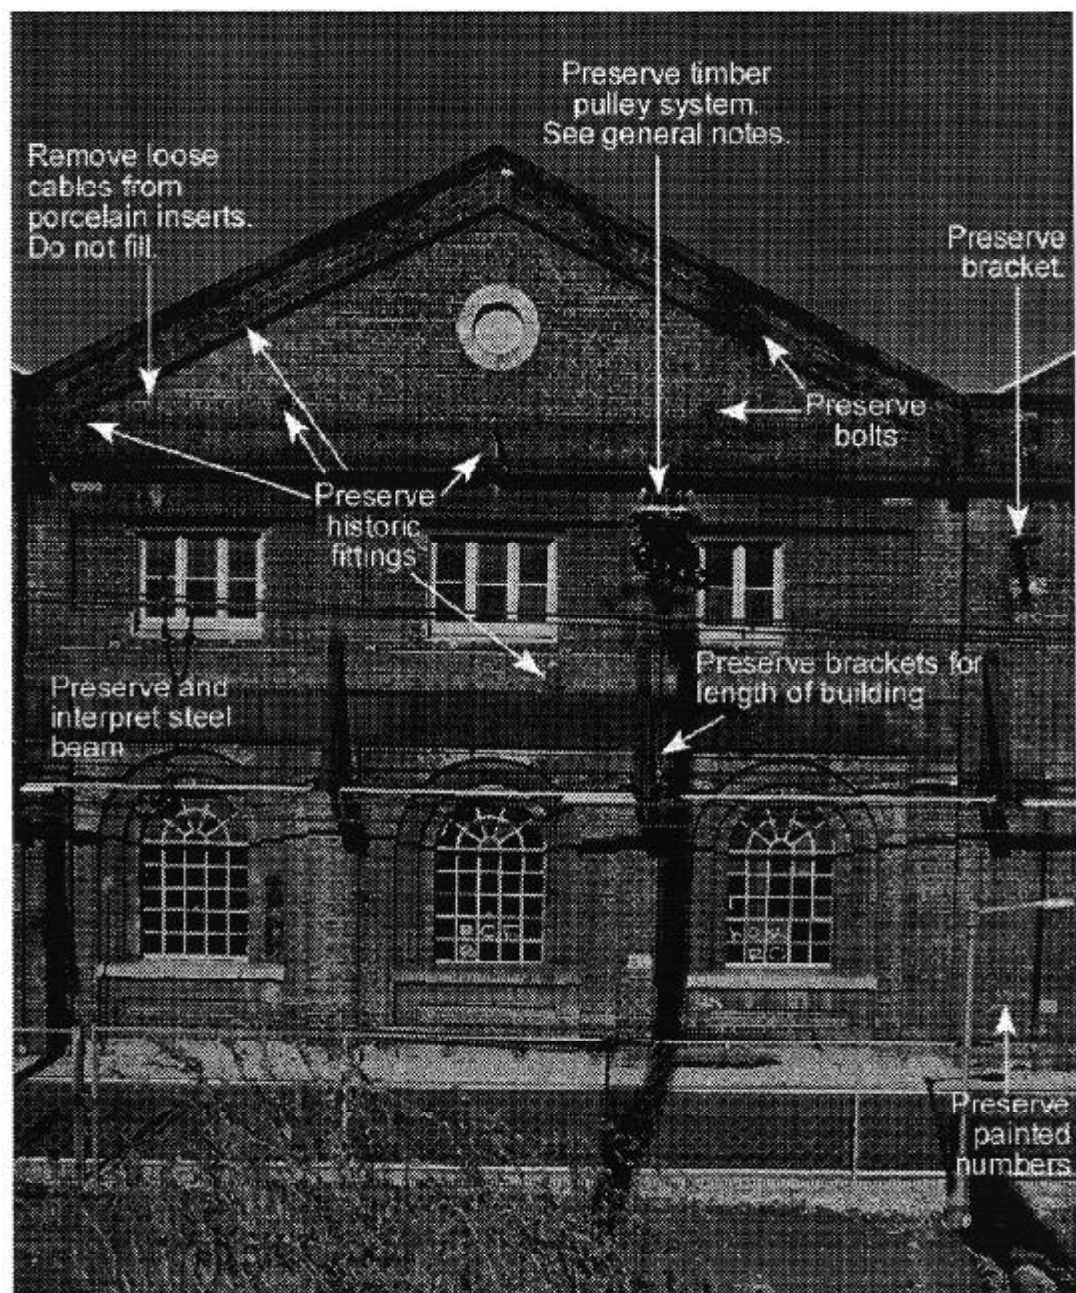
LOCATION Bay 14/13 north

Remnant seating in good condition on this bay. Consider historical interpretation.

The sills are noted on the drawing to be repaired but will require replacement in the future (10 years plus).

DESCRIPTION	SIGNIFICANCE	CONDITION	RECTIFICATION	RECOMMENDED WORKS	NOTES
lower wall continued					
GLAZED INFILL	S1	C3	R1		
THRESHOLD	S1	C2	R3	Mortar fill and els joint.	
TIMBER FRAMED WALL	N/A				
SERVICE PIPES	N/A				
STEELWORK	S1	C3	R1	Monitor metal fixings. Rust proof as required.	
PILASTER	S1	C3	R1		
STONEMWORK					
coping	S1	C3	R1		
cornice	S1	C2	R3	Repair crack with epoxy injection.	
plinth	S1	C3	R1		
inserts	Nil				
BRICKWORK					
parapet	S1	C1	R3	Repoint entire parapet.	
body	S1	C2	R3	Insert bricks and repoint as indicated. Light wash.	HP
down pipes	N/A				
inserts	S2	C3	R1	Monitor timber block inserts.	
END PILASTER	N/A				
STONEMWORKS					
coping	N/A				
cornice	N/A				
plinth	N/A				
inserts	Nil				
BRICKWORK					
parapet	N/A				
body	N/A				
pipes	N/A				
inserts	Nil				
OTHER 1	S1	C1	R1	Monitor timber seating for further deterioration.	Interpret
OTHER 2					
OTHER 3

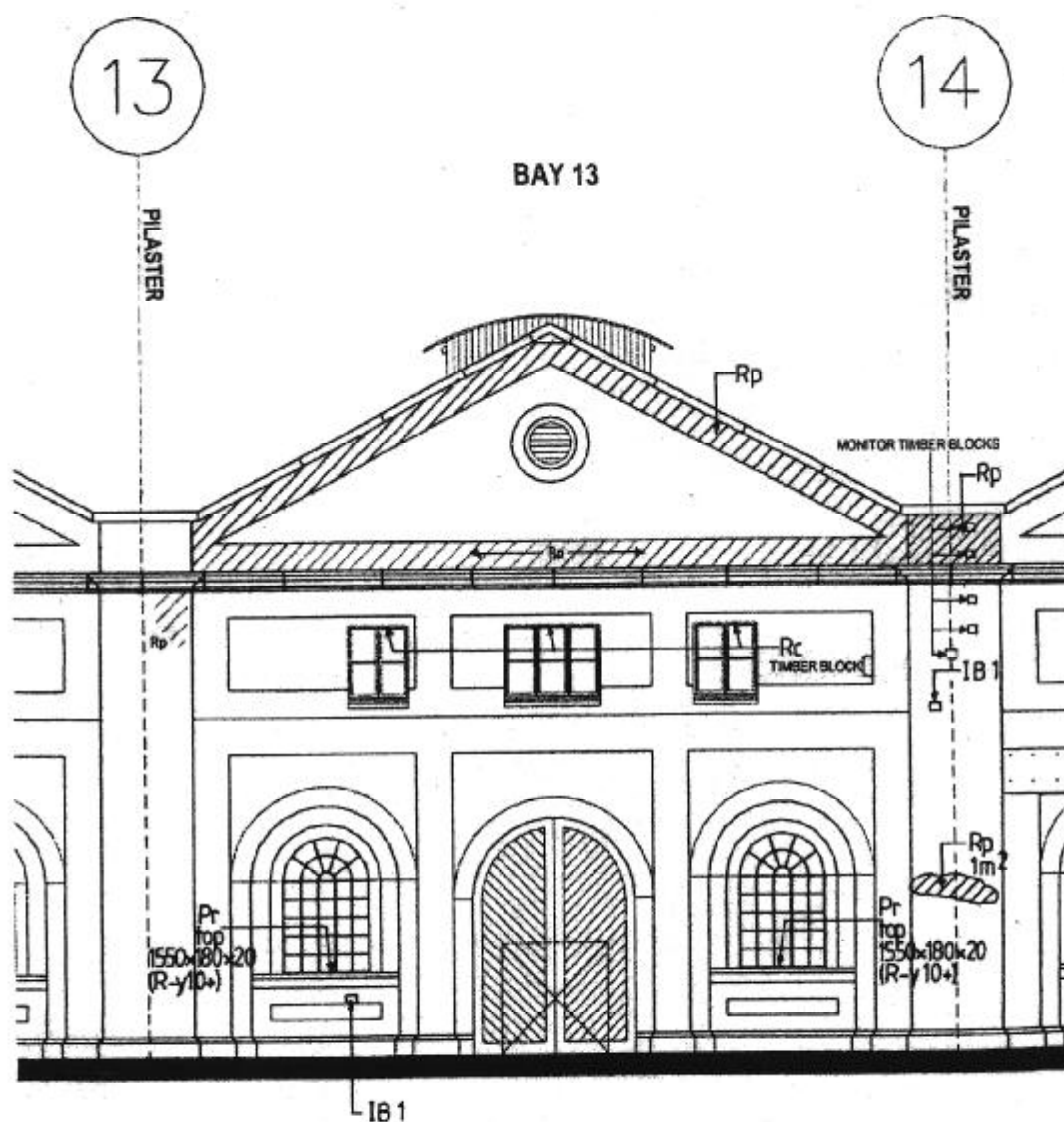
Record # 13

DESCRIPTION	SIGNIFICANCE	CONDITION	RECTIFICATION	RECOMMENDED WORKS	NOTES
PEDIMENT/PARAPET	S1	C2	R3	Major repointing required. Light wash.	
STONework					
coping	S1	C3	R1	Light wash and repoint as required.	
weathering	N/A				
inserts	N/A				
BRICKWORK					
rims	S1	C2	R3	Repoint whole top of rim	HP
panels	S1	C3	R1	Light wash and repoint as required.	
inserts	S1	C3	R1	Preserve porcelain inserts. Do not fill.	
BULLSEYE	S1	C2	R3	Reinstate louvres	
UPPER WALL	S1	C3	R1	Light wash and repoint as required.	
STONework					
cornice	S1	C2	R3	Patch and replace stone where damaged. See drawing.	
BRICKWORK					
rims	S1	C3	R1	Light wash and repoint as required.	
panels	S1	C3	R1	Light wash and repoint as required.	
inserts	S1	C3	R1	Preserve porcelain inserts on rim. Do not fill.	
WINDOWS	S1	C2	R3	Apply rust converter to window heads.	
LOUVRES	N/A				
LOWER WALL					
BRICKWORK					
rim	S1	C3	R3	Repoint where shown. Light wash, repoint as required.

arches	S1	C3	R1	Light wash and repoint as required.	
panels	S1	C3	R1	Light wash and repoint as required.	
panel under sill	S1	C3	R1	Light wash and repoint as required.	
inserts	N/A				
STONework					
window sills	S1	C2	R3	Patch sill with reinforcement. Mortar fill and els joint	
plinth	S1	C2	R3	Plinth exfoliating. Mortar fill and els joint.	
corbel	N/A				
inserts	N/A				
WINDOWS	S1	C3	R1		
DOOR(S)	S1	C3	R1	Timber gate reinstated 1995.

| <input type="checkbox"/> I Indent stone | <input checked="" type="checkbox"/> Rc Apply rust-converter to corroded ferrous metal insert |
| <input checked="" type="checkbox"/> Rp Re point | <input type="checkbox"/> Zac New Zincalume capping to replace corroded capping |
| <input checked="" type="checkbox"/> IB Insert Brick | <input type="checkbox"/> Rb Reconstruction of brick surface of wall |

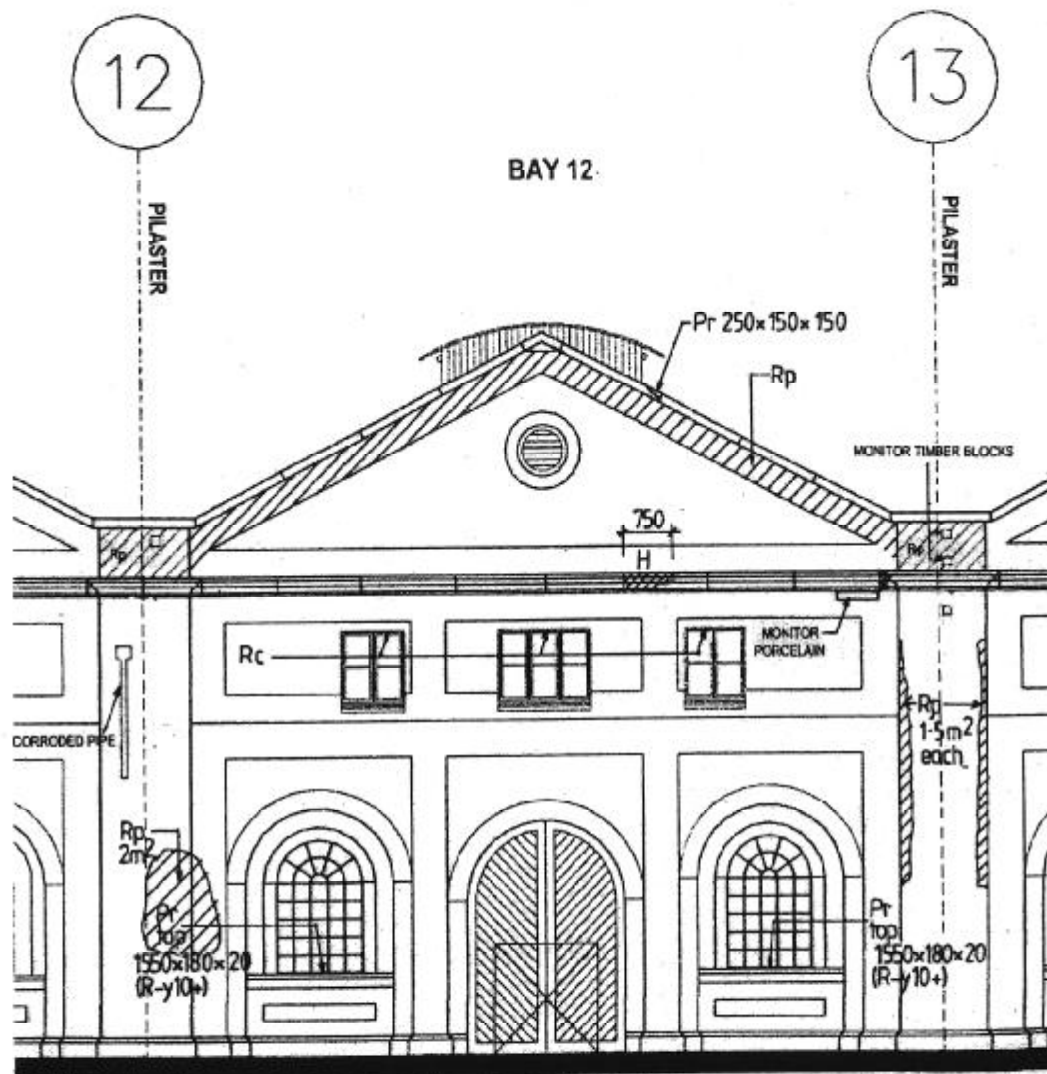
Record # 12

DESCRIPTION	SIGNIFICANCE	CONDITION	RECTIFICATION	RECOMMENDED WORKS	NOTES
PEDIMENT/PARAPET	S1	C2	R3		
STONework					
coping	S1	C2	R3	Patch as indicated. Mortar fill and els joints.	
weathering	N/A				
inserts	N/A				
BRICKWORK					
rims	S1	C1	R3	Repoint entire rim.	HP
panels	S1	C3	R1	Light wash and repoint as required.	
inserts	S1	C3	R1	Preserve porcelain inserts. Do not fill.	
BULLSEYE	S1	C2	R3	Reinstate louvres as funding permits.	
UPPER WALL					
STONework					
cornice	S1	C3	R1		
BRICKWORK					
rims	S1	C3	R1	Light wash and repoint as required.	
panels	S2	C3	R1	Light wash and repoint as required.	
inserts	S1	C3	R1	Preserve porcelain inserts in rim and panel.	
WINDOWS	S1	C2	R3	Apply rust converter to window heads.	
LOUVRES	N/A				
LOWER WALL					
BRICKWORK					
rim	S1	C3	R1	Light wash and repoint as required.	
arches	S1	C1	R3	Patch and repoint brick.	
panels	S1	C3	R1	Light wash and repoint as required.	
panel under sill	S1	C3	R1	Light wash and repoint as required.

inserts	N/A				
STONework					
window sills	S1	C1	R3	Patch stone with reinforcement. Els and mortar fill joints.	
plinth	S1	C3	R1	Light wash and repoint as required.	
corbel	N/A				
inserts	N/A				
WINDOWS	S1	C3	R1		
DOOR(S)	S1	C3	R1	Door reinstated 1995.	Done

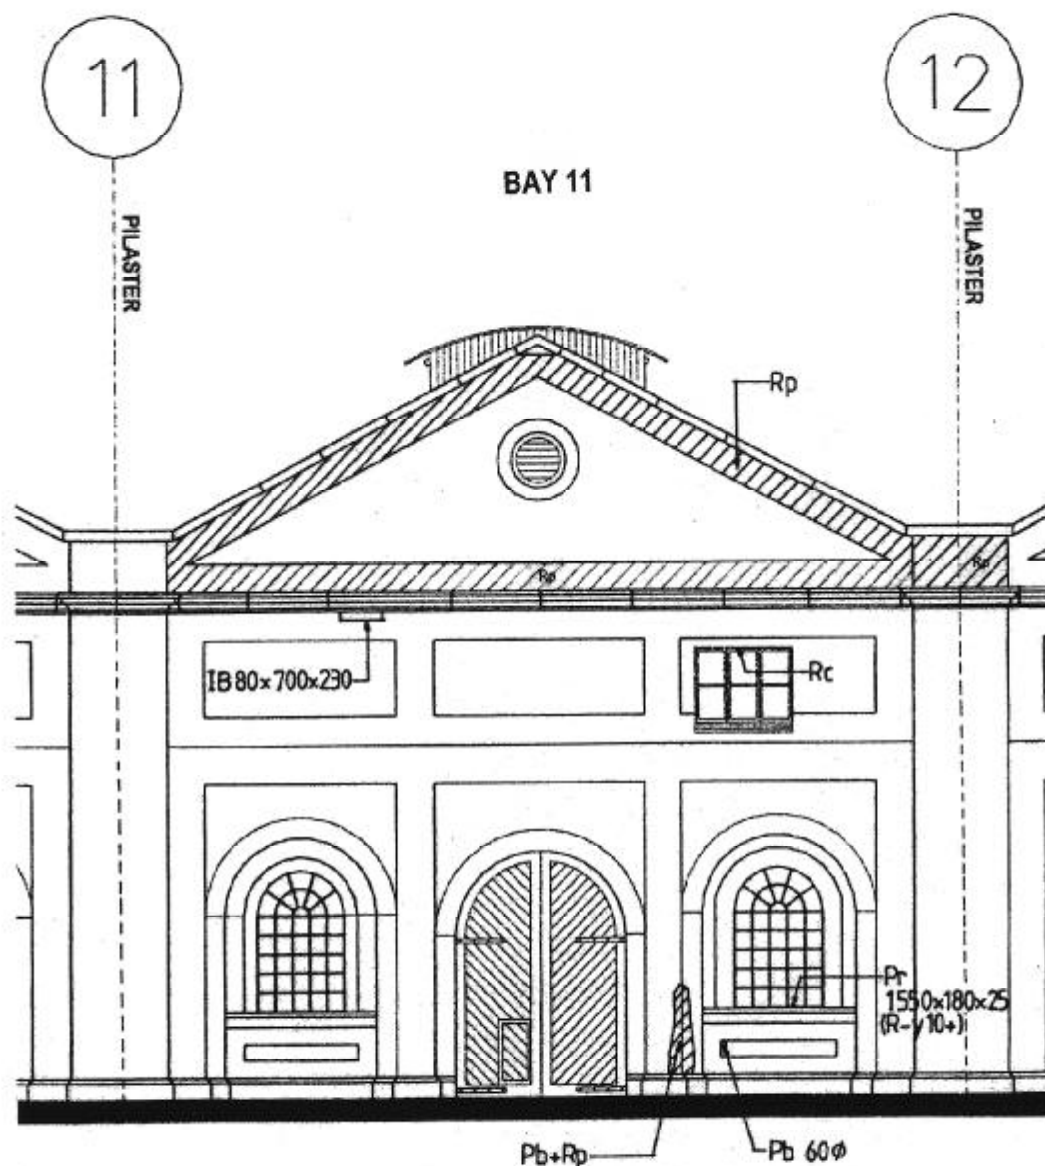
Record # 11

DESCRIPTION	SIGNIFICANCE	CONDITION	RECTIFICATION	RECOMMENDED WORKS	NOTES
PEDIMENT/PARAPET	S1	C2	R3	Major repointing required.	
STONWORK					
coping	S1	C3	R1		
weathering	N/A				
inserts	N/A				
BRICKWORK					
rims	S1	C1	R3	Repoint entire rim.	HP
panels	S1	C3	R1	Light wash and repoint as required.	
inserts	S1	C2	R3	Remove loose cables from porcelain inserts. Do not fill.	
BULSEYE	S1	C1	R3	Reinstate louvres as funds permit.	
UPPER WALL	S1	C3	R1	Light wash and repoint as required.	
STONWORK					
cornice	S1	C3	R1		
BRICKWORK					
rims	S1	C3	R1	Light wash and repoint as required.	
panels	S1	C3	R1	Light wash and repoint as required.	
inserts	N/A				
WINDOWS	S1	C2	R3	Apply rust converter to corroding metal window heads.	
LOUVRES	N/A				
LOWER WALL					
BRICKWORK					
rim	S1	C3	R1	Light wash and repoint as required.	
arches	S1	C3	R1	Light wash and repoint as required.	
panels	S1	C3	R1	Light wash and repoint as required.

panel under sill	S1	C3	R1	Light wash and repoint as required.	
inserts	N/A				
STONWORK					
window sills	S1	C2	R3	Patch with reinforcement. Els and mortar fill joints.	
plinth	S1	C3	R1		
corbel	N/A				
inserts	N/A				
WINDOWS	S1	C3	R1		
DOOR(S)	S1	C3	R1	Timber gate reinstated 1995.	Done

<input type="checkbox"/> R replace stone	<input type="checkbox"/> In Inject crack with epoxy mixture
<input type="checkbox"/> I Indent stone	<input checked="" type="checkbox"/> Rc Apply rust-converter to corroded ferrous metal insert
<input type="checkbox"/> H Hairline jointed stone insert	<input type="checkbox"/> Tme To match existing
<input checked="" type="checkbox"/> Rp Re point	<input type="checkbox"/> Zac New Zincalume capping to replace corroded capping
<input type="checkbox"/> Ci Corroded insert, remove and epoxy patch	<input type="checkbox"/> Rv Remove vegetation and rake out joints 20mm deep
<input type="checkbox"/> Ps Small epoxy patch	<input type="checkbox"/> MS Make safe by removing loose stone
<input checked="" type="checkbox"/> Pr Patch stone with reinforcement	<input checked="" type="checkbox"/> Pb Patch brickwork
<input checked="" type="checkbox"/> IB Insert Brick	<input type="checkbox"/> Rb Reconstruction of brick surface of wall

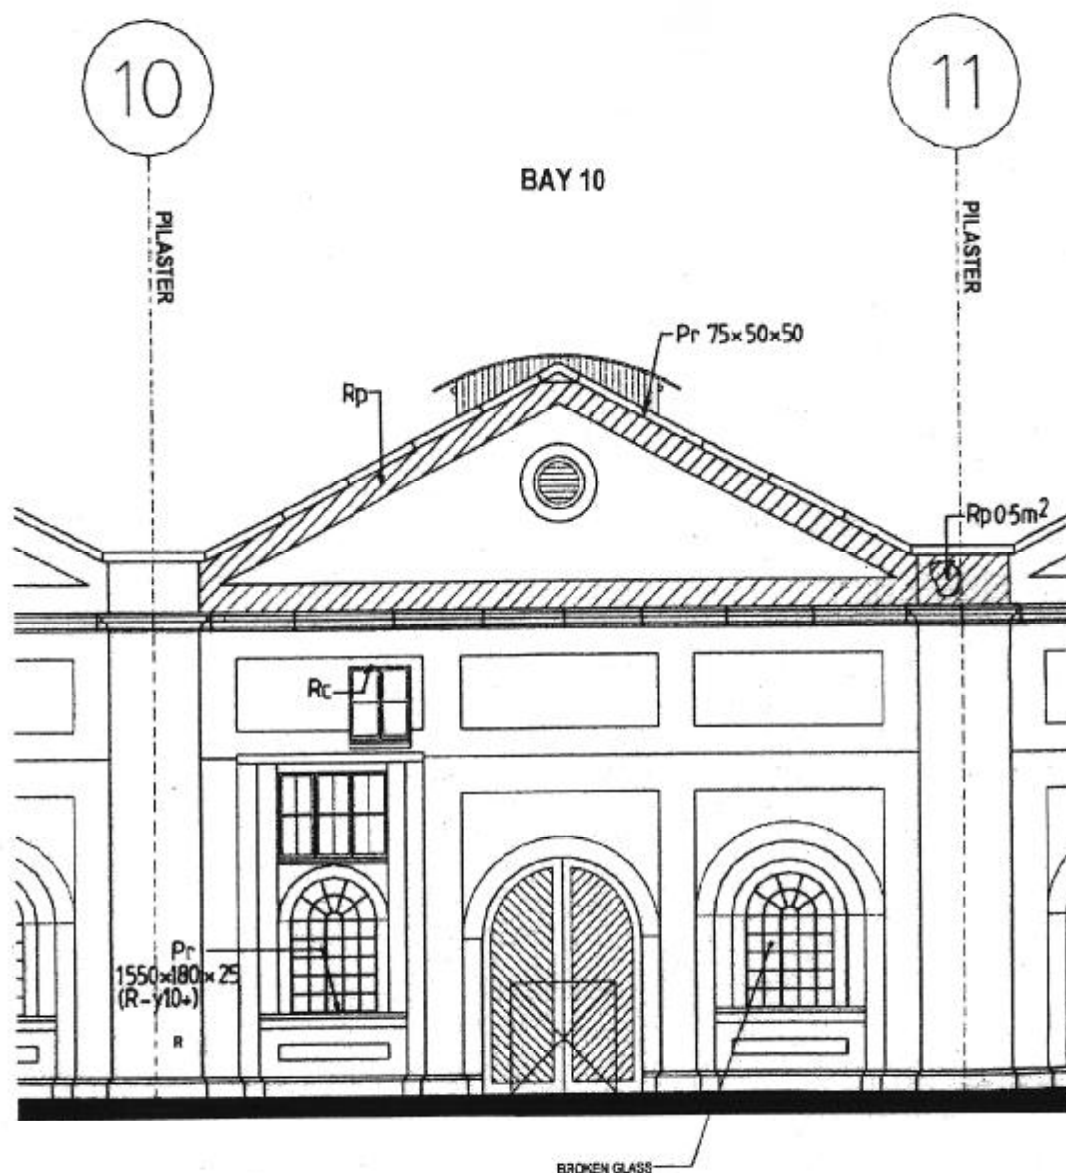
Record # 10

window sills	S1	C1	R3	Replace damaged sills.	
plinth	S1	C3	R1	Repoint horizontal stone joints	
corbel	N/A				
inserts	N/A				
WINDOWS	S1	C2	R1		
DOOR(S)	S1	C3	R1	Timber gate reinstated 1995.

<input type="checkbox"/> R	replace stone	<input type="checkbox"/> In	Inject crack with epoxy mixture
<input type="checkbox"/> I	indent stone	<input checked="" type="checkbox"/> Rc	Apply rust-converter to corroded ferrous metal insert
<input type="checkbox"/> H	Hairline jointed stone insert	<input type="checkbox"/> Tme	To match existing
<input checked="" type="checkbox"/> Rp	Re point	<input type="checkbox"/> Zac	New Zincalume capping to replace corroded capping
<input type="checkbox"/> C	Corroded insert, remove and epoxy patch	<input type="checkbox"/> Rv	Remove vegetation and rake out joints 20mm deep
<input type="checkbox"/> Ps	Small epoxy patch	<input type="checkbox"/> MS	Make safe by removing loose stone
<input checked="" type="checkbox"/> Pr	Patch stone with reinforcement	<input type="checkbox"/> Pb	Patch brickwork
<input type="checkbox"/> IB	Insert Brick	<input type="checkbox"/> Rb	Reconstruction of brick surface of wall

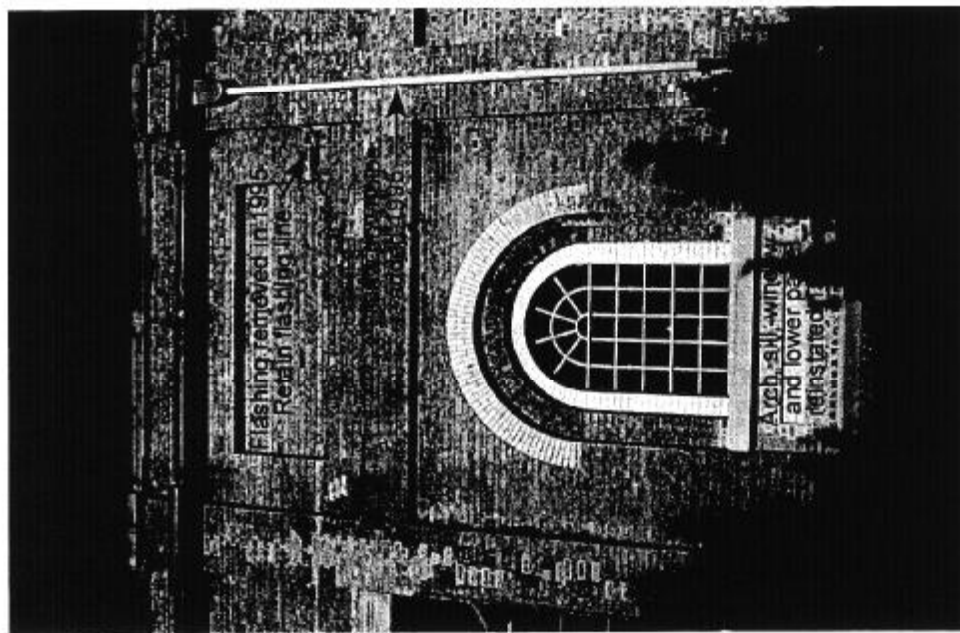
Row B/1-4 east

Works in 1995 included structural repairs to the brickwork in pilasters which had been damaged by corroding downpipes in the walls. These should be monitored to check that no further cracks develop.

New stone plinths were installed in sections of the east wall in 1995. Some of the stone is already cracked and exfoliating. The cause of this is not known but is likely to be inferior stone or chemical treatment to the stone at the time of installation. This needs further investigation.

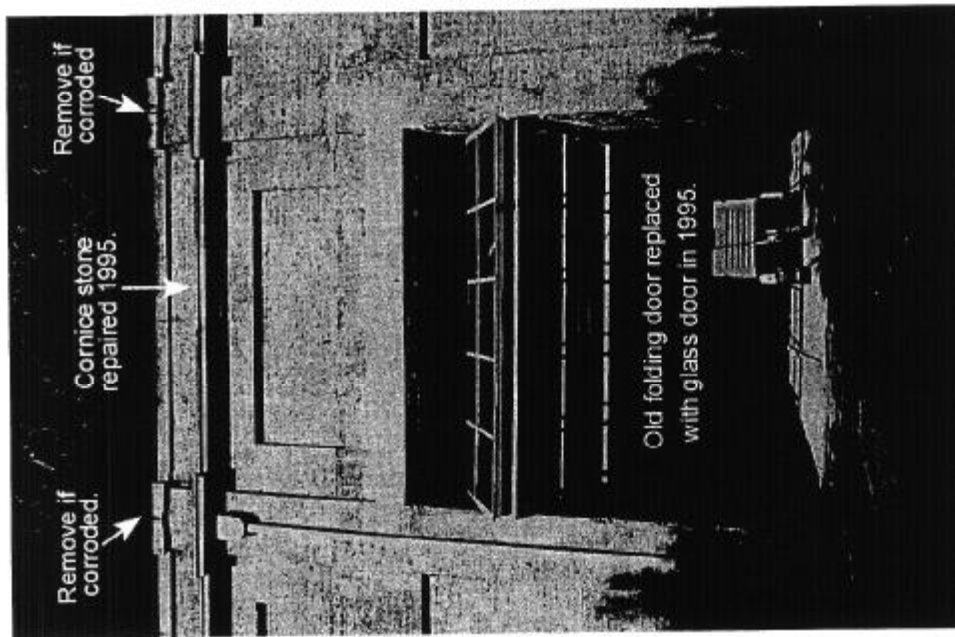
LOCATION Row C/13 east

The east wall had extensive works carried out in 1995 during the adaptive reuse of the building for the Australian Technology Park. Most of the required work identified in 1995 has been completed, but the finished work needs some further inspection. The stone joints should be checked to see if they have been filled with mortar and the tops sealed with elastomeric sealant. If this has not been done, then the general note to E5 horizontal stone joints should be applied to this wall.

Works in 1995 included structural repairs to the brickwork in pilasters which had been damaged by corroding downpipes in the walls. These should be monitored to check that no further cracks develop.

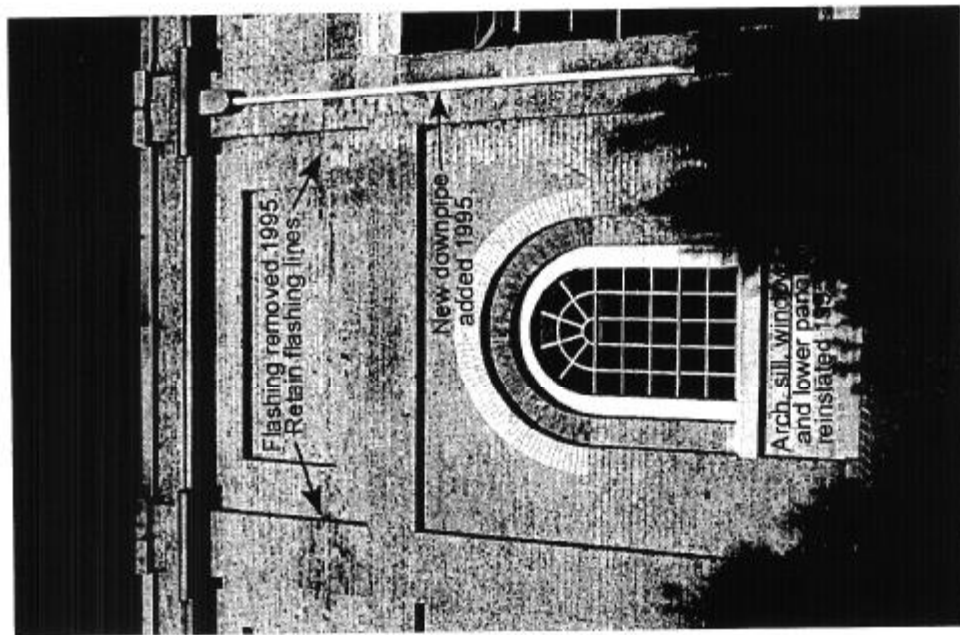
LOCATION Row D1/2 east

Works in 1995 included structural repairs to the brickwork in pilasters which had been damaged by corroding downpipes in the walls. These should be monitored to check that no further cracks develop.

New stone pinths were installed in sections of the east wall in 1995. Some of the stone is already cracked and exfoliating. The cause of this is not known but is likely to be inferior stone of chemical treatment to the stone at the time of installation. This needs further investigation.

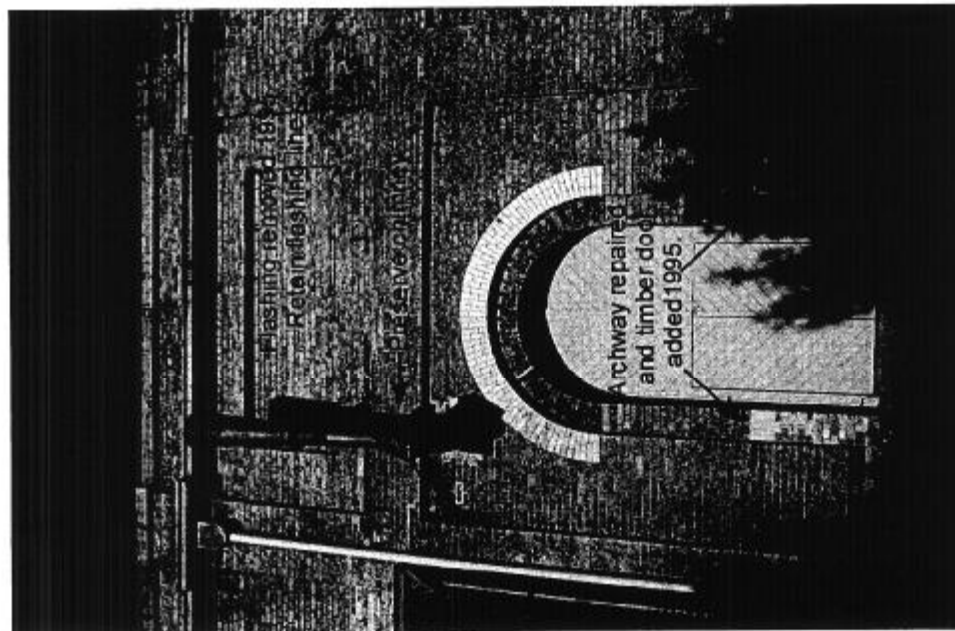
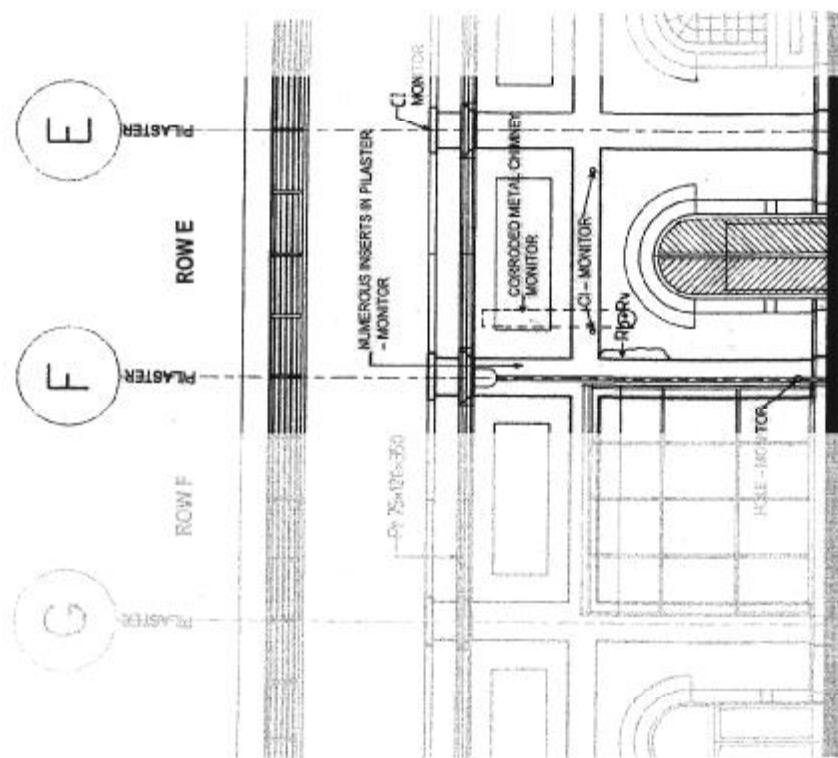
LOCATION Row E11 east

The east wall had extensive works carried out in 1995 during the adaptive reuse of the building for the Australian Technology Park. Most of the required works identified in 1995 has been completed, but the finished work needs some further inspection. The stone joints should be checked to see if they have been filled with mortar and the tops sealed with elastomeric sealant. If this has not been done, then the general note to Ets horizontal stone joints should be applied to this wall.

Works in 1995 included structural repairs to the brickwork in pilasters which had been damaged by corroding downpipes in the walls. These should be monitored to check that no further cracks develop.

NOTE: FILL OPEN JOINTS IN STONE COPING, CORNICE AND SILLS WITH LIME MORTAR & POINT TOP OF JOINT WITH ELASTOMETRIC SEALANT AND BACKING ROD.

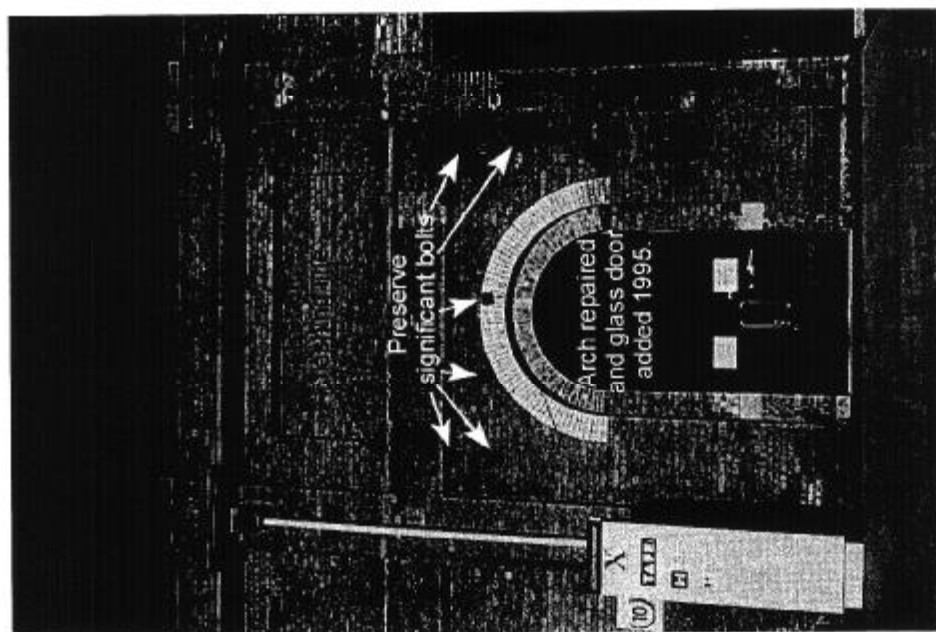
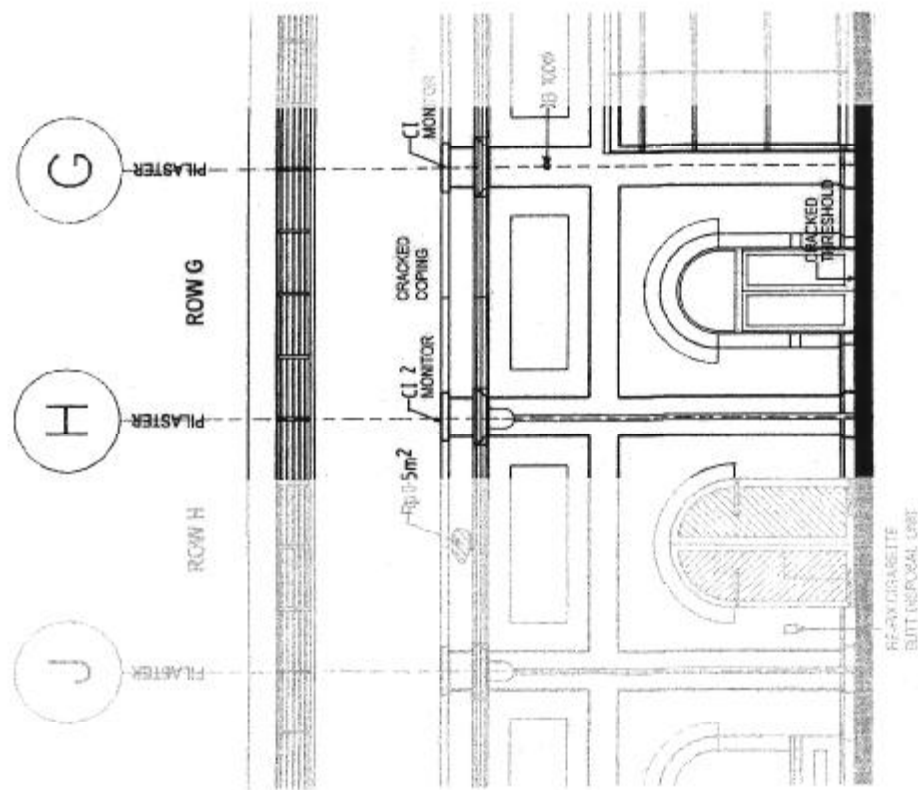
LOCATION Row G/9 east

STONEWORK					
coping	S1	C2	R3	Repair cracked coping. Mortar fill and Et joints.	
weathering	N/A				
lintels	S2	C2	R3	Monitor lintels for corrosion	
BRICKWORK					
rim	S1	C3	R1	Light wash & repoint as required	
panels	S1	C3	R1	Light wash & repoint as required	
inserts	S1	C3	R1	Preserve porcelain insert. Do not fill.	
Bullet	N/A

STONEWORK					
rim	S1	C3	R1	Preserve flashing line.	
arches	S1	C3	R1	Arch repaired in 1995.	Done
panels	S2	C3	R1	Light wash & repoint as required	
panel under	N/A				
lintels	S1	C3	R1	Preserve historic bolts

NOTE: FILL OPEN JOINTS IN STONE COPING, CORNICE AND SILLS WITH LIME MORTAR & POINT TOP OF JOINT WITH ELASTOMETRIC SEALANT AND BACKING ROD.

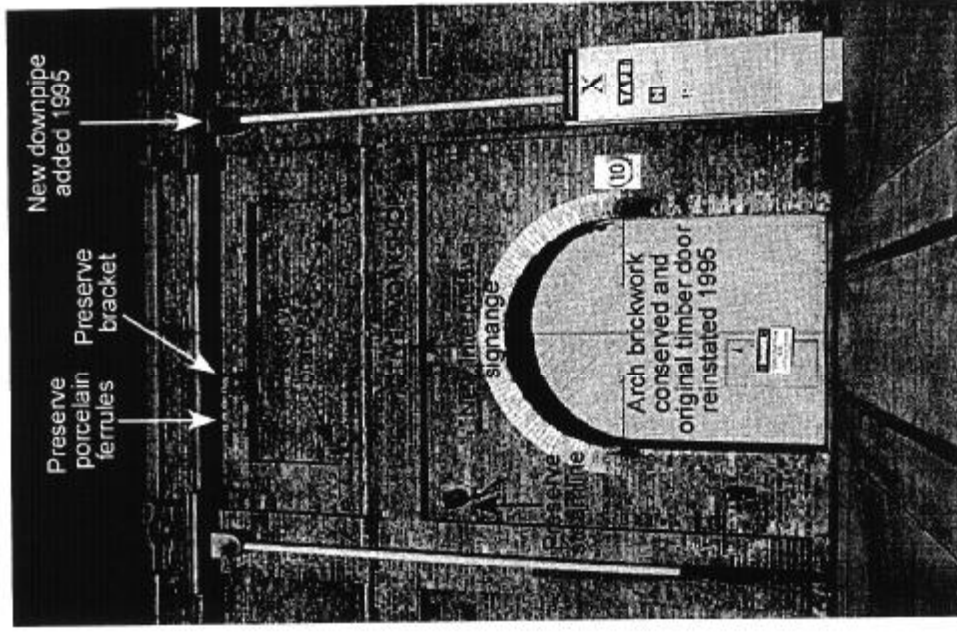
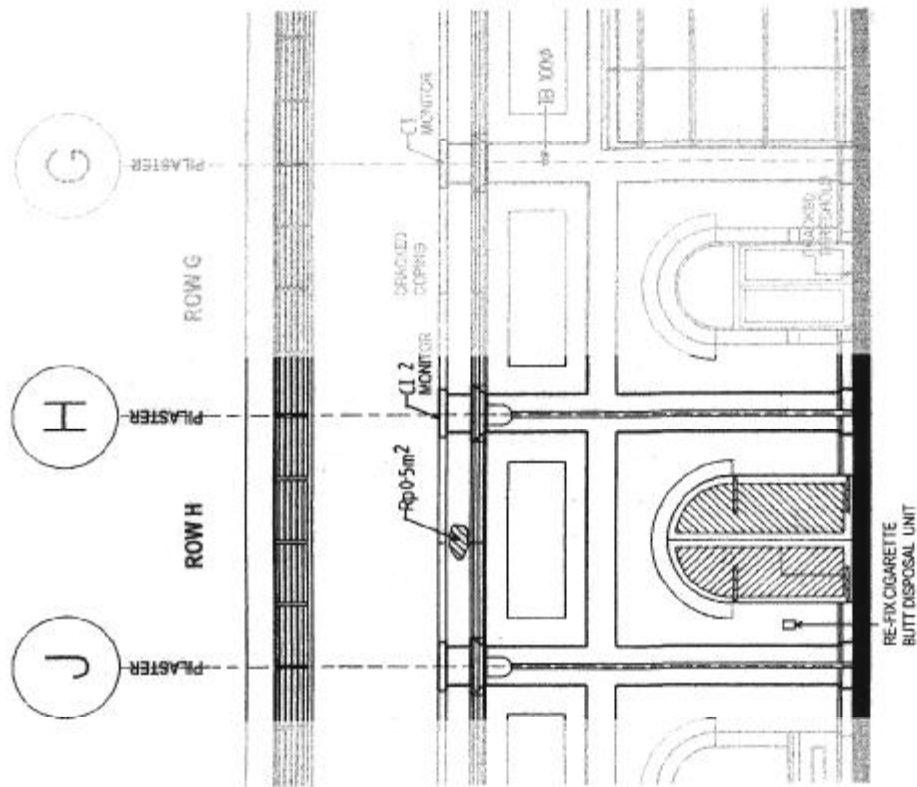
LOCATION Row H/3 east

DESCRIPTION	SIGNIFICANCE	CONDITION	RECOMMENDATION	RECOMMENDED WORKS	NOTES
<b>REDIMENT/PARAPET</b>					
Stonework coping	S1	C3	R1	Mortar fill and all joints.	
weathering	N/A				
Inserts	S2	C2	R1	Monitor corroding inserts	
<b>BELTWORK</b>					
rim	S1	C2	R3	Repoint where indicated. Light wash.	
panels	S1	C3	R1	Light wash & repoint as required.	
Inserts	N/A				
Beltwork	N/A				
<b>UPPER WALL</b>					
Stonework cornice	S1	C3	R1	Light wash & repoint as required. E/s joints.	
Stonework cornice	S1	C3	R1	Mortar fill and all joints. Light wash & repoint as required.	
<b>BELTWORK</b>					
rim	S1	C3	R1	Light wash & repoint as required.	
panels	S1	C3	R1	Light wash & repoint as required.	
Inserts	S1	C3	R1	Preserve porcelain inserts and steel brackets	Interpret
Windows	N/A				
Louvers	N/A				
<b>LOWER WALL</b>					
Stonework rim	S1	C3	R1	Light wash & repoint as required.	
arches	S1	C3	R1	Light wash & repoint as required.	
panels	S1	C3	R1	Light wash & repoint as required.

NOTE: FILL OPEN JOINTS IN STONE COPING, CORNICE AND SILLS WITH LIME MORTAR & POINT TOP OF JOINT WITH ELASTOMETRIC SEALANT AND BACKING ROD.

- ☐ R. replace stone  
☐ I. Indent stone  
☐ H. Hairline jointed stone insert  
☒ No Re joint  
☒ C. Corroded insert remove and epoxy patch  
☐ P. Small epoxy patch  
☐ P. Patch stone with reinforcement  
☐ B. Insert Brick  
☐ E. Mortar fill joint, elastometric sealant and backing rod to top

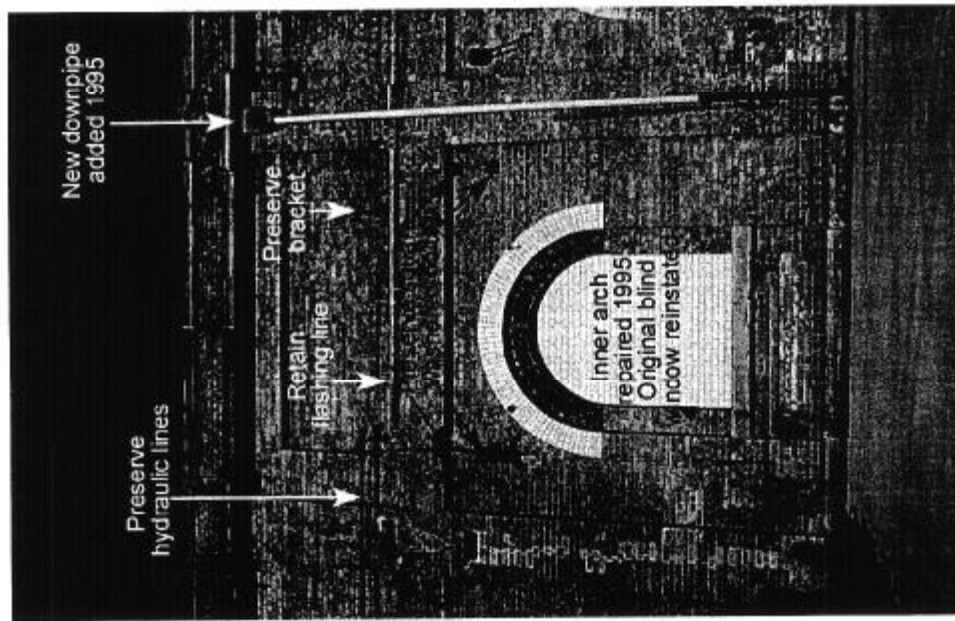
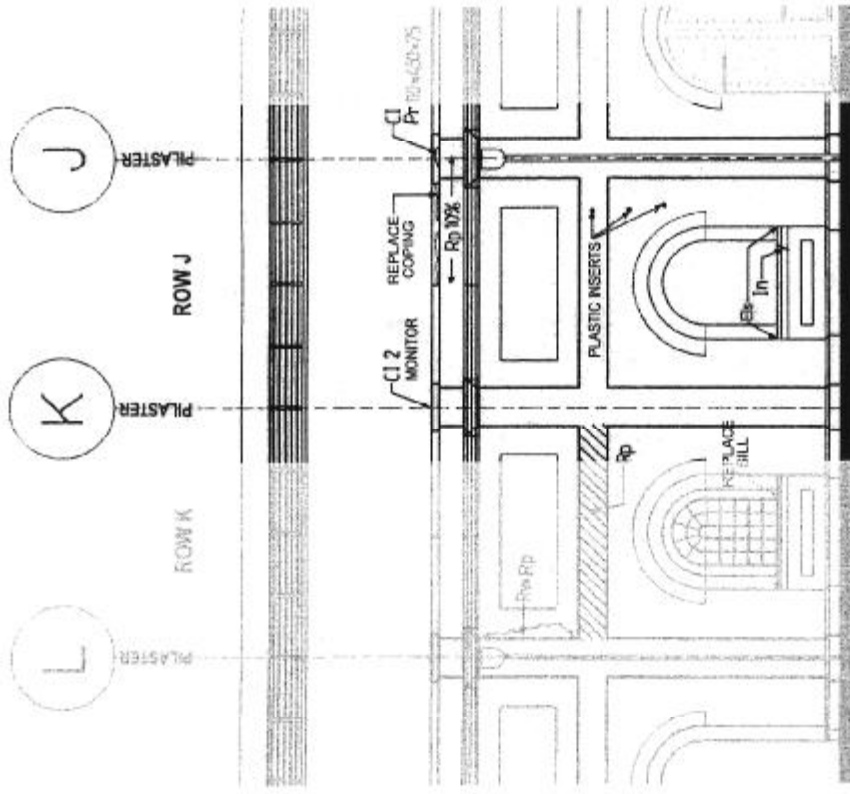
LOCATION Row J7 east

DESCRIPTION	SYNCHANCE	CONDITION	REPAIR/RECOMMENDATION	RECOMMENDED WORKS	NOTES
PEDIMENT/PART	S1	C2	R3	Light wash & repair as required.	
Stonework					
coping	S1	C1	R2	Replace coping stone as shown.	Urgent
weathering	N/A				
inserts	N/A				
BRICKWORK					
rims	S1	C3	R1	Light wash & repair as required.	
panels	S1	C3	R1	Light wash & repair as required.	
inserts	S3	C2	R1	Monitor corroded inserts	
BUENY	N/A				
UPPER WALL	S1	C3	R1	Es joints. Light wash and repair as required.	
Stonework					
cornice	S1	C3	R1	Mortar fill and es joints.	
BRICKWORK					
rims	S1	C3	R1		
panels	S1	C3	R1	Retain flashing fins. Light wash & repair as required.	
inserts	S2	C3	R1	Preserve and monitor historic fittings	
WINDOWS	N/A				
LOUVERS	N/A				
LOWER WALL	S1	C3	R1	Light wash & repair as required.	
Brickwork					
rims	S1	C3	R1	Light wash & repair as required. Preserve inserts.	
arches	S1	C3	R1	Light wash & repair as required.	
sashes	S1	C3	R1	Light wash & repair as required.

panel under	S1	C3	R1	Light wash & repair as required.	
all	S2	C3	R1	Preserve square washered bolts. Monitor other inserts.	
inserts					
Stonework					
window sill	S1	C3	R3	Mortar fill and Es joints. Inject crack as indicated.	
plinth	S1	C3	R1	Light wash & repair as required.	
corbel	N/A				
inserts	N/A				
WINDOWS	N/A				
DOOR(s)	N/A

If the replacement or indenting of coping or cornice stones as recommended does not proceed then these stone should be monitored and made safe at least every two years. This is a matter of public safety.

NOTE: FILL OPEN JOINTS IN STONE COPING, CORNICE AND SELLS WITH LIME MORTAR & POINT TOP OF JOINT WITH ELASTOMETRIC SEALANT AND BACKING ROD.

<input type="checkbox"/> A	replace stone	<input checked="" type="checkbox"/> In	Inject crack with epoxy mixture
<input type="checkbox"/> I	redent stone	<input type="checkbox"/> Rc	Apply rust-converter to corroded ferrous metal insert
<input type="checkbox"/> H	Harline jointed stone insert	<input type="checkbox"/> Tm	Time To match existing
<input checked="" type="checkbox"/> Rp	Re point	<input type="checkbox"/> Znc	New Zincalume coping to replace corroded coping
<input checked="" type="checkbox"/> Cl	Corroded insert, remove and epoxy patch	<input type="checkbox"/> Rv	Remove vegetation and rake out joints 20mm deep
<input type="checkbox"/> Ps	Small epoxy patch	<input type="checkbox"/> MS	Make safe by removing loose stone
<input type="checkbox"/> Ar	Patch stone with reinforcement	<input type="checkbox"/> Pb	Patch blowout
<input type="checkbox"/> B	Insert Brick	<input type="checkbox"/> Rb	Reconstruction of brick surface of wall
