# EVELEIGH LOCOMOTIVE WORKSHOPS

## F A B R I C I N V E N T O R Y

## 1.0 EXECUTIVE SUMMARY

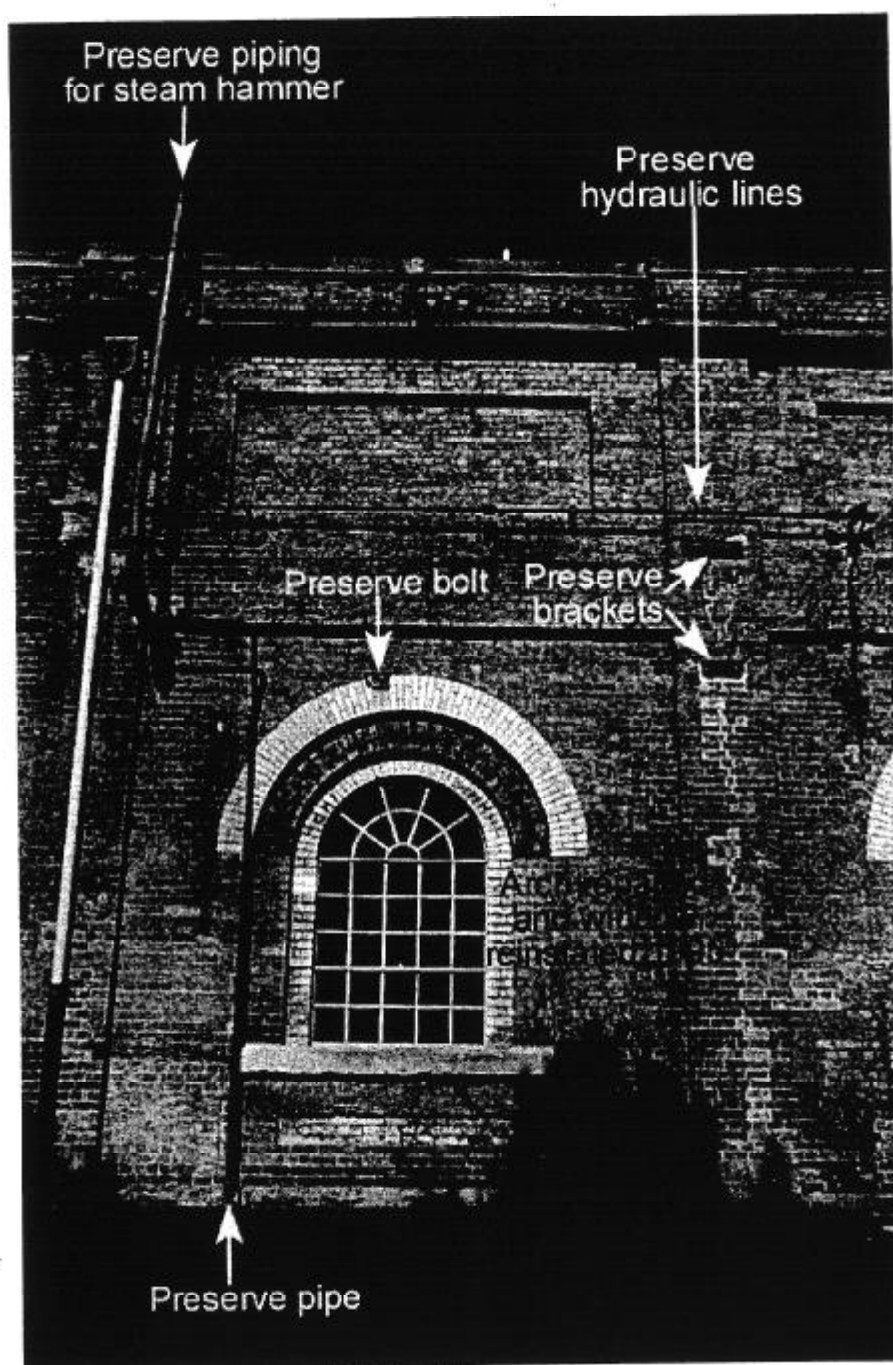
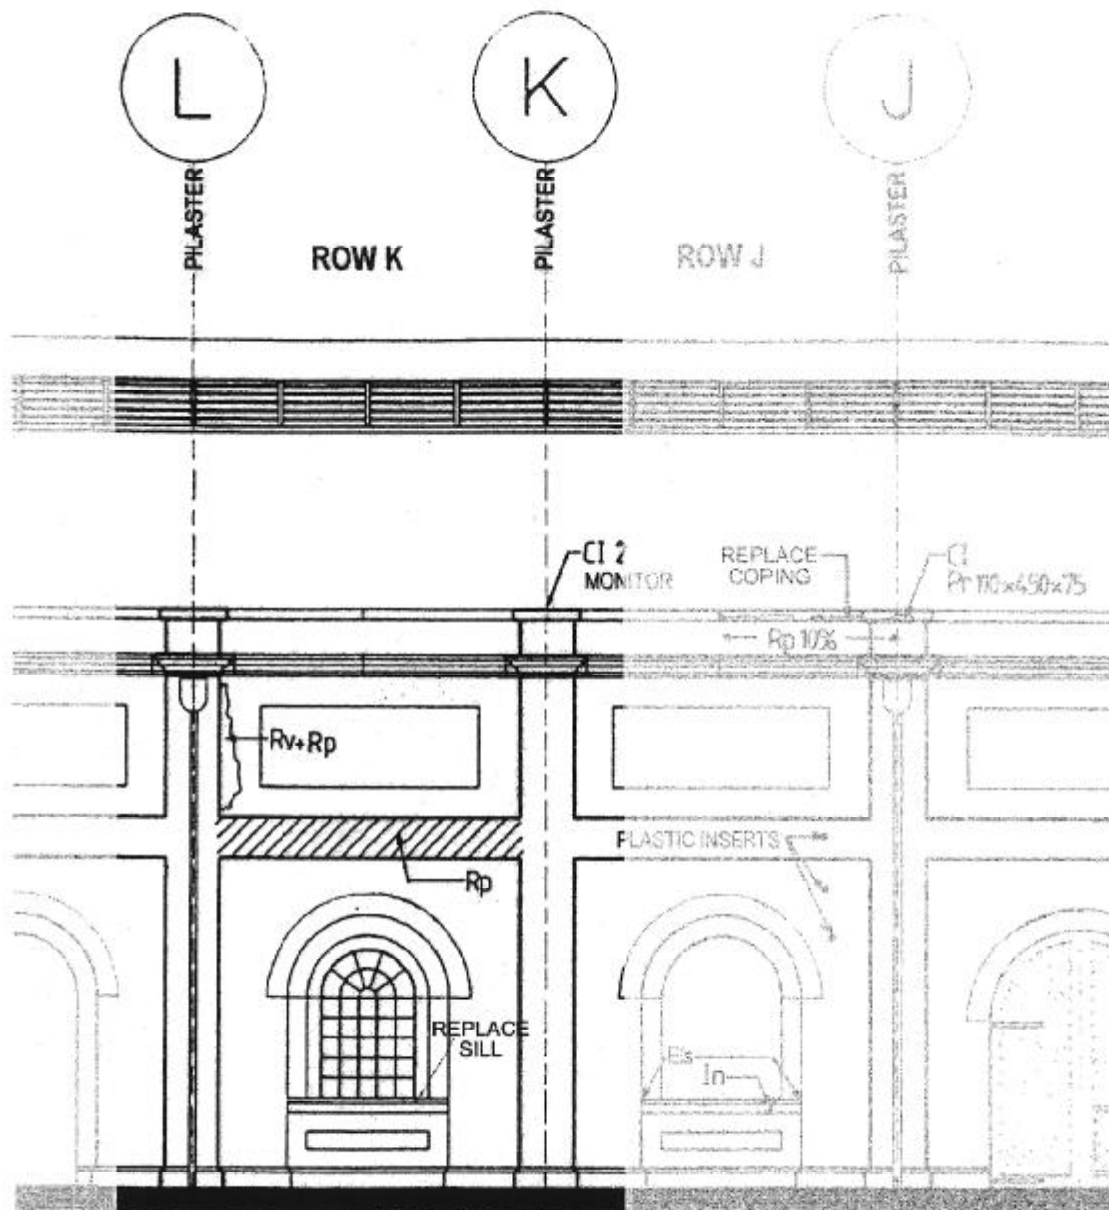
LOCATION Row K/6 east

DESCRIPTION	SIGNIFICANCE	CONDITION	RECTIFICATION	RECOMMENDED WORKS	NOTES
PEDIMENT/PARAPET	S1	C3	R1	Light wash & repoint as required. Els stone joints.	
STONWORK					
coping	S1	C3	R1	Light wash & repoint as required. Mortar fill and els joints.	
weathering	N/A				
inserts	N/A				
BRICKWORK					
rims	S1	C3	R1	Light wash & repoint as required.	
panels	S1	C3	R1	Light wash & repoint as required.	
inserts	S1	C3	R1	Monitor inserts for corrosion.	
BULLSEYE	N/A				
UPPER WALL	S1	C3	R1	Els joints. Remove vegetation. Repoint, light wash as required	
STONWORK					
cornice	S1	C3	R1	Light wash & repoint as required.	
BRICKWORK					
rims	S1	C2	R1	Remove vegetation, repoint brickwork. Light wash as	
panels	S1	C3	R1	Preserve hydraulic lines.	
inserts	N/A				
WINDOWS	N/A				
LOUVRES	N/A				
LOWER WALL					
BRICKWORK					
rim	S1	C3	R1	Repoint rim. Light wash as required.	
arches	S1	C3	R1	Preserve bolts in arch.	
panels	S1	C3	R1	Preserve hydraulic lines

panel under sill	S1	C3	R1	Light wash & repoint as required.	
inserts	N/A				
STONWORK					
window sills	S1	C1	R3	Replace stone sill.	
plinth	S1	C3	R1	Light wash & repoint as required. Mortar fill and els joints	
corbel	N/A				
inserts	N/A				
WINDOWS	S1	C3	R1	Reinstated 1995	Done
DOOR(S)

NOTE: FILL OPEN JOINTS IN STONE COPING, CORNICE AND SILLS WITH LIME MORTAR & POINT TOP OF JOINT WITH ELASTOMETRIC SEALANT AND BACKING ROD.

| <input checked="" type="checkbox"/> Rp Re point | <input type="checkbox"/> Zac New Zincalume capping to replace corroded capping |
| <input checked="" type="checkbox"/> CI Corroded insert, remove and epoxy patch | <input checked="" type="checkbox"/> Rv Remove vegetation and rake out joints 20mm deep |

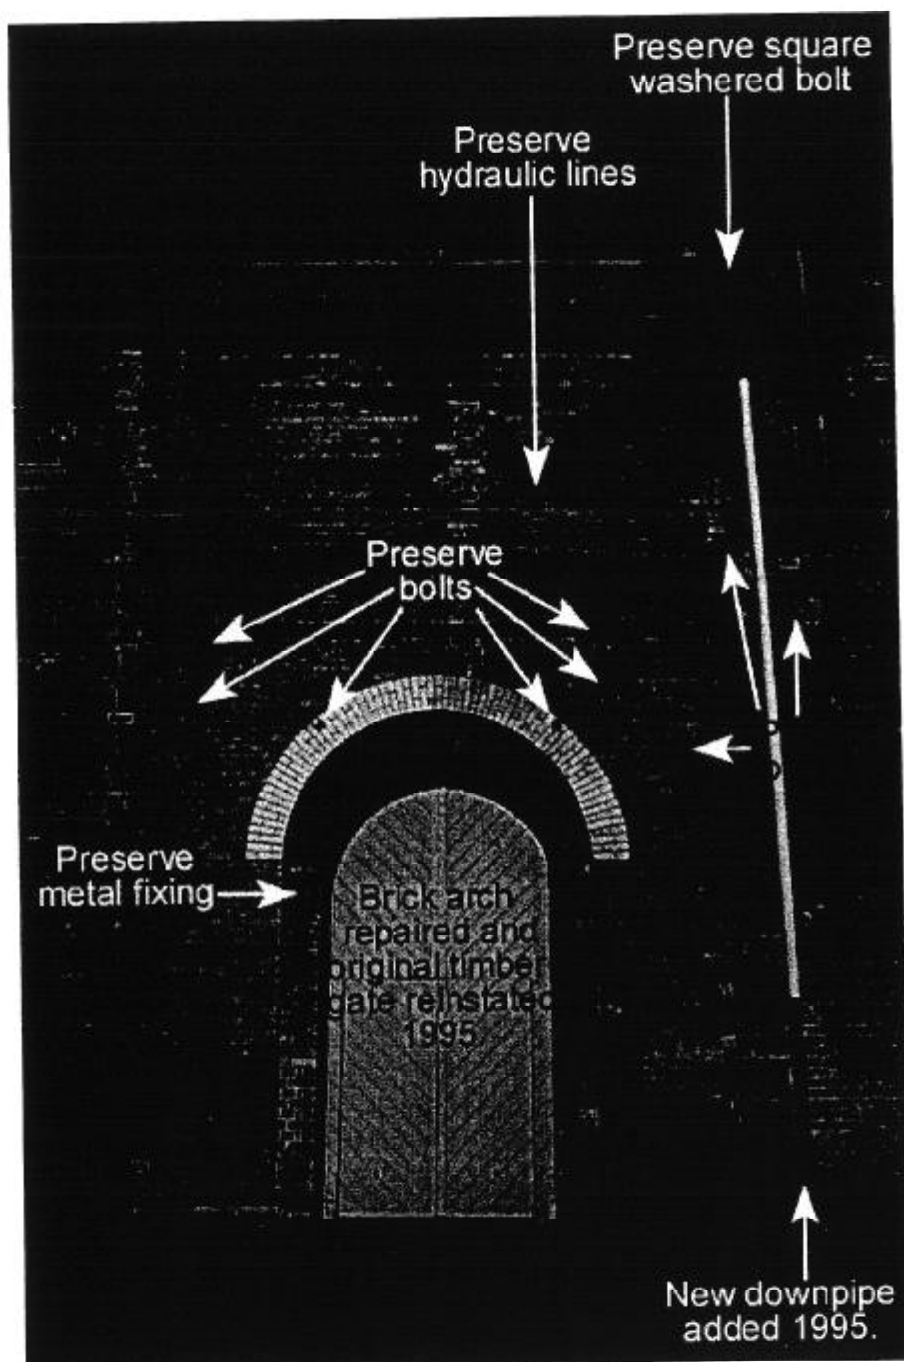
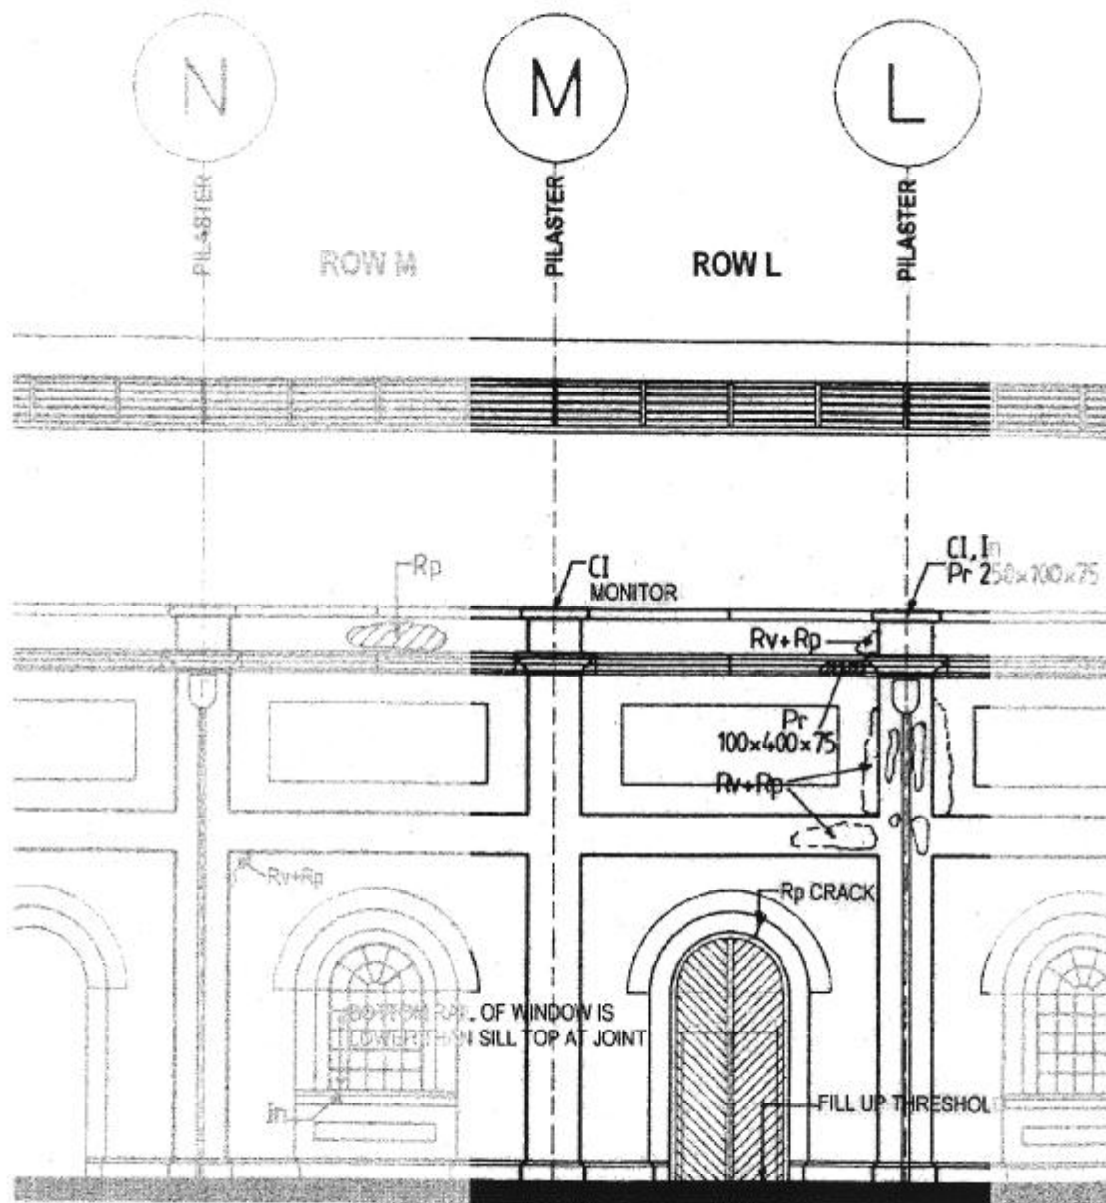
LOCATION Row L/5 east

DESCRIPTION	SIGNIFICANCE	CONDITION	RECTIFICATION	RECOMMENDED WORKS	NOTES
PEDIMENT/PARAPET	S1	C2	R1	Light wash & repoint as required.	
STONEWORK					
coping	S1	C3	R1	Light wash & repoint as required. Mortar fill and els joints.	
weathering	N/A				
inserts	N/A				
BRICKWORK					
rims	S1	C2	R3	Remove vegetation and repoint brickwork. Light wash.	
panels	S1	C2	R1	Remove vegetation, repoint brickwork, light wash.	
inserts	S3	C3	R1	Monitor inserts for corrosion	
BULLSEYE	N/A				
UPPER WALL	S1	C2	R3	Repoint and patch as indicated. Light wash. Els joints.	
STONEWORK					
cornice	S1	C2	R3	Patch cornice as indicated. Mortar fill and els joints.	
BRICKWORK					
rims	S1	C2	R3	Remove vegetation and repoint brickwork, light wash	
panels	S1	C3	R1	Light wash & repoint as required.	
inserts	N/A				
WINDOWS	N/A				
LOUVRES	N/A				
LOWER WALL					
BRICKWORK					
rim	S1	C2	R3	Remove vegetation and repoint brickwork, light wash	
arches	S1	C3	R1

panels	S1	C3	R1	Light wash & repoint as required.	
panel under sill	N/A				
inserts	S1	C3	R1	Monitor all inserts for corrosion.	
STONEWORK					
window sills	N/A				
plinth	S1	C3	R1		
corbel	N/A				
inserts	N/A				
WINDOWS	N/A				
DOOR(S)	S1	C3	R1	Timber gate reinstated in 1995.	Done

DESCRIPTION	SIGNIFICANCE	CONDITION	RECTIFICATION	RECOMMENDED WORKS	NOTES
lower wall continued					
GLAZED INRILL	N/A				
THRESHOLD	S1	C3	R1		
TIMBER FRAMED WALL	N/A				
SERVICE PIPES	N/A				
STEELWORK	N/A				
PILASTER	S1	C3	R1	Light wash & repoint as required. Patch stone. Els joints.	
STONEMWORK					
coping	S1	C2	R3	Patch stonework where indicated. Mortar fill and els joints.	
cornice	S1	C3	R1	Light wash & repoint as required.	
plinth	S1	C3	R1	Light wash & repoint as required.	
inserts	Nil				
BRICKWORK					
parapet	S1	C3	R1	Light wash & repoint as required.	
body	S1	C3	R1	Remove vegetation, light wash & repoint as required.	
down pipes	S3	C3	R1	New downpipe added in 1995.	
inserts	S1	C3	R1	Preserve historic fittings.	
END PILASTER	N/A				
STONEMWORKS					
coping	N/A				
cornice	N/A				
plinth	N/A				
inserts	Nil				
BRICKWORK					
parapet	N/A				
body	N/A				
pipes	N/A				
inserts	Nil				
OTHER 1	S1	C3	R1	Preserve bolts and brackets as indicated in photograph.

**NOTE: FILL OPEN JOINTS IN STONE COPING, CORNICE AND SILLS WITH LIME MORTAR & POINT TOP OF JOINT WITH ELASTOMETRIC SEALANT AND BACKING ROD.**

| <input type="checkbox"/> R replace stone | <input checked="" type="checkbox"/> In Inject crack with epoxy mixture |
| <input checked="" type="checkbox"/> Rp Re point | <input type="checkbox"/> Zac New Zincalume capping to replace corroded capping |
| <input checked="" type="checkbox"/> O Corroded insert, remove and epoxy patch | <input checked="" type="checkbox"/> Rv Remove vegetation and rake out joints 20mm deep |

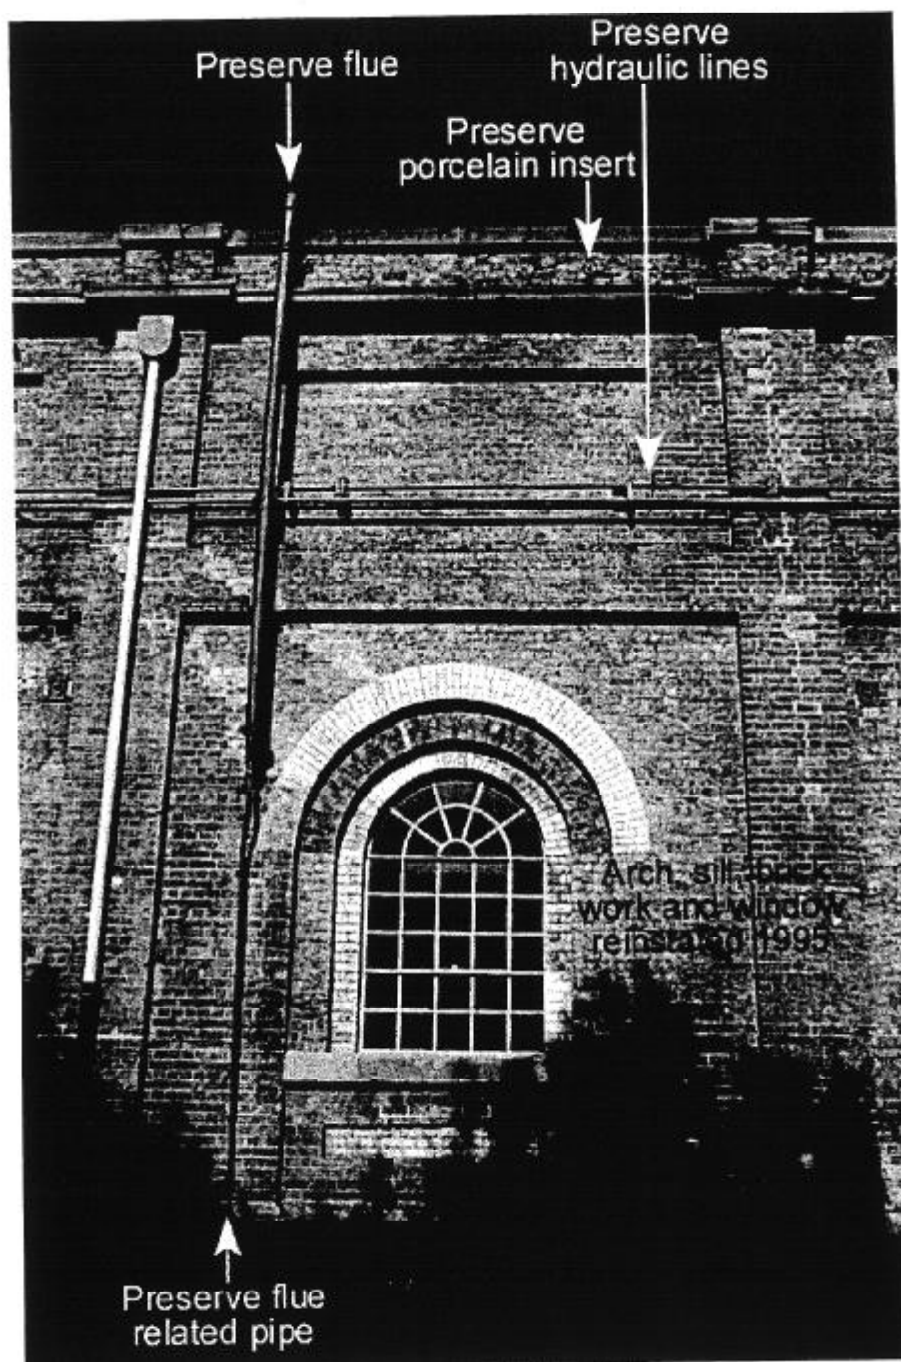
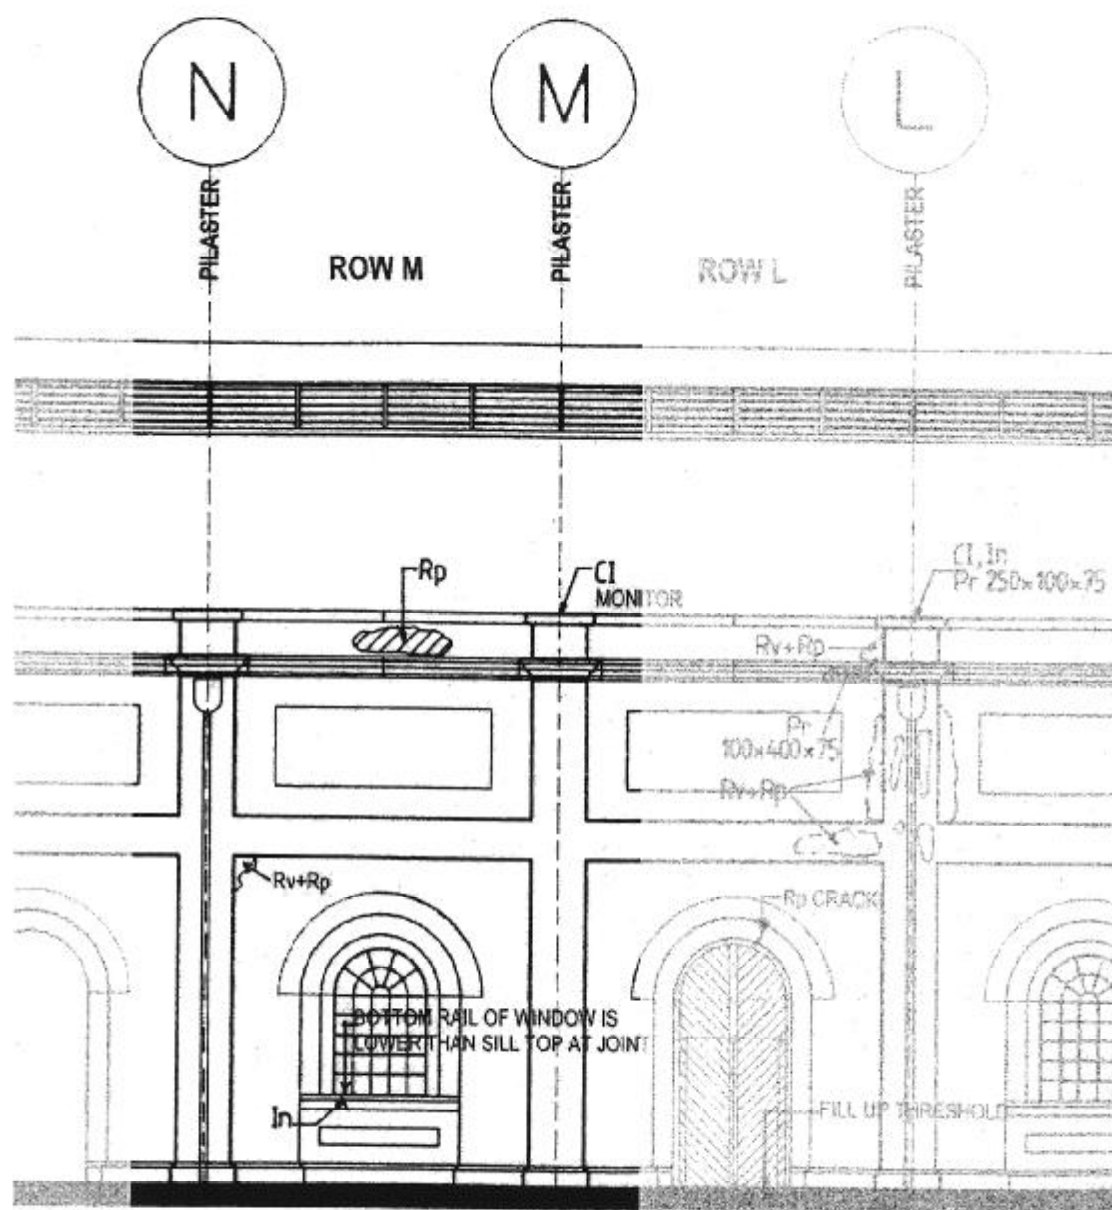
LOCATION Row M/4 east

DESCRIPTION	SIGNIFICANCE	CONDITION	RECTIFICATION	RECOMMENDED WORKS	NOTES
PEDIMENT/PARAPET	S1	C2	R3	Repoint brickwork as indicated. Light wash. Els stone joints.	
STONEWORK					
coping	S1	C3	R1	Light wash & repoint as required. Mortar fill and els joints.	
weathering	N/A				
inserts	S3	C2	R1	Monitor insert for corrosion	
BRICKWORK					
rims	S1	C2	R3	Repoint brickwork as indicated.	
panels	S1	C2	R3	Repoint brickwork as indicated	
inserts	S1	C3	R1	Preserve porcelain insert	
BULLSEYE	N/A				
UPPER WALL	S1	C3	R1	Light wash & repoint as required. Els stone joints.	
STONEWORK					
cornice	S1	C3	R1	Light wash & repoint as required. Mortar fill and Els joints.	
BRICKWORK					
rims	S1	C3	R1	Light wash & repoint as required.	
panels	S1	C3	R1	Light wash & repoint as required.	
inserts	N/A				
WINDOWS	N/A				
LOUVRES	N/A				
LOWER WALL					
BRICKWORK					
rim	S1	C3	R1	Light wash & repoint as required.	
arches	S1	C3	R1	Arch restored in 1995.	Done

panels	S1	C3	R1	Remove vegetation and repoint.	
panel under sill	S1	C3	R1	Light wash & repoint as required.	
inserts	S2	C2	R1	Monitor any inserts for corrosion.	
STONEWORK					
window sills	S1	C2	R3	Window or sill not level. See line drawing. Els stone joints.	
plinth	S1	C3	R1	Light wash & repoint as required. Mortar fill and els joints.	
corbel	N/A				
inserts	N/A				
WINDOWS	S1	C3	R1	Cast-iron window reinstated in 1995.	Done
DOOR(S)	N/A

<input type="checkbox"/> R replace stone	<input checked="" type="checkbox"/> In Inject crack with epoxy mixture
<input type="checkbox"/> I Indent stone	<input type="checkbox"/> Rc Apply rust-converter to corroded ferrous metal insert
<input type="checkbox"/> H Hairline jointed stone insert	<input type="checkbox"/> Tme To match existing
<input checked="" type="checkbox"/> Rp Re point	<input type="checkbox"/> Zac New Zincalume capping to replace corroded capping
<input type="checkbox"/> Cl Corroded insert, remove and epoxy patch	<input checked="" type="checkbox"/> Rv Remove vegetation and rake out joints 20mm deep
<input type="checkbox"/> Ps Small epoxy patch	<input type="checkbox"/> MS Make safe by removing loose stone
<input type="checkbox"/> Pr Patch stone with reinforcement	<input type="checkbox"/> Pb Patch brickwork
<input type="checkbox"/> IB Insert Brick	<input type="checkbox"/> Rb Reconstruction of brick surface of wall

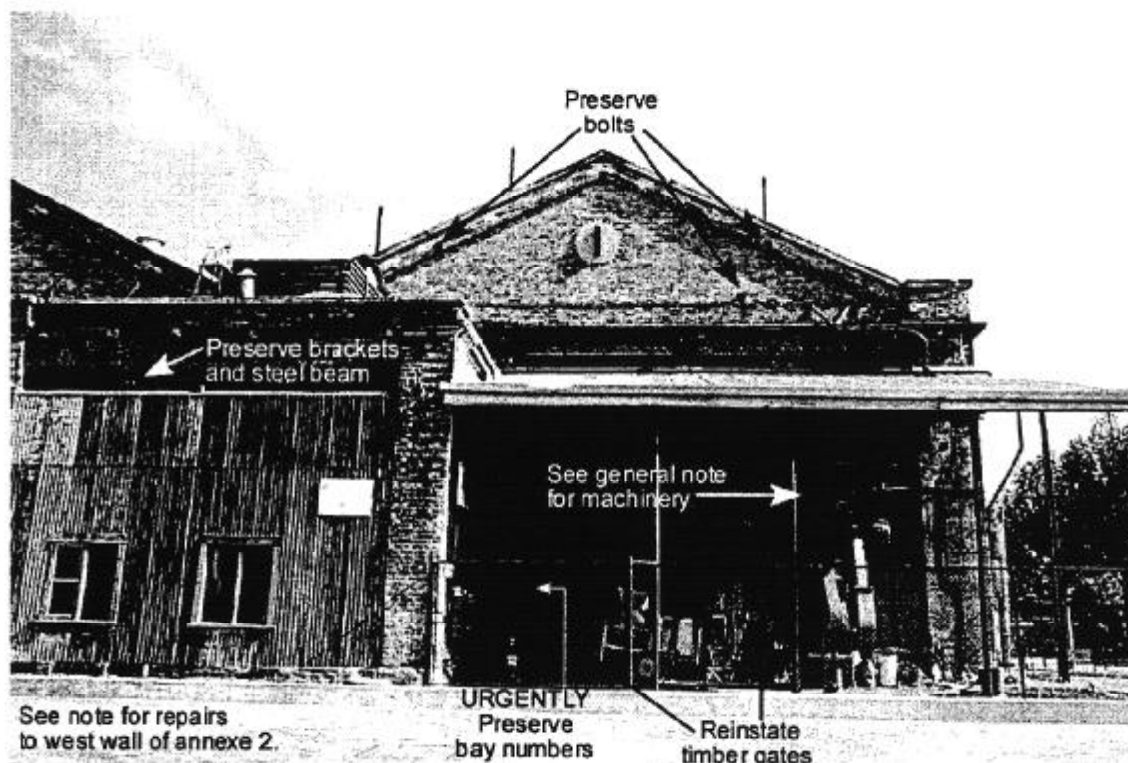
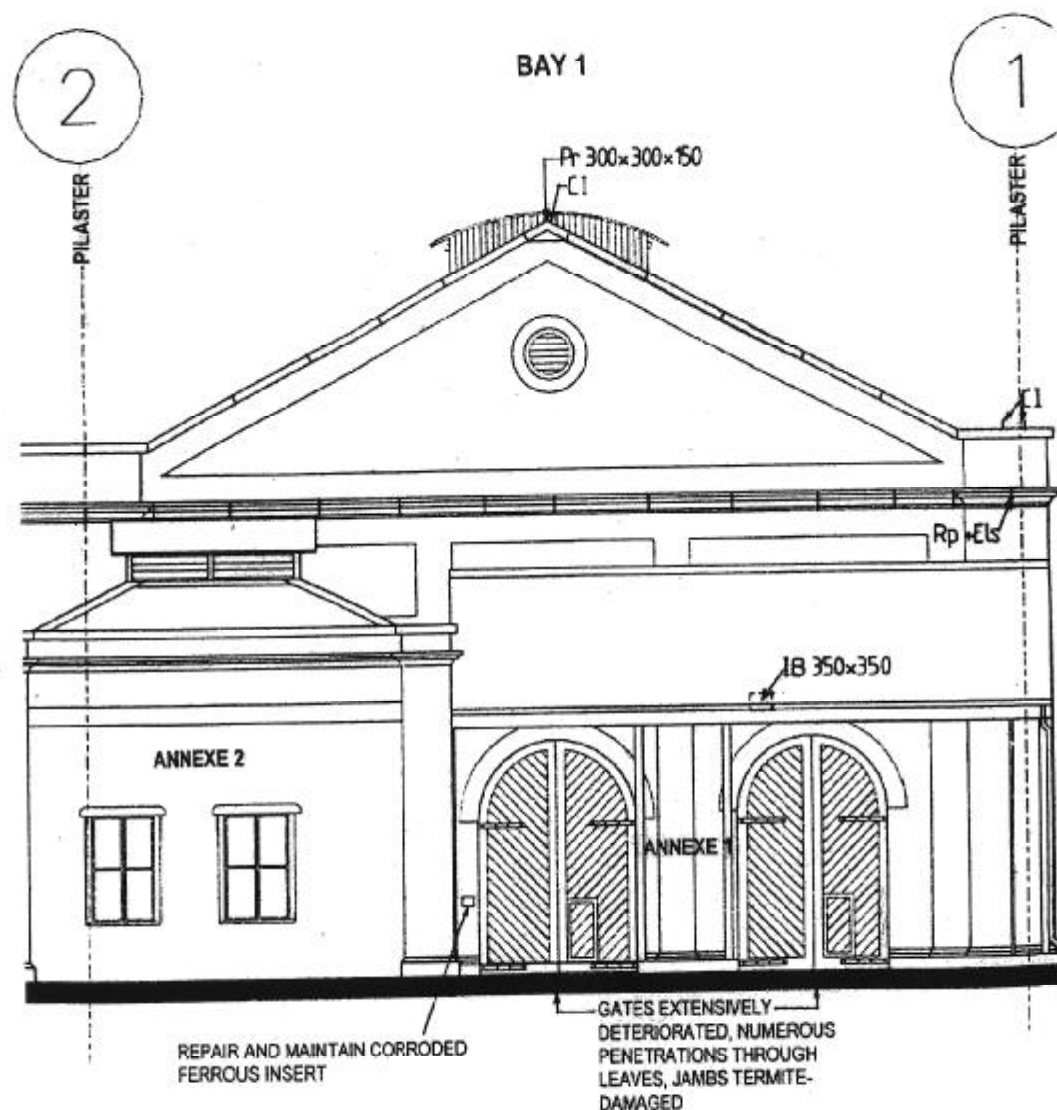
LOCATION Bay 1/I south

There is severe structural cracking in the brickwork where Annex 2 adjoins Bay 1. This is commented on in the general introduction to this fabric inventory. A structural engineering assessment is needed and urgent stabilisation and repair.

The brickwork in the gable rims in Bays 1 to 4 South are split on their bed planes indicating a possible problem with corroding embedded metal. There is crude repointing in this area and it is not known if the problem was adequately assessed and repaired. The fault needs structural assessment and repair.

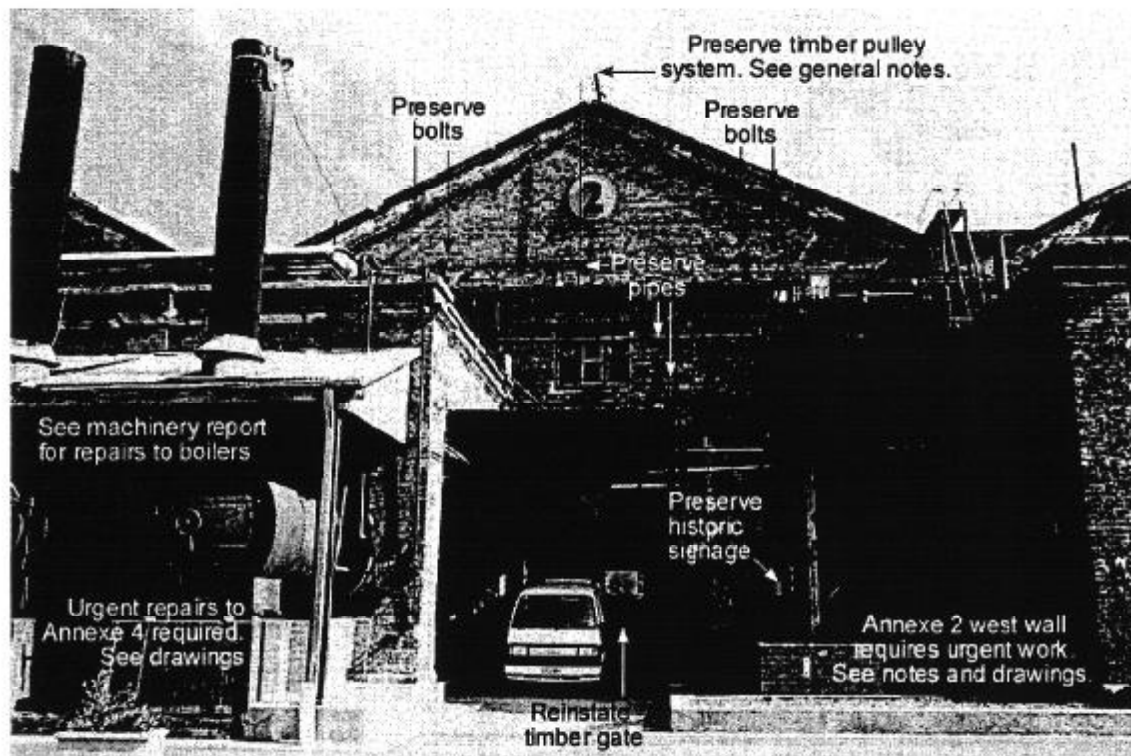
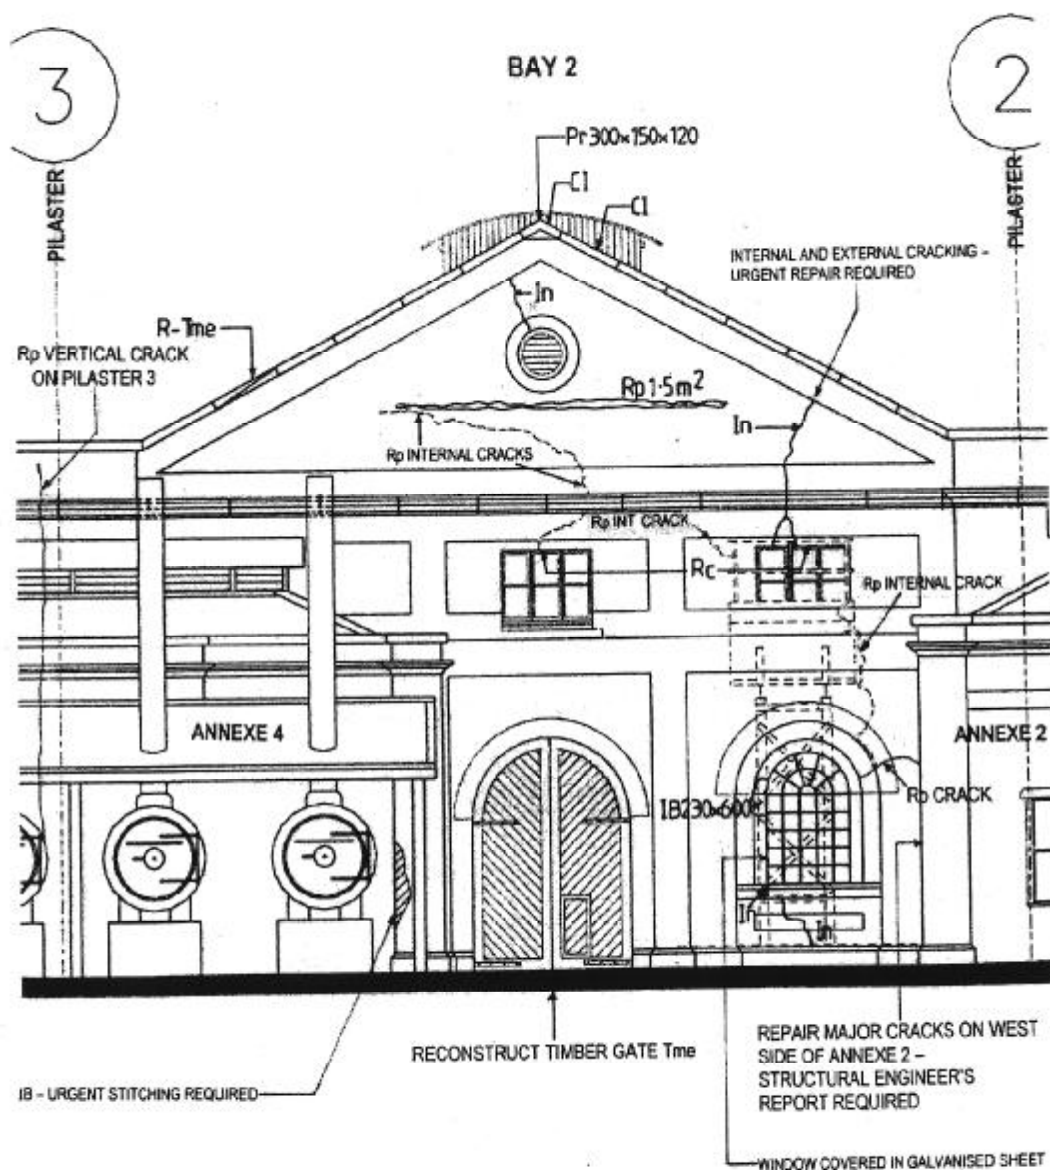
LOCATION Bay 2/2 south

A section of plinth is noted for repair. See general notes re plinths. New stone plinths were installed in sections of the east wall in 1995. Some of the stone is already cracked and exfoliating. The cause of this is not known but is likely to be inferior stone or chemical treatment to the stone at the time of installation. The repair of plinths needs further consideration. It may be preferable to treat with sacrificial render prior to installation of new stones. Care should be taken not to breach the asphalt damp proof course in any works to the plinth.

If the replacement or indenting of coping or cornice stones as recommended does not proceed then these stone should be monitored and made safe at least every two years. This is a matter of public safety.

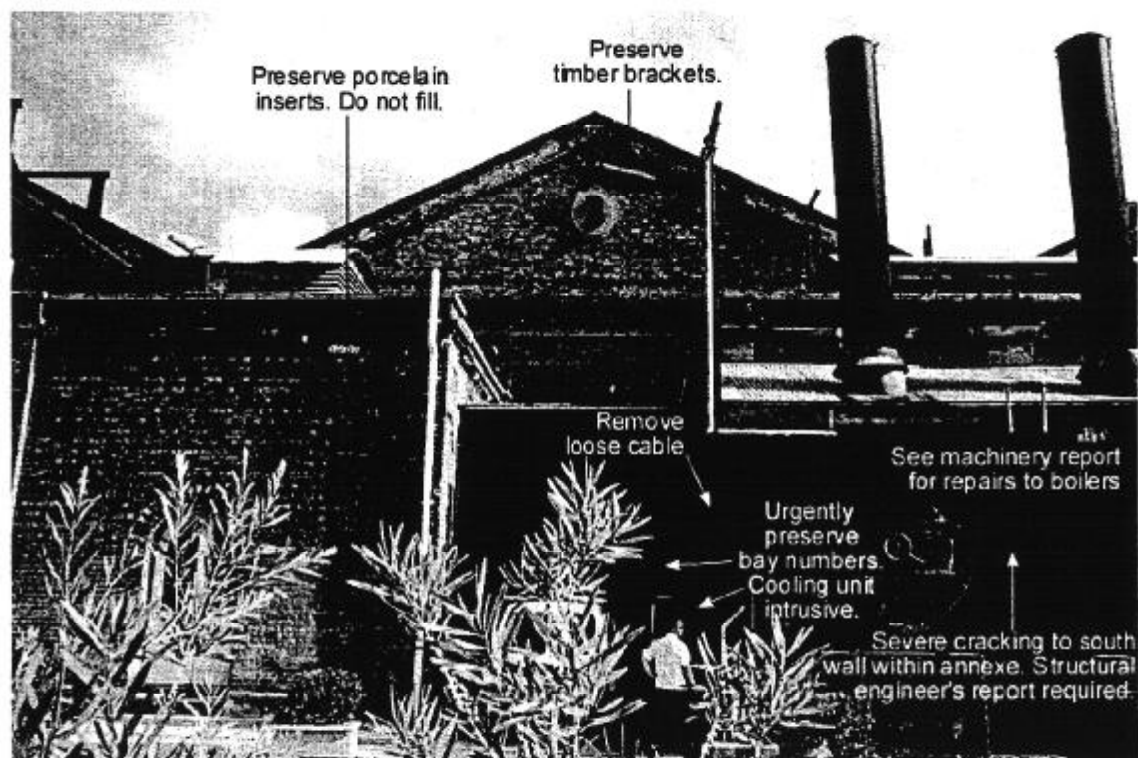
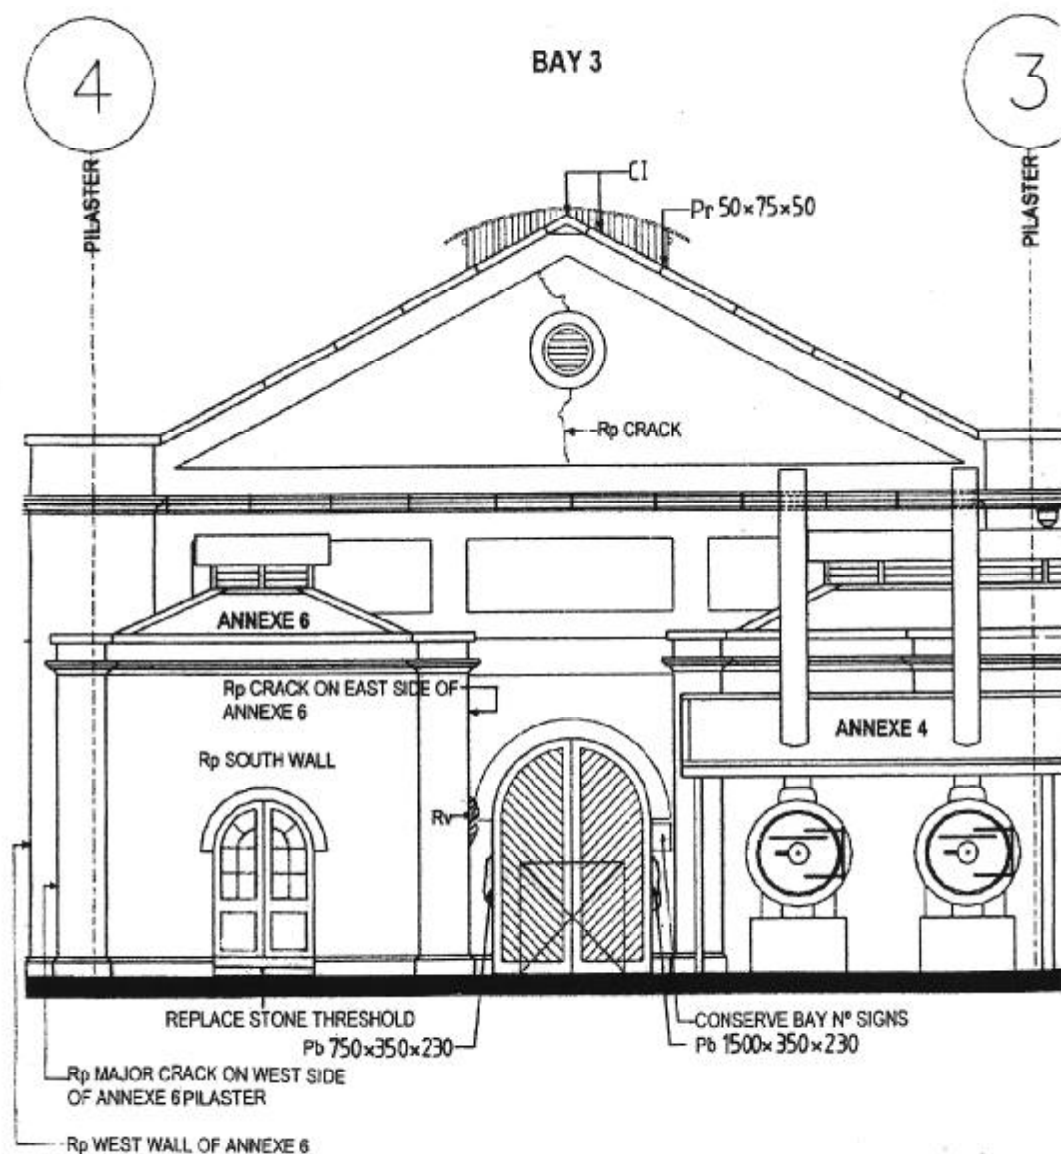
LOCATION Bay 3/3 south

The brickwork in the gable rims in Bays 1 to 4 South are split on their bed planes indicating a possible problem with corroding embedded metal. There is crude repointing in this area and it is not known if the problem was adequately assessed and repaired. The fault needs structural assessment and repair.

A section of plinth is noted for repair. See general notes re plinths. The repair of plinths needs further consideration. It may be preferable to treat with sacrificial render. Care should be taken not to breach the asphalt damp proof course in any works to the plinth.

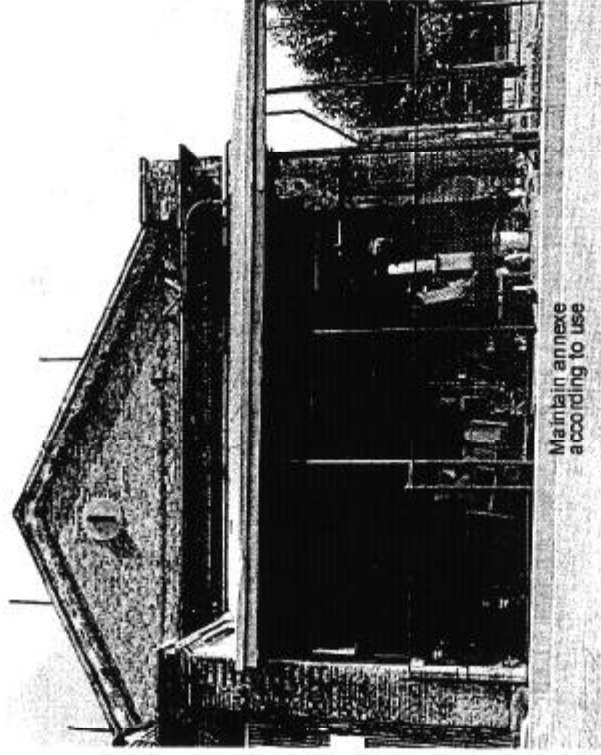
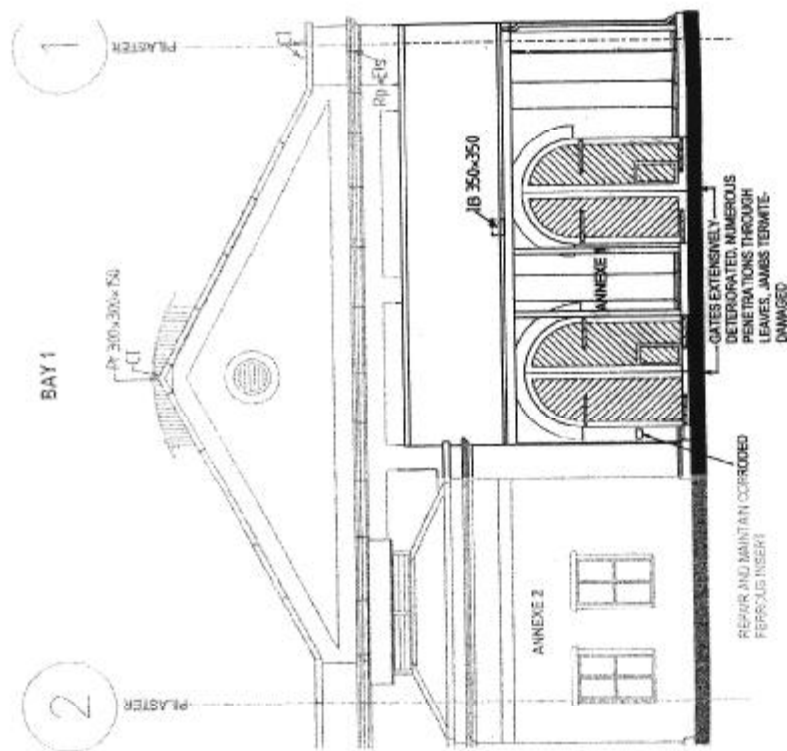
LOCATION Annexe 1/ South

The existing fabric is not of particular significance but the annex form and materials should be retained. The structure should be generally maintained. New elements may be necessary for continued operational safety.

Repair major cracking  
on west wall of annexe  
URGENTLY. Structural  
engineer's report required.

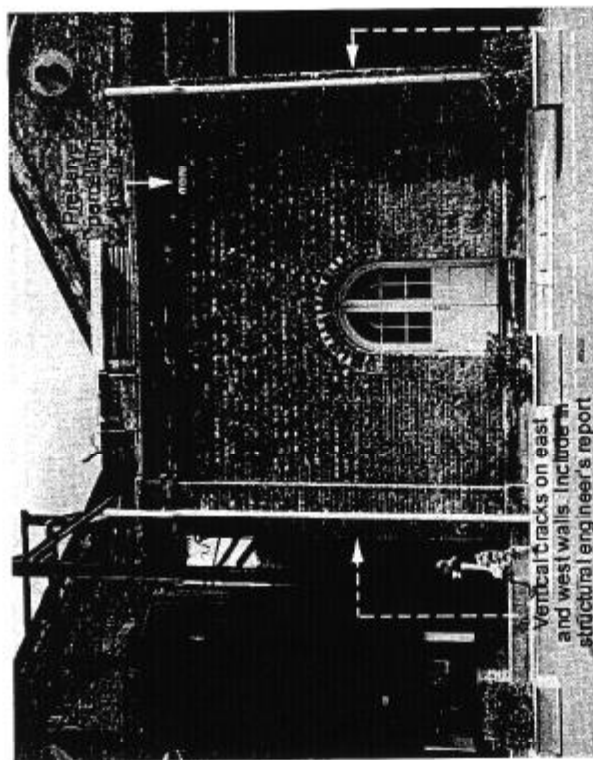
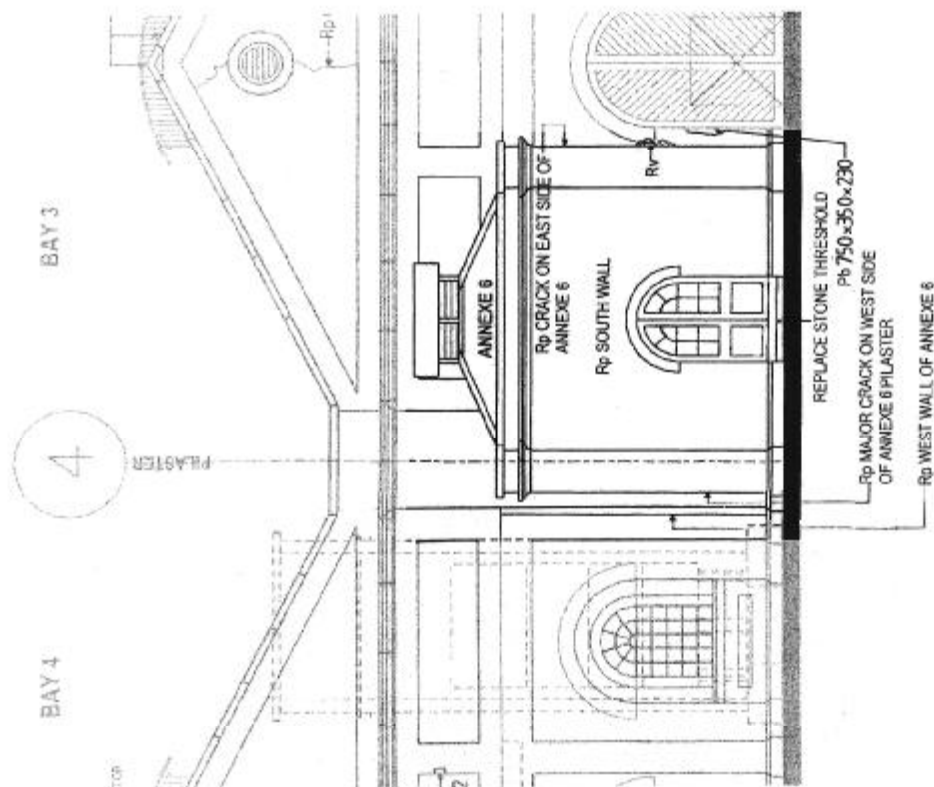
Annexe 6 / South

This annex is the Hydraulic Engine House and significant machinery including hydraulic pumps and steam engines are within it. These should be conserved and interpreted. The timber floor in the annex is badly deteriorated and should be repaired so the place can be accessed safely.

The annex has a lantern roof which should be conserved. See general notes in the introduction to this inventory for repair methods, etc.

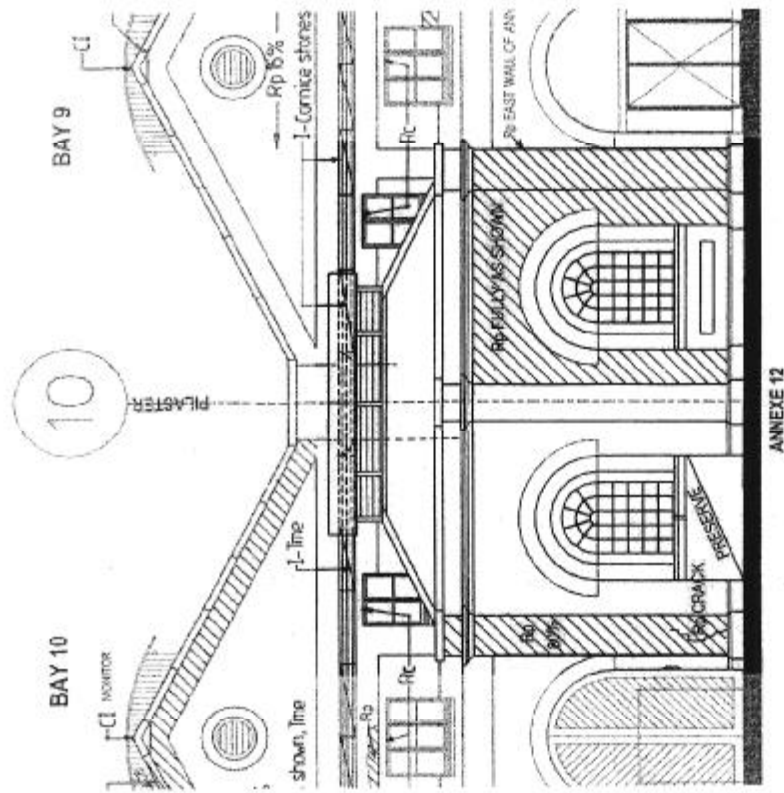
Record # 4

DESCRIPTION	SIGNIFICANCE	CONDITION	RECOMMENDATION	RECOMMENDED WORKS	NOTES
REDIMENT/PARAPET	S1	C2	R3	Es joints. Repoint brickwork. Light wash as required.	
STONEWORK					
coping	S1	C2	R3	Es joints. Light wash as required.	
weathering	N/A				
inserts	N/A				
BRICKWORK					
rims	N/A				
panels	S1	C2	R3	Repoint parapet. Light wash as required.	
inserts	N/A				
bullet	N/A				
UPPER WALL	S1	C2	R3	Es joints. Repoint, patch. Light wash as required.	
STONEWORK					
cornice	S1	C2	R3	Es joints. Repoint cracks. Patch brick. Light wash as required.	HP
BRICKWORK					
rims	N/A				
panels	N/A				
inserts	N/A				
WINDOWS	N/A				
LOUNGS	N/A				
LOWER WALL					
BRICKWORK					
rim	S1	C2	R3	[Central plaster] Repoint brickwork. Light wash as required.	
arches	S1	C3	R1	South wall. monitor eastern arch. Repoint arches as req'd.	
panels	S1	C1	R3	Repoint fully (all walls). Light wash as required.	HP
panel under	S1	C3	R1	Light wash repairs. Unable to survey panel behind initial

inserts	S1	C3	R1	Preserve historic bolt plates.	
STONEWORK					
window sills	S1	C2	R3	Es joints. Light wash as required. Repair cracks if required.	HP
plinth	S1	C3	R3	Plinth badly eroded. repair. repoint. Light wash	
corbel	N/A				
inserts	N/A				
WINDOWS	S1	C3	R1	Apply rust converter to frames if required.	
DOORS	S3	C3	R1	New glazed doors installed 1995, east/west walls of annexe.

NOTE: FILL OPEN JOINTS IN STONE CORNICE AND SILLS WITH LIME MORTAR & POINT TOP OF JOINT WITH ELASTOMETRIC SEALANT AND BACKING ROD.

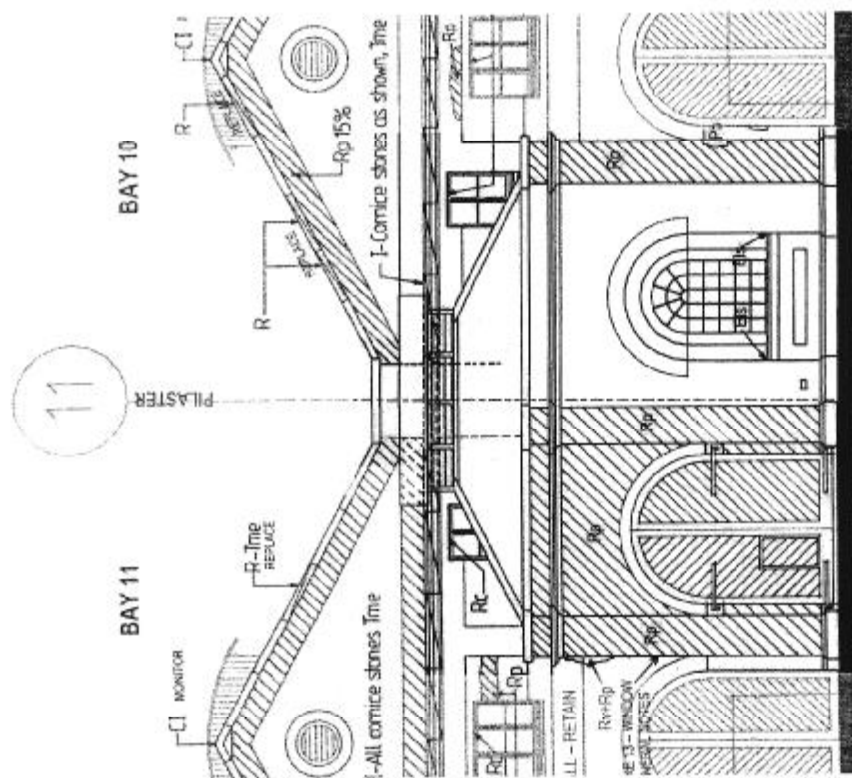
LOCATION Annexe 13 / South

DESCRIPTION	SIGNIFICANCE	CONDITION	RECOMMENDATION	RECOMMENDED WORKS	NOTES
PEDIMENT/PARAPET	S1	C3	R1	Light wash, repoint as required. Els joints.	
Stonework					
coping	S1	C3	R1	Els joints. Patch any cracks. Light wash as required.	
weathering	N/A				
rusts	N/A				
Brickwork					
rusts	N/A				
panels	S1	C2	R3	Repoint whole parapet as indicated. Light wash as required.	
rusts	N/A				
BALLISTE	N/A				
UPPER WALL	S1	C1	R3	Repair corners, repoint cracks. Treat corrosion.	HP
Stonework					
cornice	S1	C1	R3	Patch stone. Repoint cracks. Els joints. Light wash.	HP
Brickwork					
rusts	N/A				
panels	N/A				
rusts	N/A				
Windows	N/A				
LOURES	N/A				
LOWER WALL					
Brickwork					
rust	S1	C2	R3	[Central pilaster] Repoint. Light wash as required.	
arches	S1	C3	R1	Monitor arches for cracking. Light wash, repoint as required.	
panels	S1	C2	R3	Repoint brickwork. Light wash as required.	
panel under sill	S1	C2	R3	Insert brick (west wall). Light wash, repoint as required.

rusts	S1	C3	R1	Monitor bolt plates for corrosion and water ingress.	
Stonework					
window sill	S1	C2	R3	Elts joints.	
plinth	S1	C1	R3	Elts joints. Repoint cracks. Monitor hole-base of central HP.	
corbel	N/A				
rusts	N/A				
Windows	S1	C2	R3	Apply rust converter to frames as required.	
Door(s)	S1	C3	R1	Front gate: preserve hinges. East wall: 1995 glazed door.

Arches generally in good condition. At the main gate, the brick keystone has been replaced with stone. This may indicate earlier problems and the arches should be monitored.

Plinth severely deteriorating. Repairs are noted above but in the long term replacement or indenting of the stone may be required.

ANNEXE 13: Rp 50%  
OF EASTERN WALL
