# EVELEIGH LOCOMOTIVE WORKSHOPS

## F A B R I C I N V E N T O R Y

## 1.0 EXECUTIVE SUMMARY

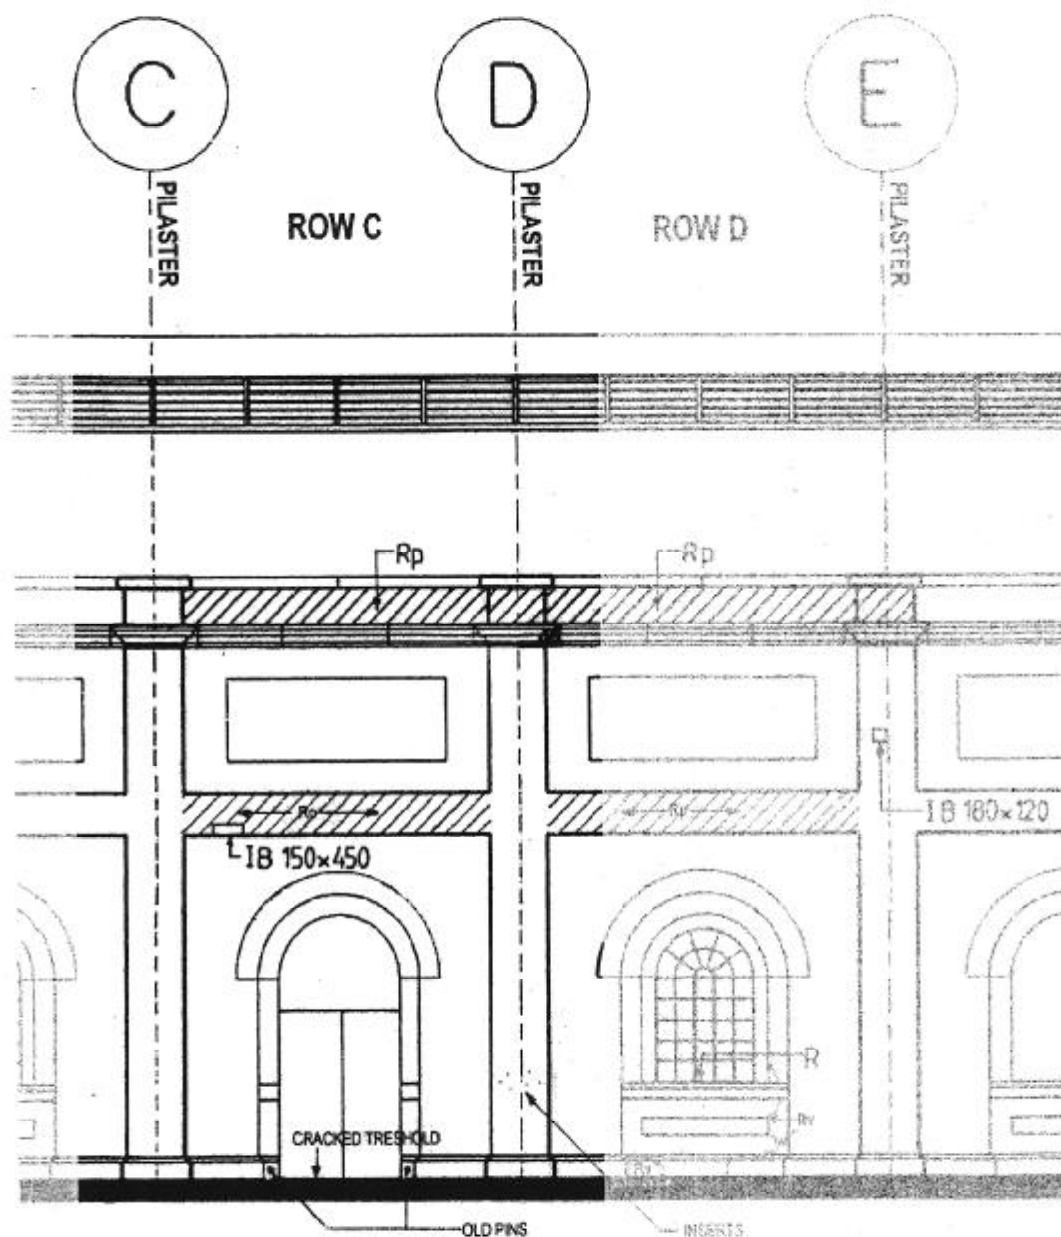
Row C/13 west

DESCRIPTION	SIGNIFICANCE	CONDITION	RECTIFICATION	RECOMMENDED WORKS	NOTES
PEDIMENT/PARAPET	S1	C2	R3	Repoint parapet brickwork. Els joints. Light wash as required.	
STONWORK					
coping	S1	C2	R3	Mortar fill and Els joints.	
weathering	N/A				
inserts	N/A				
BRICKWORK					
rims	N/A				
panels	S1	C2	R3	Repoint entire parapet. Light wash as required.	
inserts	N/A				
BULLSEYE	N/A				
UPPER WALL	S1	C3	R1	Light wash and repoint as required.	
STONWORK					
cornice	S1	C3	R1	Mortar fill and els stone joints.	
BRICKWORK					
rims	S1	C3	R1	Light wash and repoint as required.	
panels	S1	C3	R1	Light wash and repoint as required.	
inserts	N/A				
WINDOWS	N/A				
LOUVRES	N/A				
LOWER WALL					
BRICKWORK					
rim	S1	C2	R3	Repoint rim and insert brick as shown.	
arches	S1	C3	R1	Light wash and repoint as required.	
panels	S1	C3	R1	Light wash and repoint as required.	
panel under sill	N/A				
inserts	N/A				
STONWORK					
window sills	N/A

DESCRIPTION	SIGNIFICANCE	CONDITION	RECTIFICATION	RECOMMENDED WORKS	NOTES
<i>lower wall continued</i>					
GLAZED INFILL	S3	C3	R1	New glazed door added 1995.	Done
THRESHOLD	S1	C1	R3	Repair cracked threshold. Els joints. Light wash as required.	
TIMBER FRAMED WALL	N/A				
SERVICE PIPES	N/A				
STEELWORK	S1	C2	R1	Preserve steel brackets. Rust proof as required.	Interpret
PILASTER					
STONWORK					
coping	S1	C2	R3	Els joints. Light wash as required.	
comice	S1	C3	R1		
plinth	S1	C3	R1		
inserts	Nil				
BRICKWORK					
parapet	S1	C2	R3	Repoint entire parapet. Light wash as required.	
body	S1	C3	R1	Light wash and repoint as required.	
down pipes	N/A				
inserts	S2	C2	R1	Monitor inserts and brickwork. Repair as necessary	Comment
END PILASTER	N/A				
STONWORKS					
coping	N/A				
comice	N/A				
plinth	N/A				
inserts	Nil				
BRICKWORK					
parapet	N/A				
body	N/A				
pipes	N/A				
inserts	Nil				
OTHER 1	S4	C2	R3	Remove loose cables stretched between steel brackets.	Intrusive.

OTHER 2	S1	C2	R1	Monitor historic metal fittings for corrosion and cracked brickwork.	
OTHER 3

In the pilaster and lower panel ferrous metal inserts have some heritage value. Monitor inserts for corrosion and surrounding brickwork for cracks. Do not remove unless insert is rusting and expanding and causing significant damage to structure or fabric. Consider application of rust convertor or other treatment to stabilise.

Consider a more sympathetic lighting solution for the west wall.

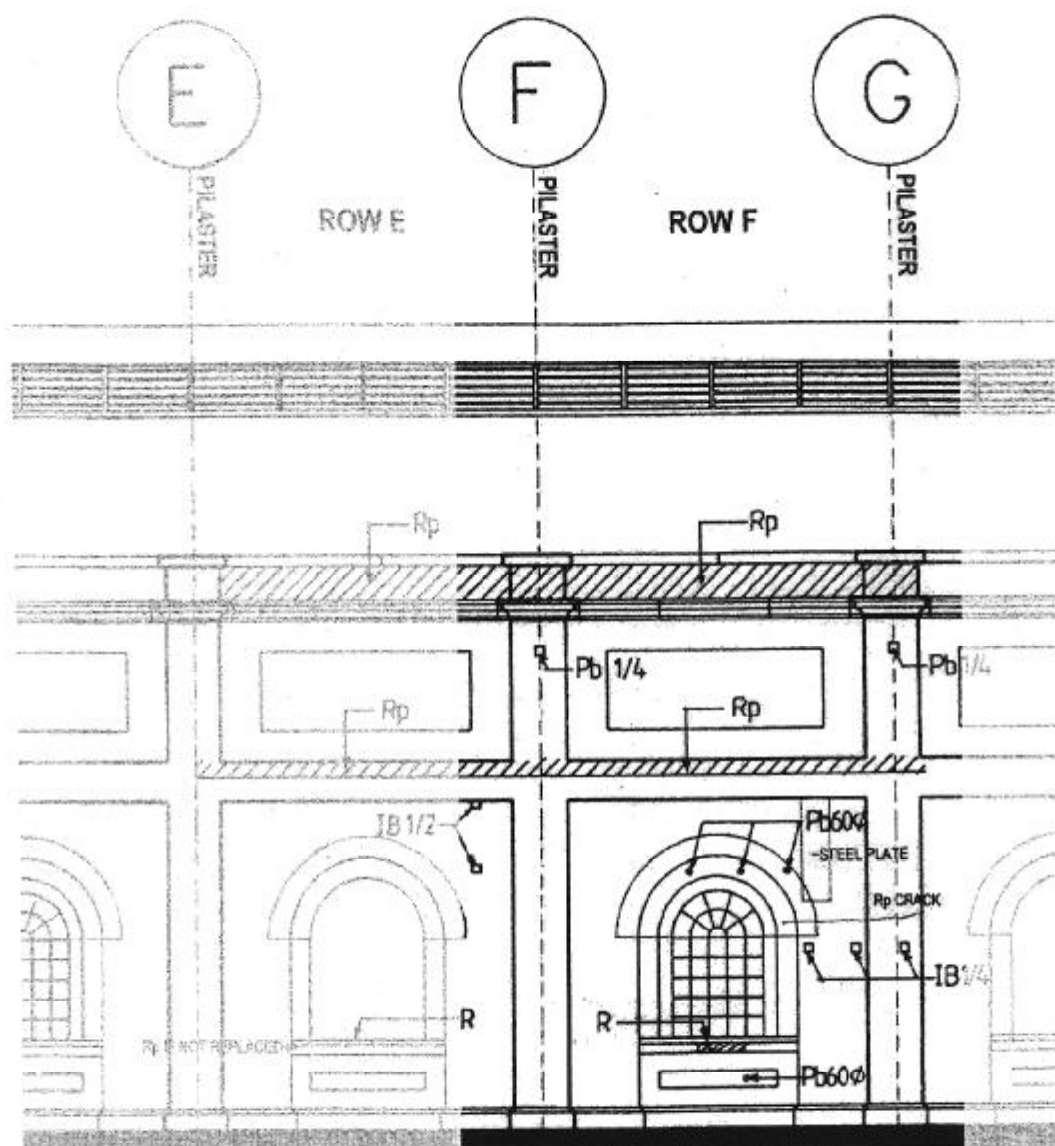
Row F/10 west

PVC pipe inserted into panel under window sill. Monitor for cracks and water ingress then reassess.

See drawing for Row G / West for further information regarding vertical crack in pilaster F.

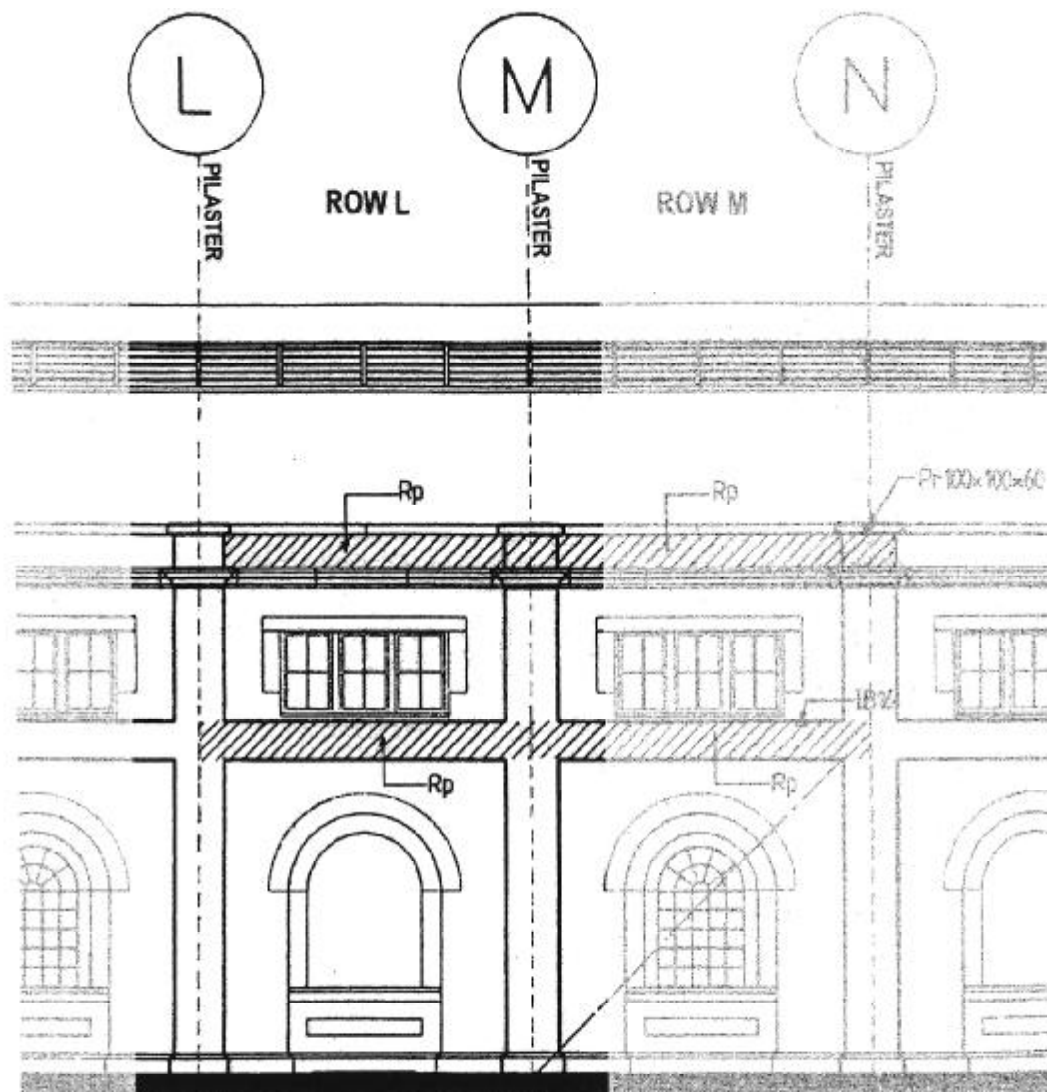
Record # 11

Area shown crossed out not surveyable

Preserve any  
historic fittings  
(eg. steel bolts)

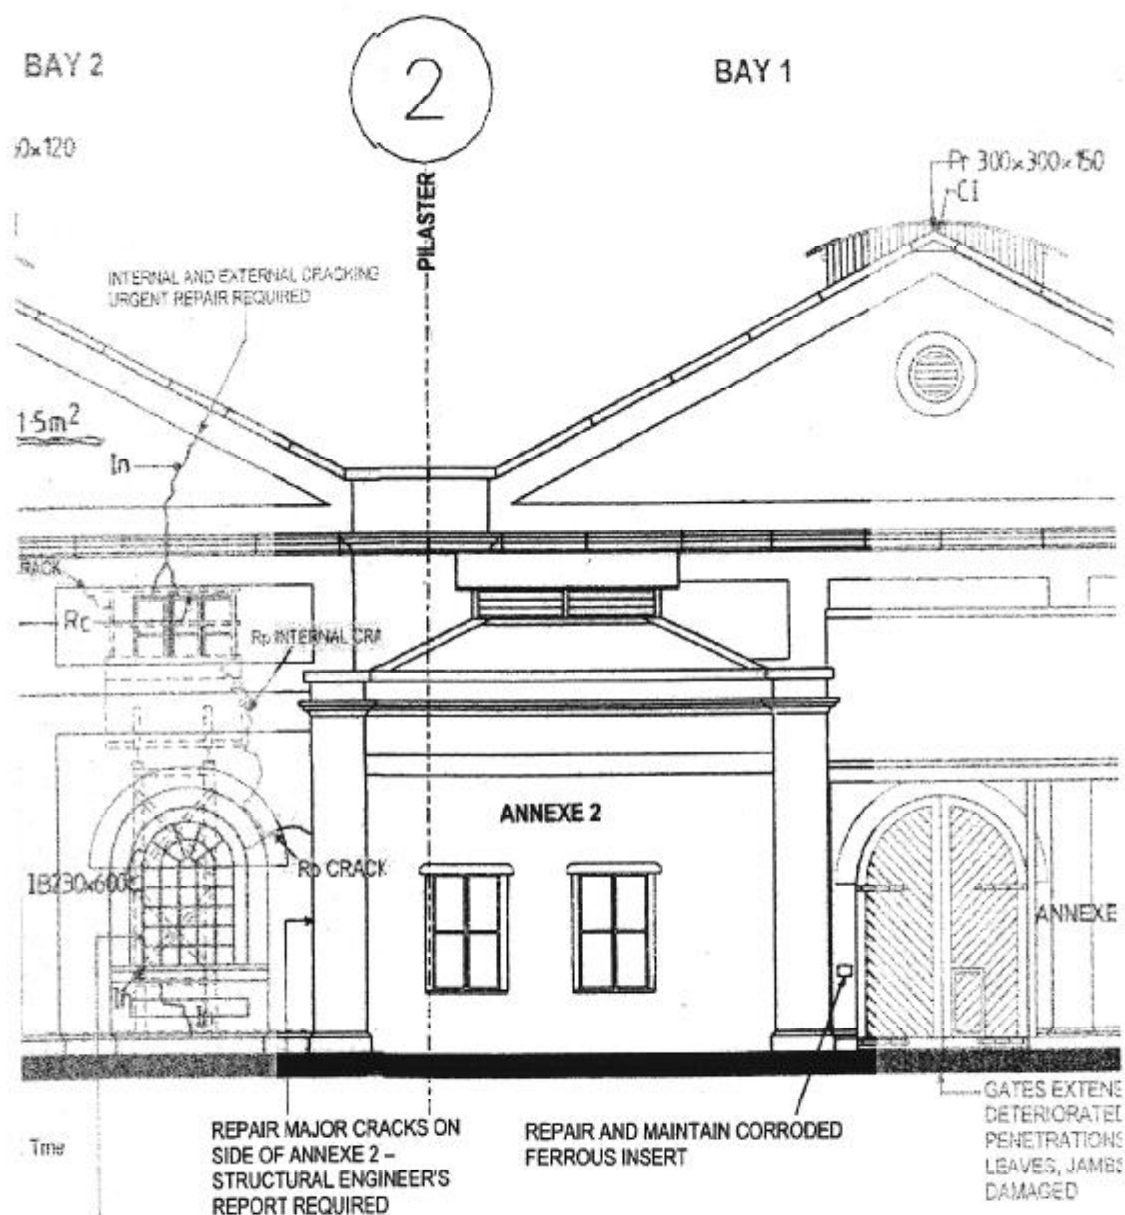
Annexe 2 /South

Large internal and external cracks indicate structural instability in Annexe 2. A structural engineer's report is required, particularly to assess the west wall. Stabilising and repairing Annexe 2 should be given highest priority. See also the Fabric Inventory report for a more detailed study of the interior fabric.

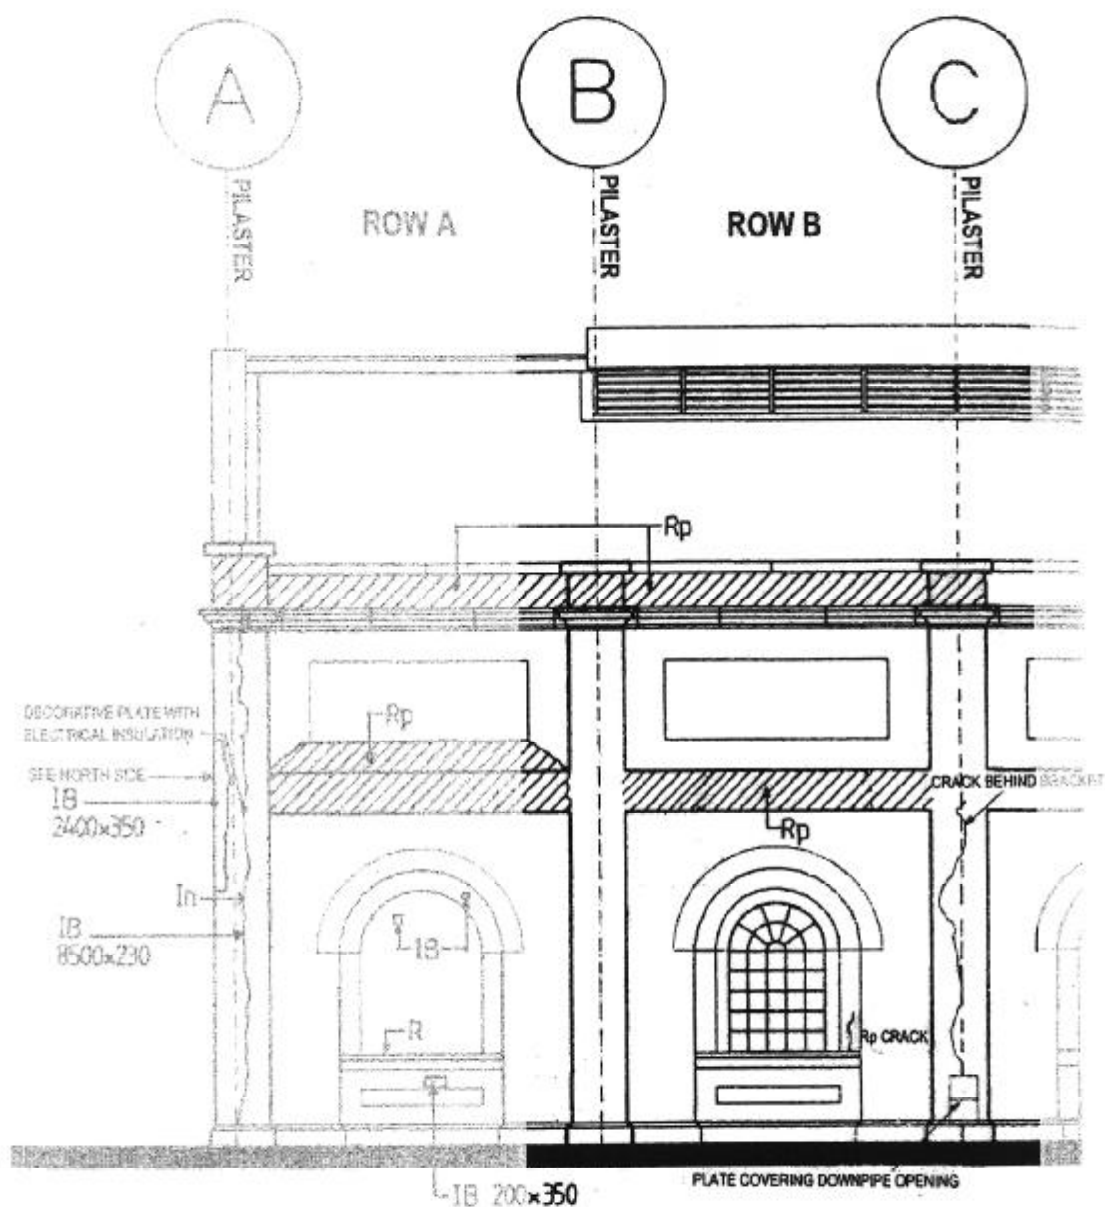
Record # 2

DESCRIPTION	SIGNIFICANCE	CONDITION	RECTIFICATION	RECOMMENDED WORKS	NOTES
PEDIMENT/PARAPET	S1	C2	R3	Repoint entire parapet and Els joints. Light wash as required.	
STONework					
coping	S1	C2	R3	Els joints. Light wash as required.	
weathering	N/A				
inserts	N/A				
BRICKWORK					
rims	N/A				
panels	S1	C2	R3	Repoint entire parapet. Light wash as required.	
inserts	N/A				
BULLSEYE	N/A				
UPPER WALL	S1	C2	R3	Els cornice joints. Repoint and light wash brickwork as	
STONework					
cornice	S1	C2	R3	Mortar fill & Els joints. Light wash as required.	
BRICKWORK					
rims	S1	C3	R1	Light wash and repoint as required.	
panels	S1	C3	R1	Light wash and repoint as required.	
inserts	N/A				
WINDOWS	N/A				
LOUVRES	N/A				
LOWER WALL					
BRICKWORK					
rim	S1	C2	R3	Repoint and insert brick as indicated in drawing	
arches	S1	C2	R3	Repoint crack.	
panels	S1	C3	R1	Light wash and repoint as required.	
panel under sill	S1	C3	R1	Light wash and repoint as required.

inserts	N/A				
STONework					
window sills	S1	C2	R3	Mortar fill and Els joints. Light wash as required.	
plinth	S1	C3	R1		
corbel	N/A				
inserts	N/A				
WINDOWS	S1	C3	R1		
DOOR(S)	N/A

Row B/14 west

- ☐ R replace stone
- ☐ I Indent stone
- ☐ H Hairline jointed stone insert
- ☒ Rp Re point
- ☐ Ci Corroded insert, remove and epoxy patch
- ☐ Ps Small epoxy patch
- ☐ Pr Patch stone with reinforcement
- ☒ IB Insert Brick
- ☐ Els Mortar fill joint, elastometric sealant and backing rod to top
